**Engineering and Technical  
Services for Joint Group on  
Acquisition Pollution  
Prevention (JG-APP) Pilot  
Projects**

**Field Evaluation Report I**

**Inspection of Aircraft for  
Validation of Alternatives to  
Chromate-Containing Primer  
Coatings for Aircraft Exterior  
Mold Line Skins**

**May 22, 1998**

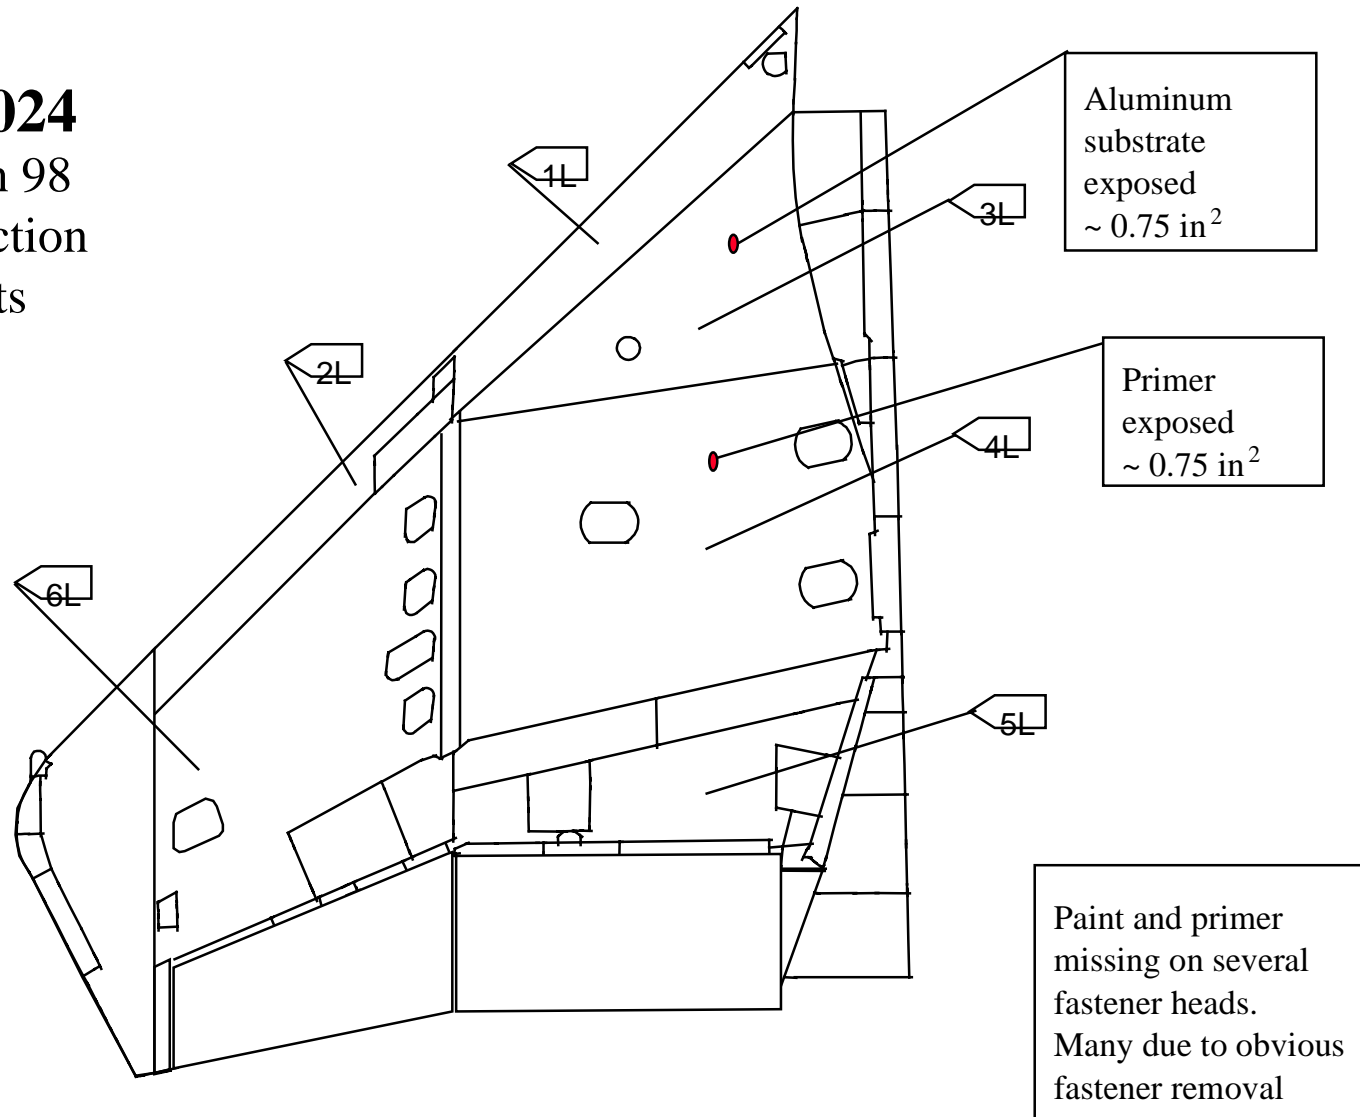
**Figure 1. F-15 #81 024, View Looking Down, Left Wing**

Aircraft #81 024 was inspected first and was found to have several areas of the titanium substrate exposed on the lower wing surfaces. There was bare titanium on the left wing and right wing but more sites and larger sites on the right wing (see Figure 1 through Figure 4 for additional details).

Leading edges of the wings revealed erosion and mechanical paint damage. The left wing had more erosion areas and more severe erosion than the right wing.

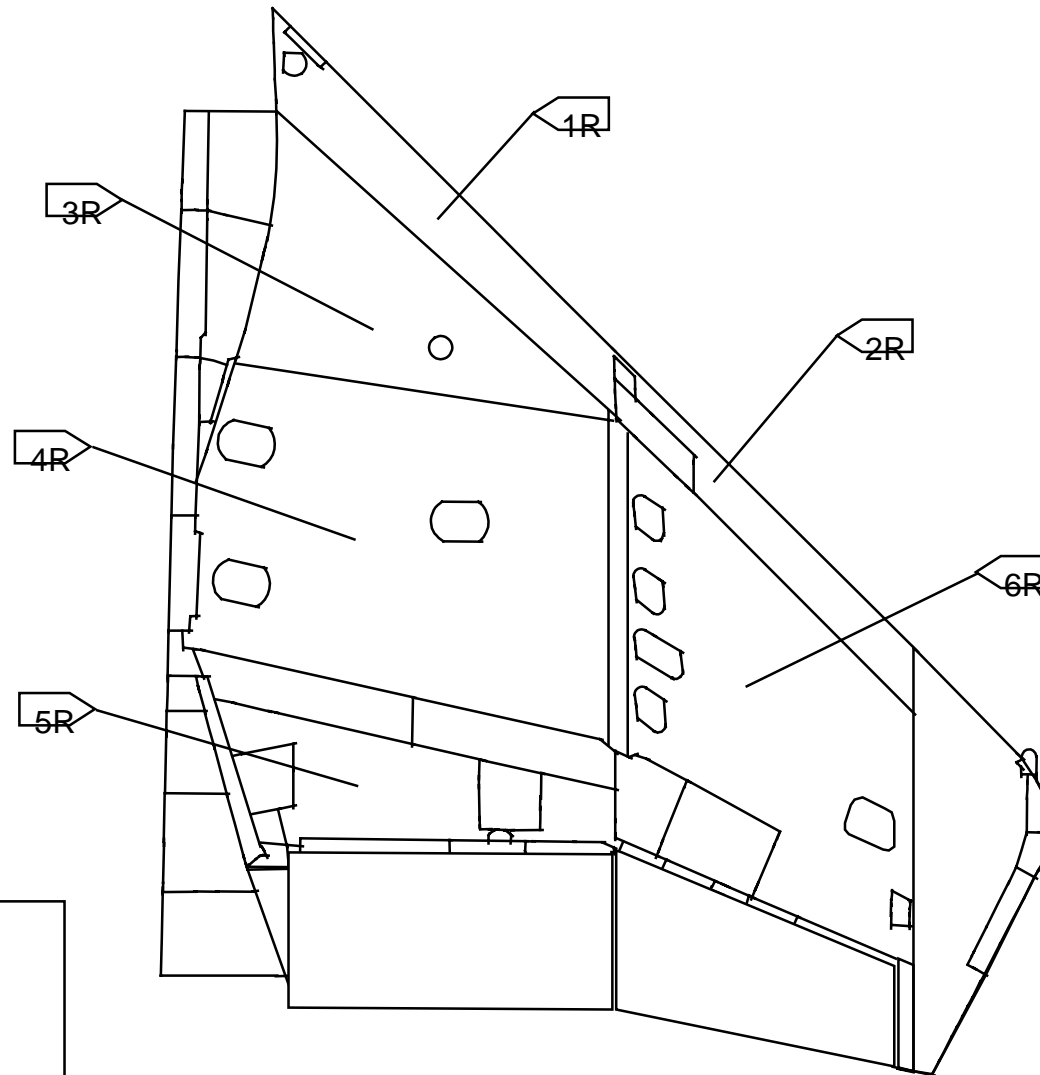
**Figure 3. F-15 #81 024, View Looking Down, Right Wing**

Topcoat and primer were missing from several fastener heads on the upper surfaces of both wings. Several such areas of missing coating were obviously due to mechanical damage from fastener removal, which resulted in chipped paint around the fasteners and around the removable covers. There were also several fastener heads exposed due to loss of adhesion on titanium and steel fasteners. Paint damage to fasteners on upper surfaces is often caused by walking on the aircraft. The quantity and severity of the areas of missing coating were approximately equal on the left and right wings.

Paint and primer  
missing on several  
fastener heads.  
Many due to obvious  
fastener removal

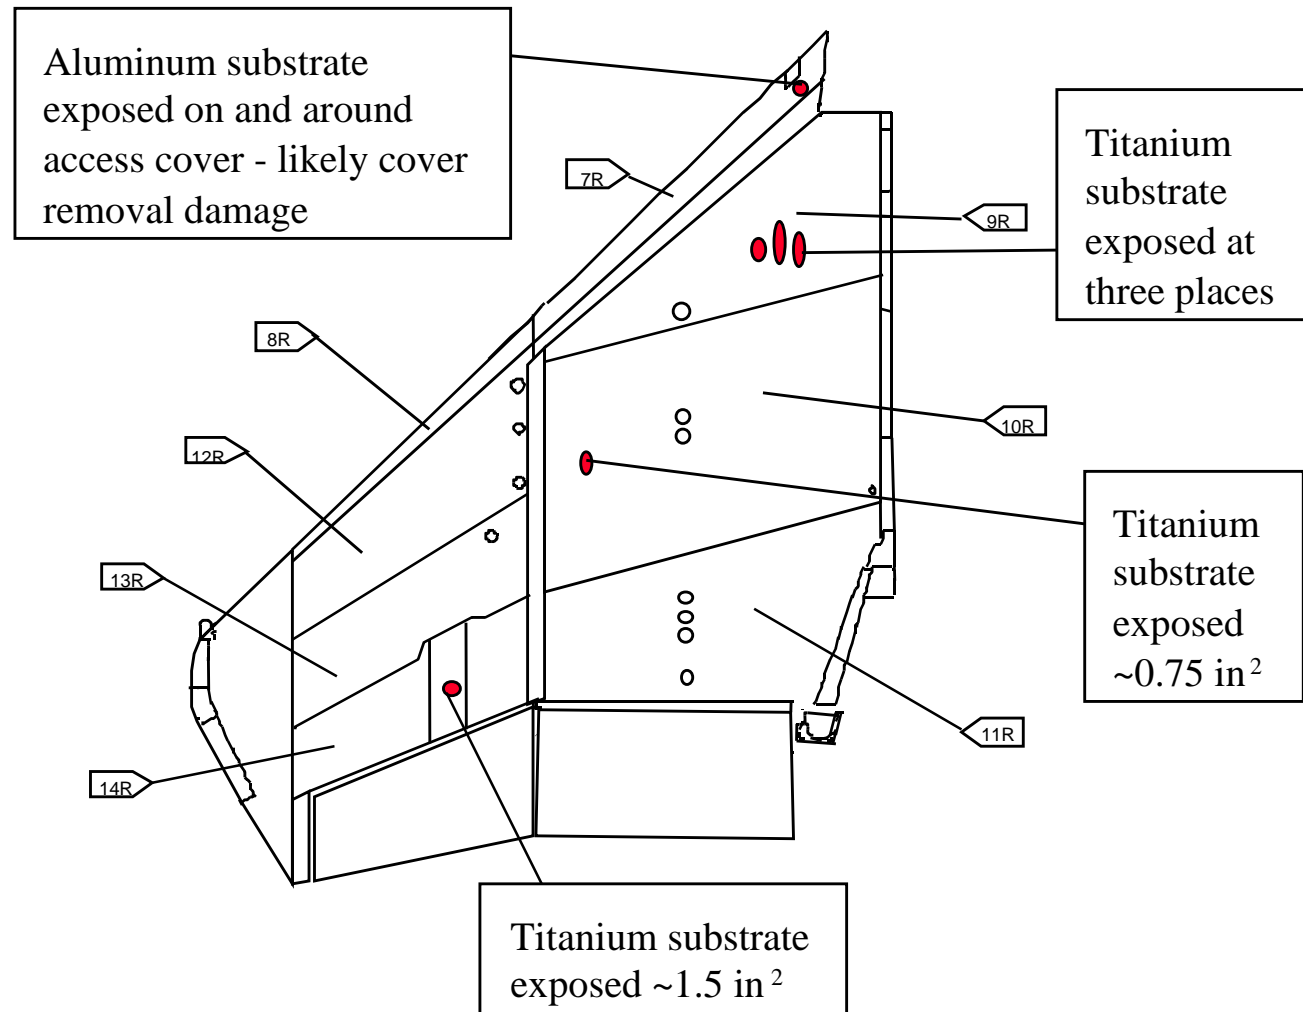
**Figure 4. F-15 #81 024, View Looking Up, Right Wing**

Based on the initial inspection of #81 024, a simple analysis of the defects would indicate that the adhesion of the waterborne nonchromate primer to the titanium surfaces is not as good as the solventborne control primer. Preparation of the substrate, particularly titanium, is known to be more of a factor for good adhesion with waterborne primers than with solventborne primer and is not a function of chromate versus nonchromate primers. The primer failures identified during this inspection were localized, leading to the conclusion that the failures may be due to factors other than a poorly performing primer. If primer failures were widely dispersed over the titanium surfaces it would be more indicative of a poorly performing primer.

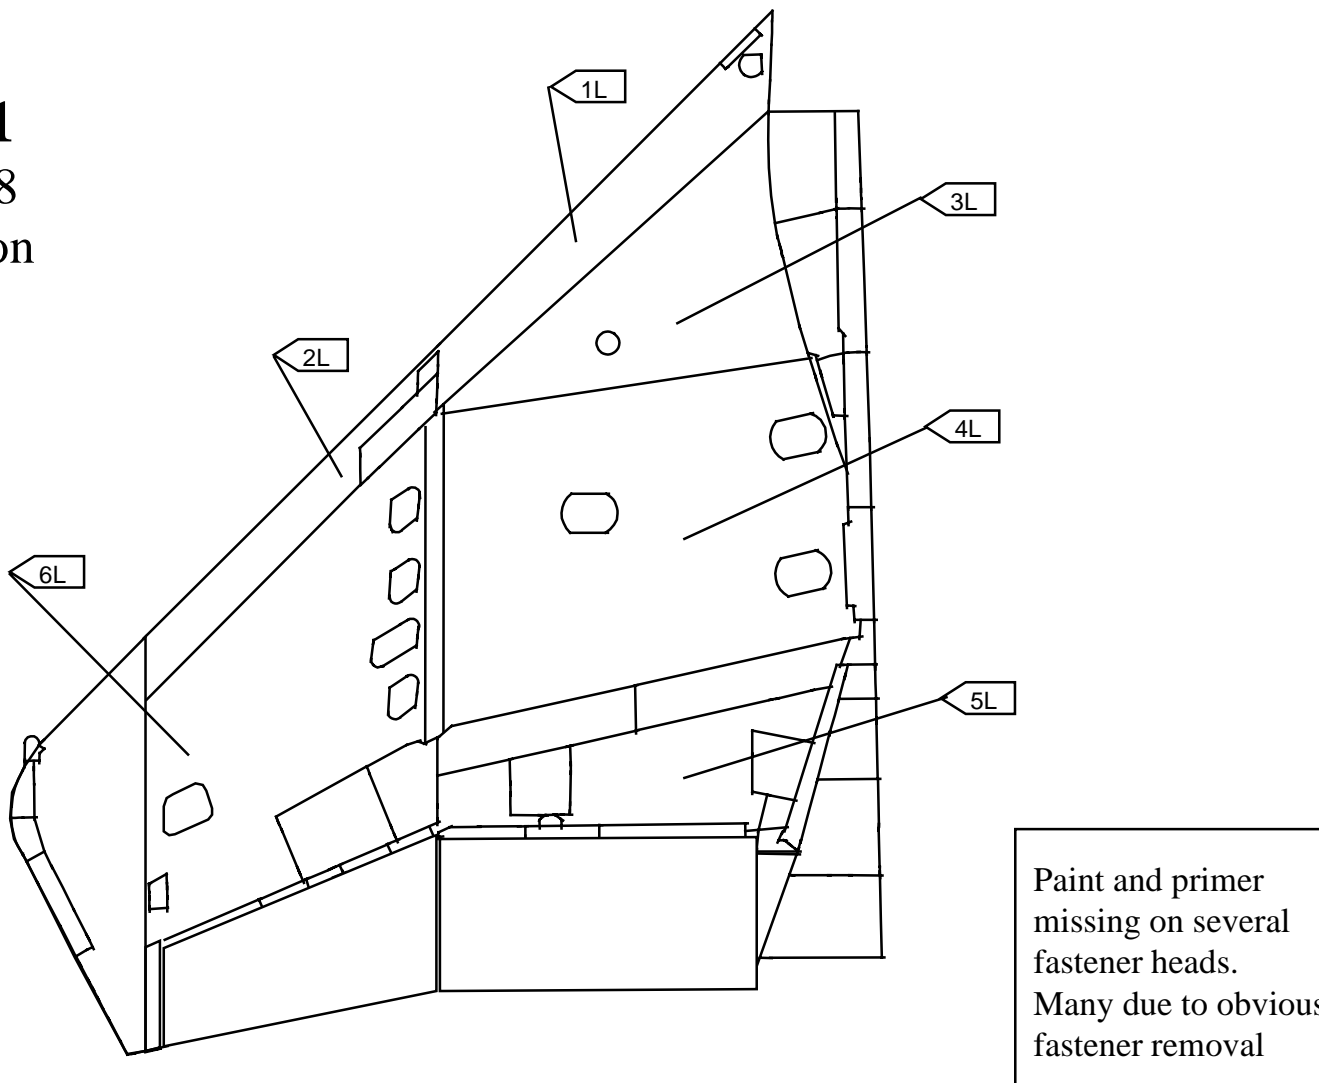
**Figure 5. F-15 #79 011, View Looking Down, Left Wing**

Aircraft #79 011 was found to have minimal paint defects on the lower wing surfaces and there were no significant differences between the chromate and nonchromate sides. There were areas of mechanical damage and erosion on leading edges that were more pronounced on the left wing (see Figure 5 through Figure 8 for locations).

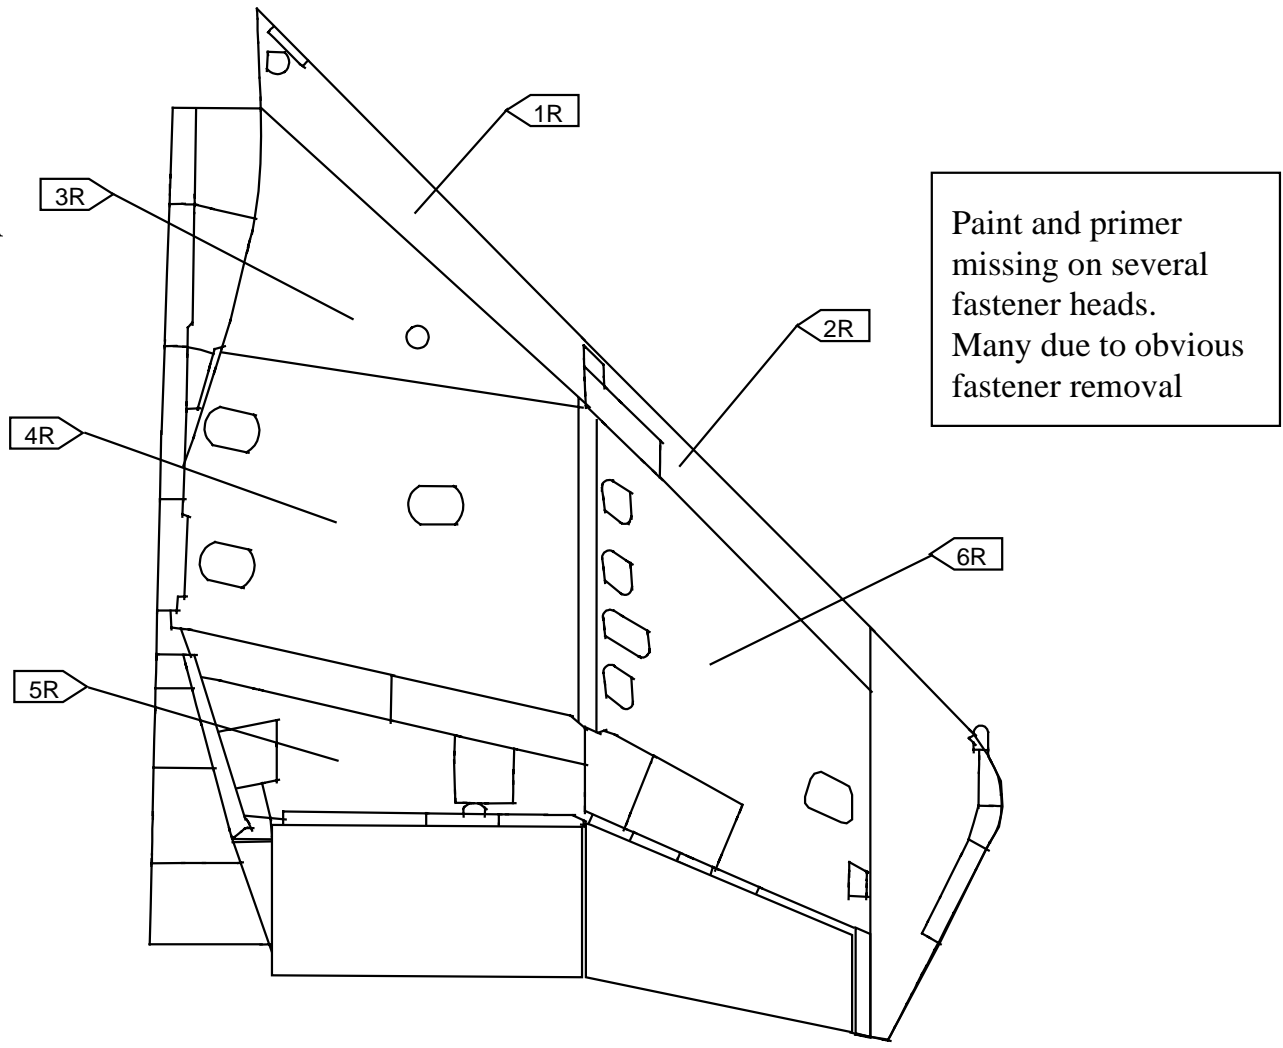
**Figure 7. F-15 #79 011, View Looking Down, Right Wing**

Topcoat and primer were missing from fastener heads on the upper surfaces of both wings. As with aircraft #81 024, topcoat and primer were missing from several fastener heads on the upper surfaces of both wings. Several such areas were obviously due to mechanical damage from fastener removal, which resulted in chipped paint around the fasteners and around the removable covers. There were also several fastener heads exposed due to loss of paint adhesion on titanium and steel fasteners. The quantity and severity of the areas of missing coating were approximately equal on the left and right wings.
