# **Engineering and Technical Services for Joint Group on Acquisition Pollution Prevention (JG-APP) Pilot Projects**

### **Inspection of Aircraft for Validation of Alternatives to Chromate-Containing Primer Coatings for Aircraft Exterior Mold Line Skins**

**September 14, 1998**

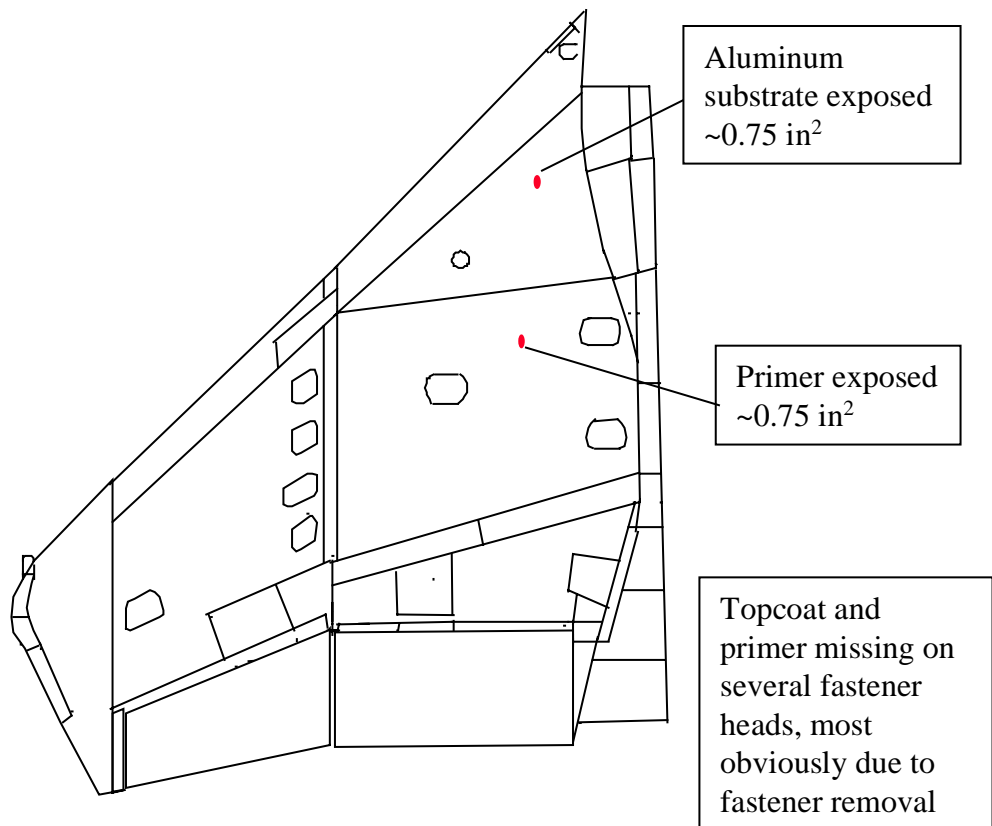
**Figure 1. F-15 #81-024, View Looking Down, Left Wing**

No new defects were found on the upper surface of the left wing since the last inspection. Topcoat and primer were missing from several fasteners with chipped paint around the fasteners due to fastener removal. There was only one new area of peeling paint on the lower titanium skins and the two areas noted in the January inspection had not appreciably increased in size. Additional areas of aluminum substrate were exposed on the leading edge and the areas noted in the previous inspection had increased in size, likely due to erosion. Figures 1 and 2 show the locations of the observed coating defects.

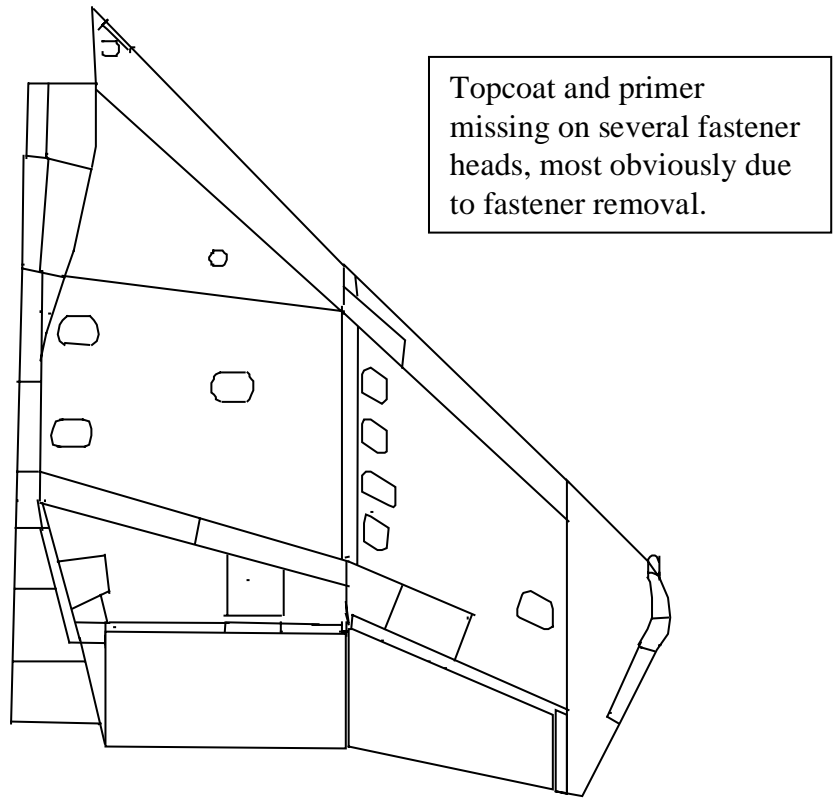
**Figure 3. F-15 #81-024, View Looking Down, Right Wing**

No new defects were observed on the upper surface of the right wing since the last inspection. Topcoat and primer were missing from several fasteners with chipped paint around the fasteners due to fastener removal. Multiple areas of peeling paint had been found on the lower titanium wing skins during the January inspection; many of these peeling paint areas had increased in size. New areas of peeling paint were also observed on the lower titanium skins. Small areas of peeling primer (approximately 0.5 inch in diameter) have appeared on the lower surface of the wing on aluminum substrates. Most defects are on and adjacent to fasteners but two small areas were also noted on the wing tip skin. Only one defect noted on the leading edge appeared to have been initiated by mechanical damage. Figures 3 and 4 show the locations of the observed coating defects.

It is recommended that the coating defects on the right wings be touched up with nonchromate primer.

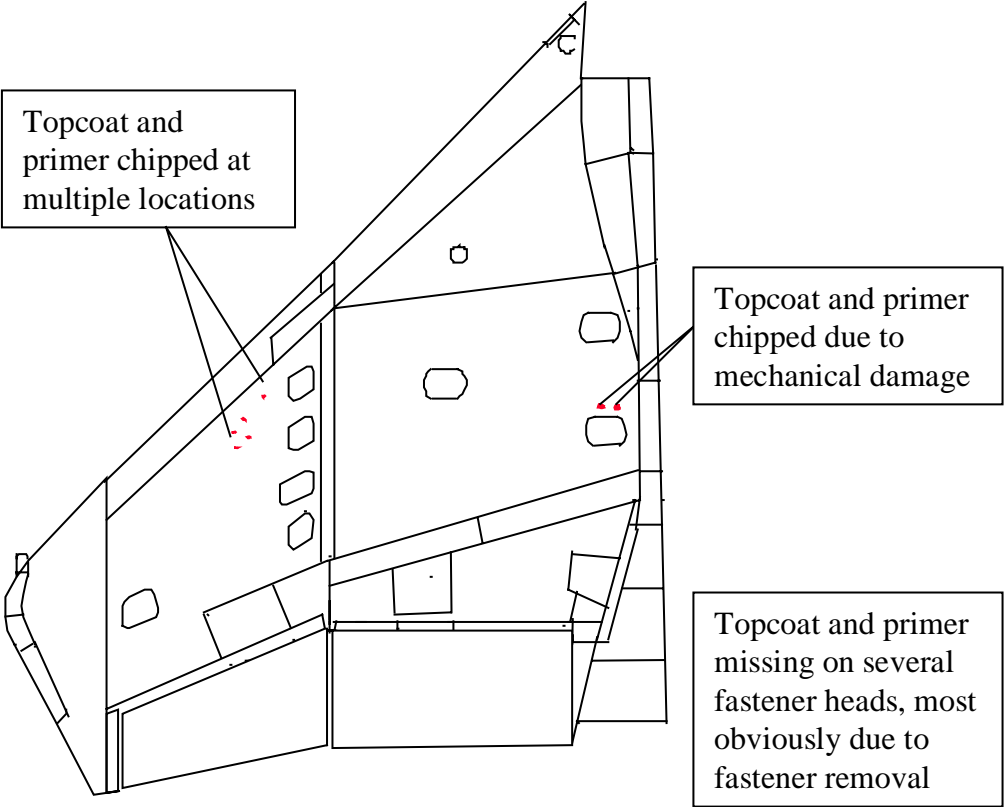
**Figure 5. F-15 #79-011, View Looking Down, Left Wing**

Multiple areas of chipped paint were found on the outboard panel and two areas on an inboard panel of the upper surface of the left wing. These areas were probably initiated by mechanical damage. Topcoat and primer were missing from several fasteners with chipped paint around the fasteners due to fastener removal. No new areas of peeling paint on the titanium surfaces of the lower wing appeared since the January inspection. One area at the splice of the inner and outer skins

had a new rust-colored stain at a fastener location. Additional areas of aluminum substrate were exposed on the leading edge and the areas noted in the previous inspection had increased in size, likely due to erosion. Figures 5 and 6 show the locations of the observed coating defects.

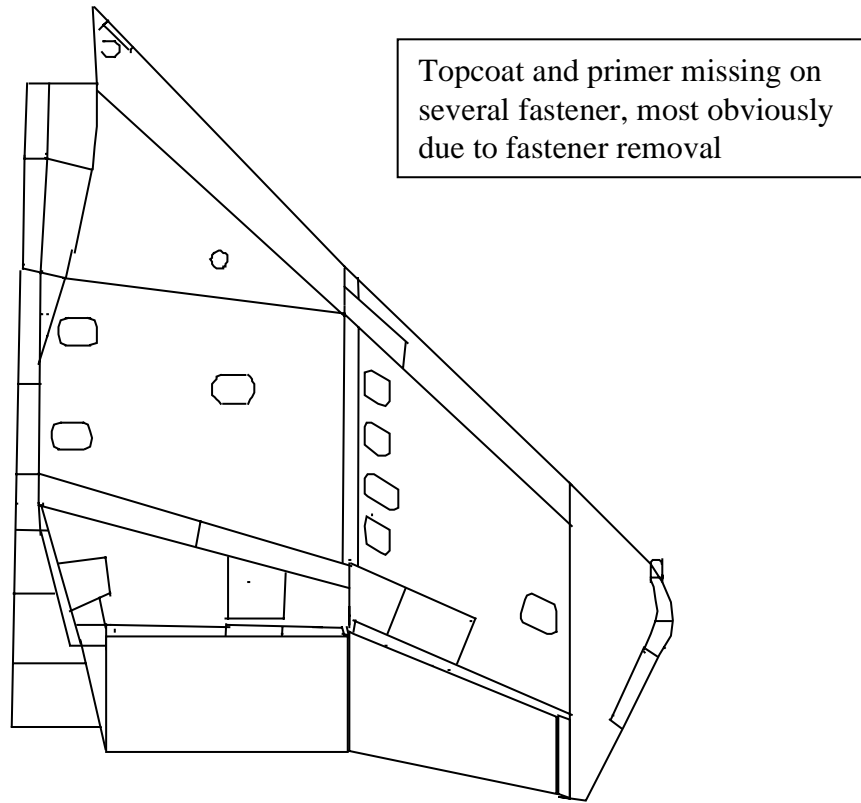
**Figure 7. F-15 #79-011, View Looking Down, Right Wing**

No new defects were observed on the upper surface of the right wing since the last inspection. Topcoat and primer were missing from several fasteners with chipped paint around the fasteners due to fastener removal. Seven new areas of peeling paint were identified at this inspection on titanium and aluminum skins. Adhesion defects were much more severe on titanium than on aluminum. In addition, small areas of peeling paint on aluminum substrates at permanent or non-removable fastener locations were observed. No defects were noted on the leading edge of the right wing except at the inboard marker light; this defect was likely initiated when the light was removed. Figures 7 and 8 show the locations of the observed coating defects.
