**Engineering and Technical  
Services for Joint Group on  
Pollution Prevention  
(JG-PP) Pilot Projects**

**Field Evaluation Report IX:**

**Inspection of Aircraft  
for Validation of  
Alternatives to  
Chromate-Containing  
Primer Coatings for Aircraft  
Exterior Mold Line Skins**

**February 16, 1999**

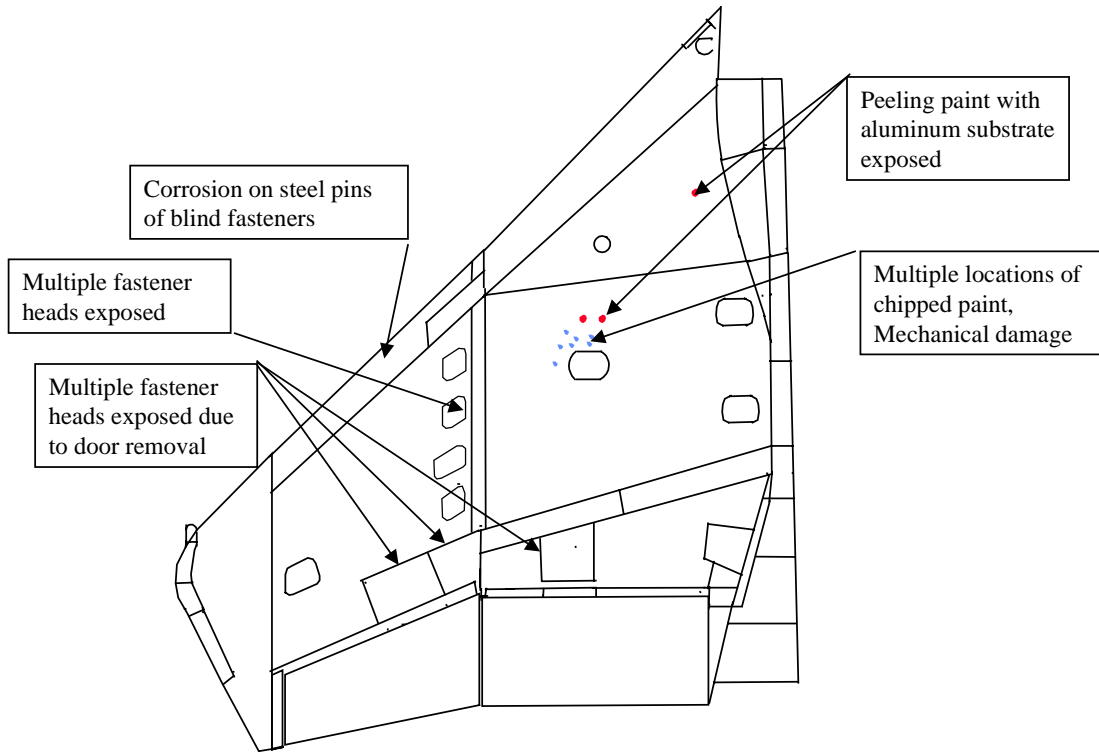
**Figure 1. F-15 #81-024, Left-Hand Wing Looking Down**

New defects found on the upper surface of the wing since the last inspection were minor corrosion on the steel stems of some blind fasteners, additional exposed fastener heads and additional areas of chipped paint. Paint and primer were missing from several fasteners that did not appear to have been removed and covers that were removed had exposed fastener heads and chipped paint around the fasteners.

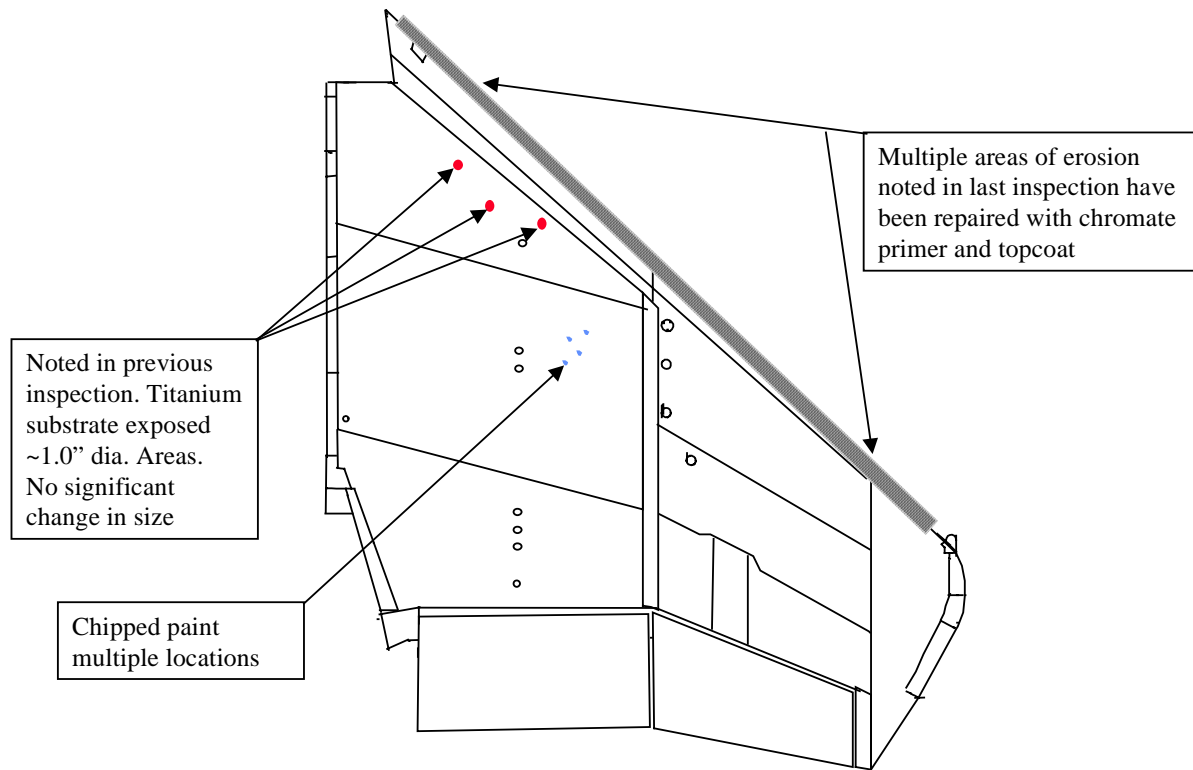
**Figure 2. F-15 #81-024, Left-Hand Wing Looking Up**

There was only one new area of peeling paint on the lower titanium skins and the two areas noted in the January inspection did not appreciably increase in size. The exposed aluminum substrate on the leading edge noted in the last inspection has been repaired with chromate primer and topcoat. (Ref. Figures 1 and 2)

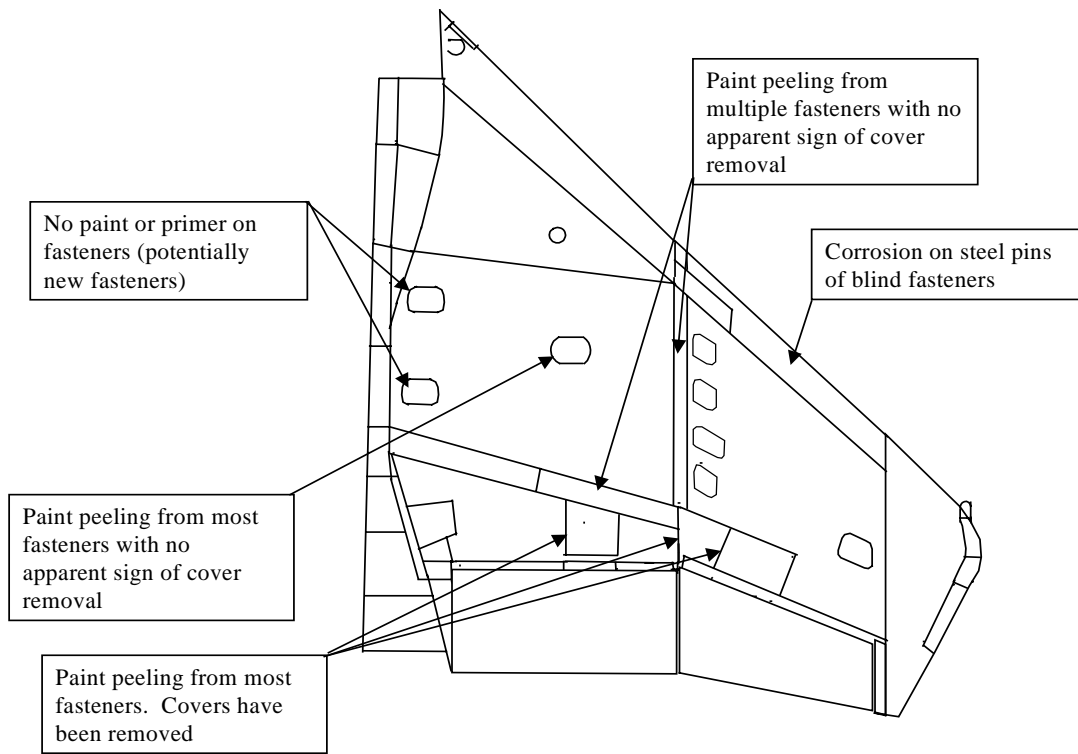
**Figure 3. F-15 #81-024, Right-Hand Wing Looking Down**

New defects on the upper surface of the wing include minor corrosion on the steel stems of some blind fasteners and additional exposed fasteners since the last inspection. There were more exposed fastener heads than on the left wing. Paint and primer had peeled from several fasteners with chipped paint around the fasteners due to fastener removal.

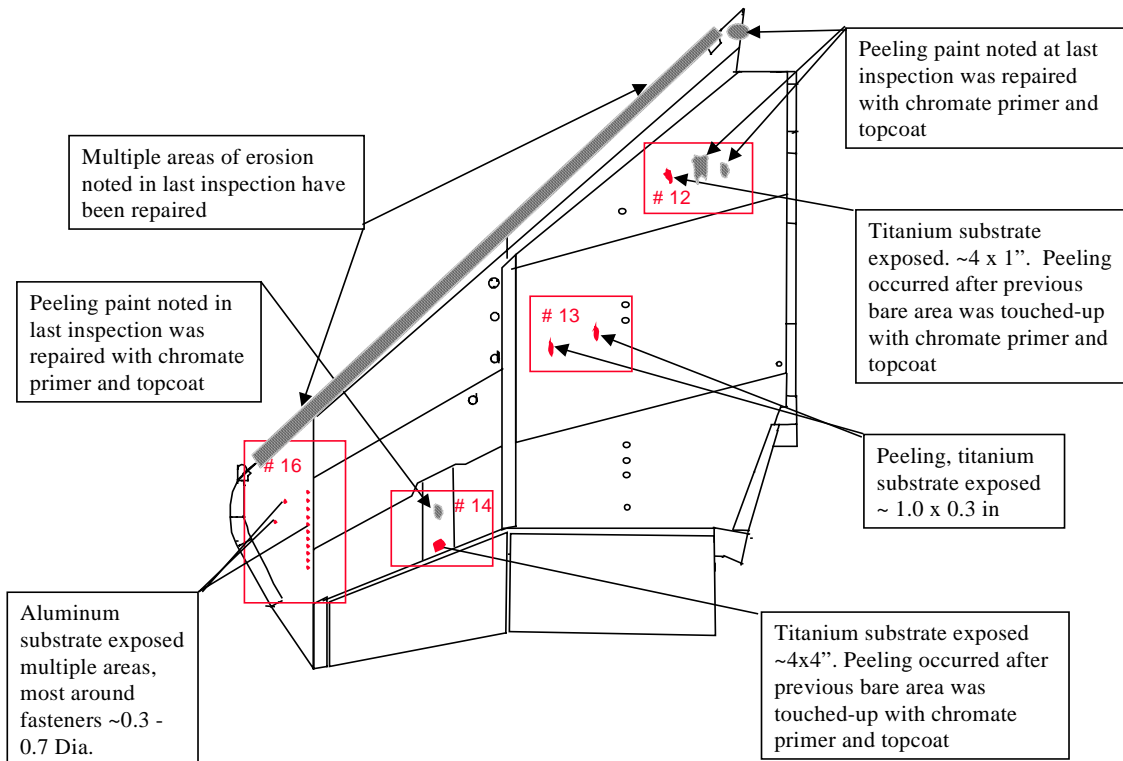
**Figure 4. F-15 #81-024, Right-Hand Wing Looking Up**

Multiple areas of peeling paint were noted on the lower titanium wing skins when inspected in July. The squadron has repaired most of the peeling paint areas with chromate primer and topcoat. Two of the repair locations have begun to peel since repair. New areas of peeling paint have also started on the titanium skins.

Additional areas of peeling primer, approximately one half to one inch in diameter have appeared on the lower surface of the aluminum wing tip. Most of the defects were on and adjacent to fasteners but two small areas were also noted on the wing tip skin. The leading edge skin has been repainted since the last inspection with chromate primer and topcoat. (Ref. Figures 3 and 4)

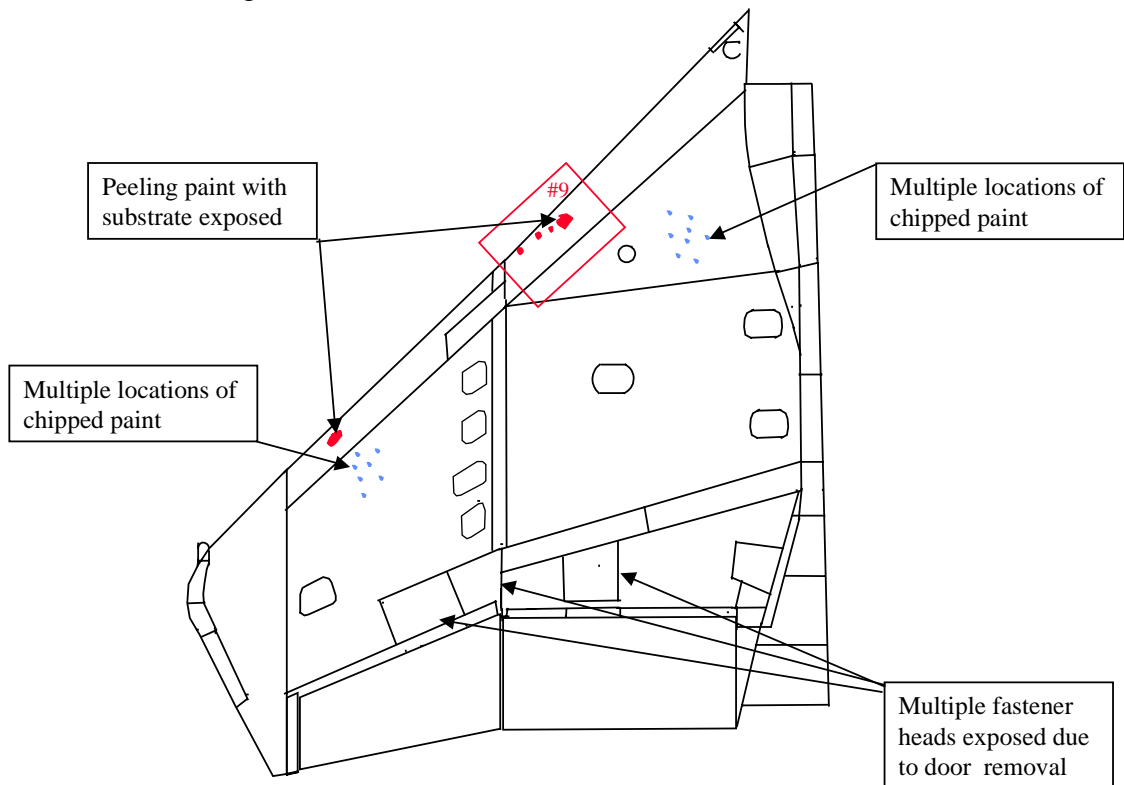
**Figure 5. F-15 #79-011, Left-Hand Wing Looking Down**

Multiple areas of chipped paint were noted on the outboard panel and inboard panels of the upper wing surface. These areas were likely initiated by mechanical damage. Paint and primer were missing from several fasteners with chipped paint around the fasteners due to fastener removal.

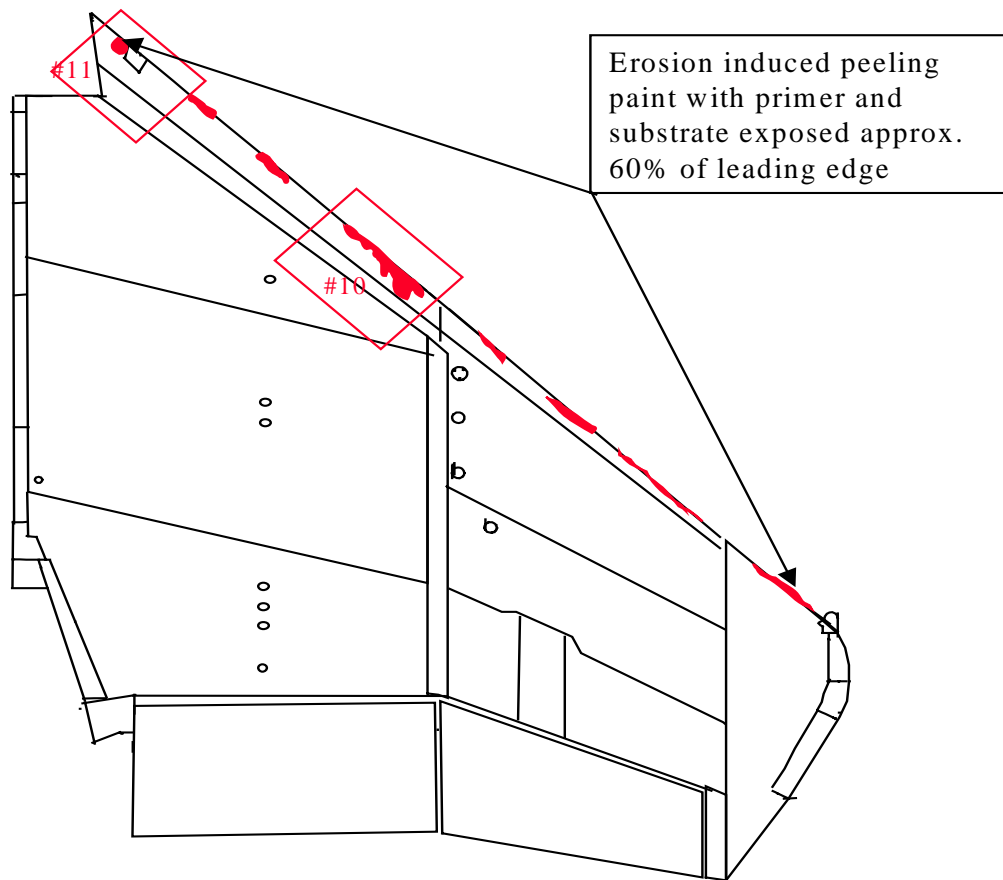
**Figure 6. F-15 #79-011, Left-Hand Wing Looking Up**

There were additional areas of exposed aluminum substrate on the leading edge and the areas noted in the previous inspection have increased in size, likely due to erosion. Approximately 60% of the leading edge had exposed substrate due to erosion. The leading edge erosion was evident on the upper and lower views but is only depicted in the view looking up. (Ref. Figures 5 and 6)

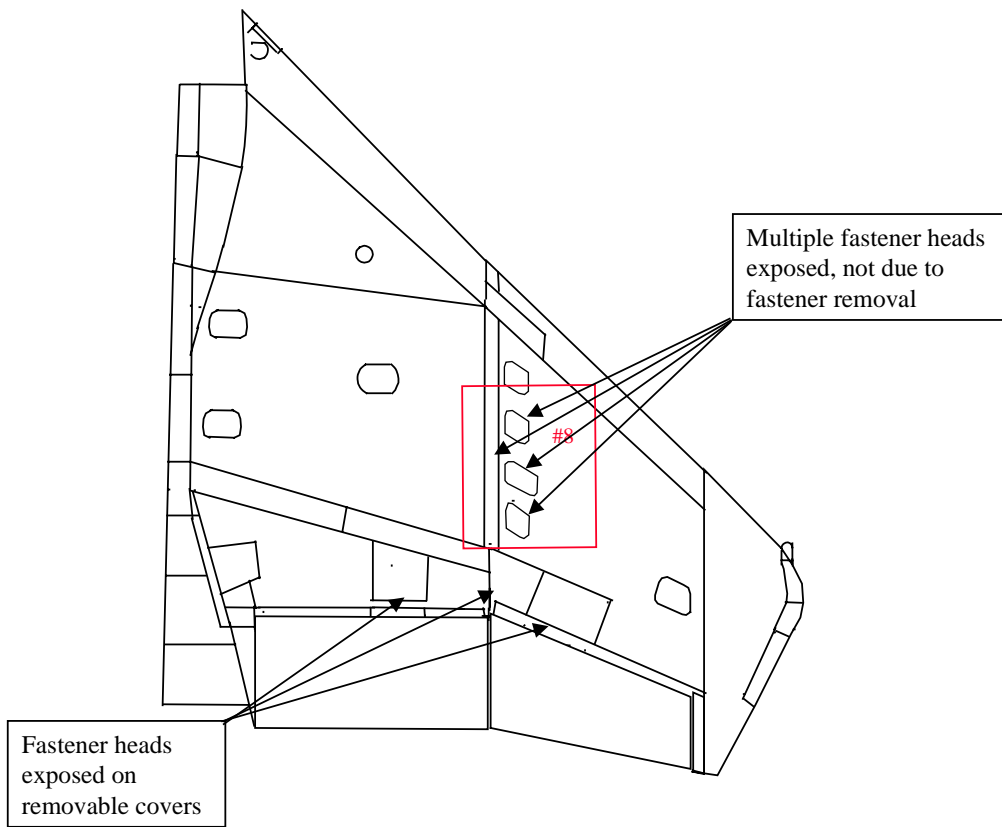
**Figure 7. F-15 #79-011, Right-Hand Wing Looking Down**

Paint and primer was missing from several fasteners with chipped paint around the fasteners due to fastener removal as noted in the last inspection. There were also several exposed fastener heads that showed no indication of having been removed.

The squadron, F-15 engineering, and Air Force Corrosion Office representatives all agreed that aircraft #79-011 should be repaired with the nonchromate primer to maintain the test objective. Dexter has agreed to furnish the necessary primer to the squadron for repairs.

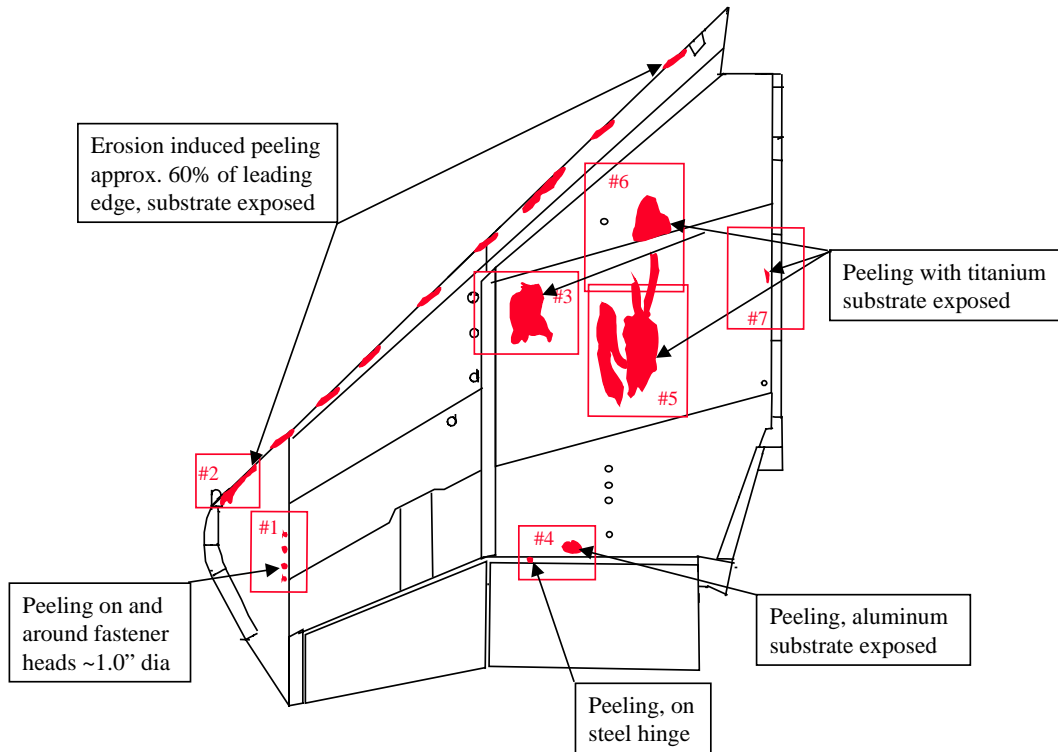
**Figure 8. F-15 #79-011, Left-Hand Wing Looking Up**

The lower wing surface had large areas of peeling paint on the titanium skins near the pylon fittings. There were also small areas of paint peeling on aluminum substrates at permanent or non-removable fastener locations that have increased slightly since the last inspection.

Leading edge erosion was evident on approximately 60% of the wing with the degree of failure similar to the left-hand wing. The leading edge erosion was evident on the upper and lower views but only depicted in the view looking up. (Ref. Figures 7 and 8)
