Field Evaluation Report VII:

**Inspection of Aircraft for
Validation of Alternatives to
Chromate-Containing Primer
Coatings for Aircraft Exterior
Mold Line Skins**

December 3, 1998

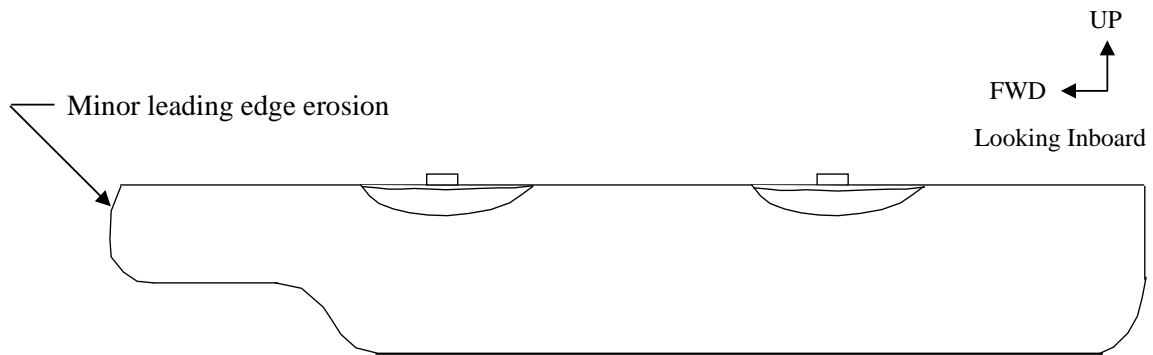
Figure 1. Left-hand Strake Looking Inboard

The strake showed no signs of coating failure except minimal erosion on the leading edge. The inboard side was heavily soiled but did not exhibit any softening or peeling of the coating. Figure 1 shows the location of the only coating defects observed on this component.

Erosion resistance of the nonchromate primer appears to be better than the chromate control primer, based on the severity of erosion after only 30 flight hours. It should be noted, however, that additional mechanical damage might have contributed to the erosion even though only one area of damage was obvious.

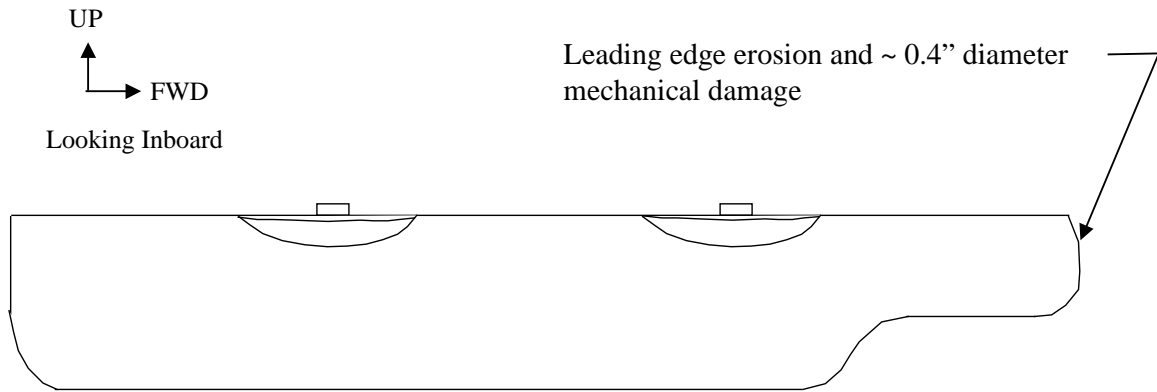
Figure 2. Right-hand Strake Looking Inboard

The strake showed no signs of coating failure except erosion on the leading edge. Erosion was more pronounced than on the L/H strake. There was also a small mechanical damage defect approximately 0.4 inch in diameter that exposed and damaged the carbon fibers. As with the L/H strake the inboard side was heavily soiled but did not exhibit any softening of or peeling of the coating. Figure 2 shows the location of the erosion and mechanical damage.

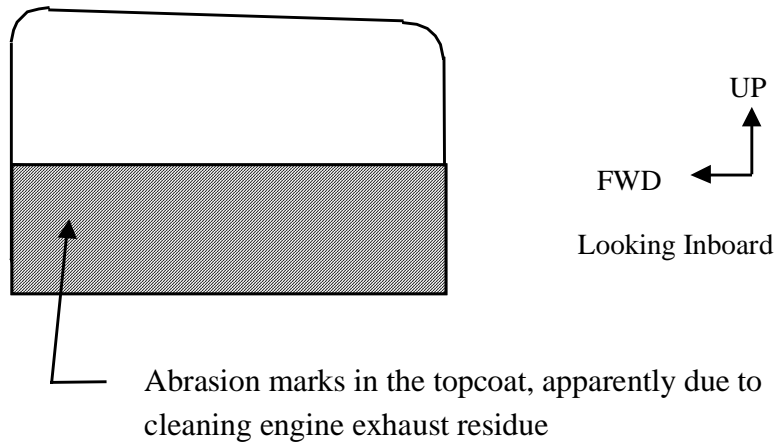
Figure 3. Left-hand #60 Door Looking Inboard

The #60 door showed no signs of coating failure or defects. There was some heat related discoloration of the topcoat on the lower half of the door and abrasion marks in the topcoat, that were apparently due to cleaning of engine exhaust residue. Figure 3 shows a sketch of the door and location of the abrasions.

The objective of this test was to evaluate heat resistance of the primer and there were no heat-related defects, other than topcoat discoloration, noted on the test components.
