Field Evaluation Report VIII:

Inspection of Aircraft for Validation of Alternatives to Chromate-Containing Primer Coatings for Aircraft Exterior Mold Line Skins

January 21, 1999

National Defense Center for Environmental Excellence (NDCEE)

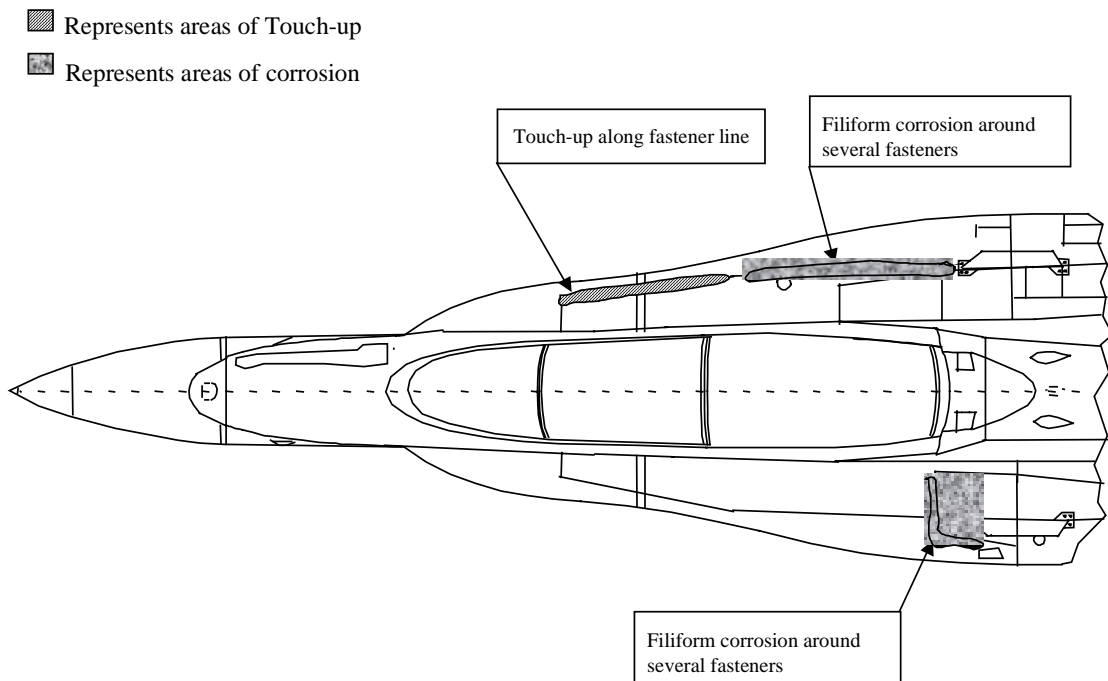
Figure 1. F/A-18 #164638, View Looking Down

There were several areas of corrosion identified on the upper surfaces mainly around fasteners and at the periphery of some skins as shown in Figures 1 and 2. The corrosion was filiform type corrosion initiated at the fasteners or the edge of the skins. Corrosion extended less than one-eighth inch from initiation points except one location on the left-hand side noted in Figure 2.

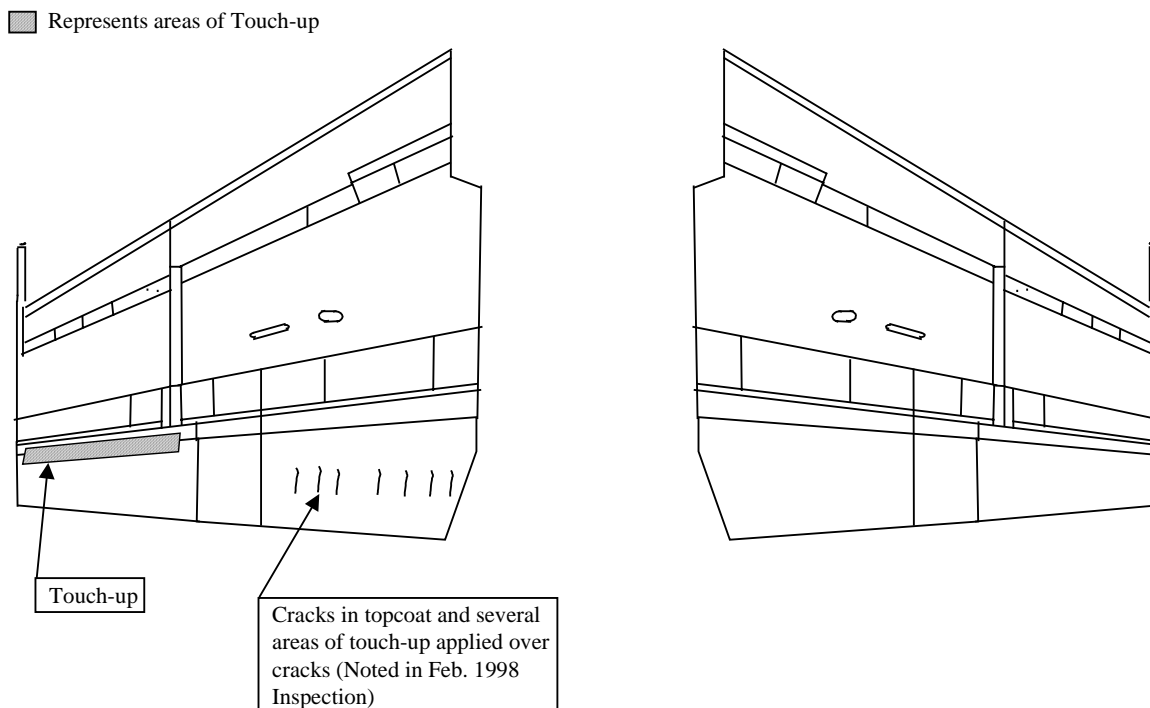
Figure 3. F/A-18 #164638, View Looking Down

■ Represents areas of Touch-up

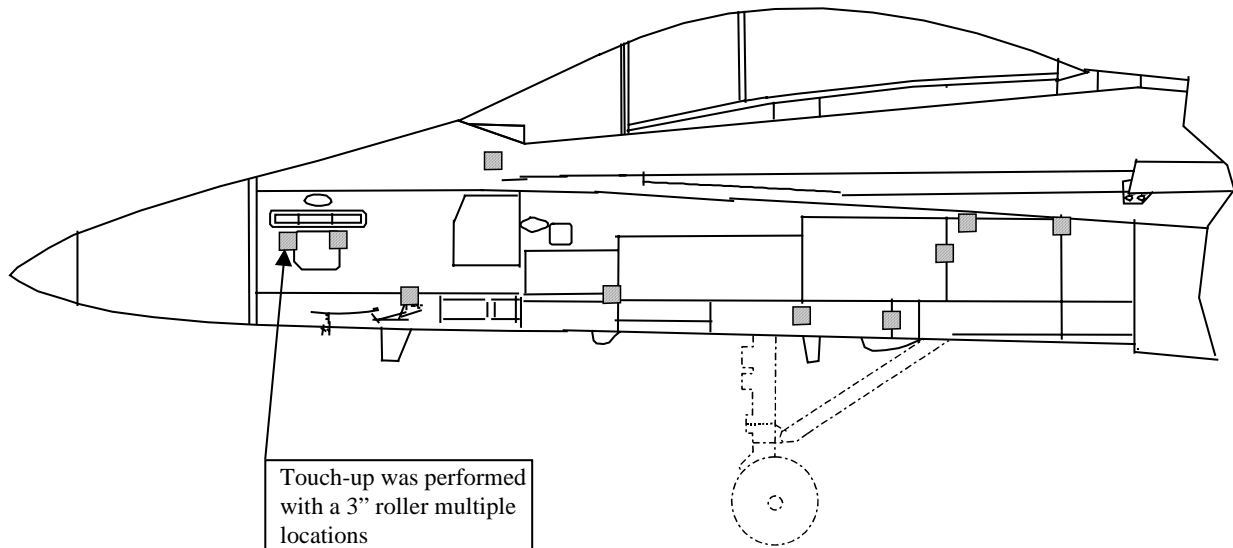
Figure 4. F/A-18 #164638, Left Hand View

■ Represents areas of Touch-up

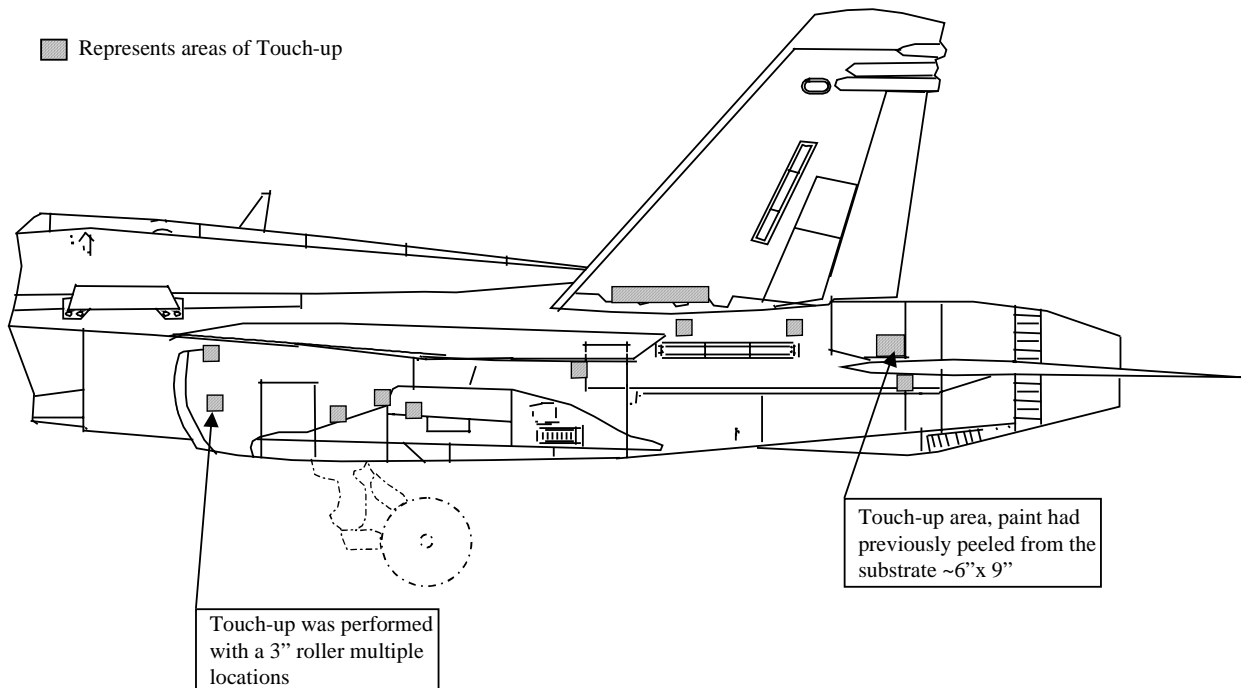
Figure 5. F/A-18 #164638, Left Hand View

■ Represents areas of Touch-up

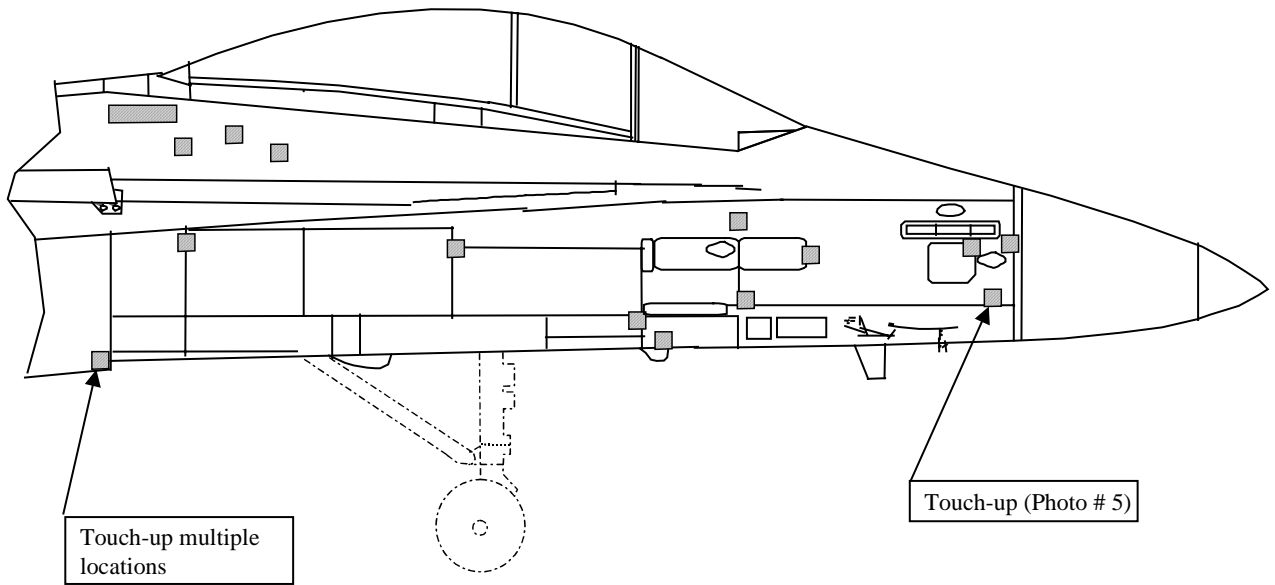
Figure 6. F/A-18 #164638, Right Hand View

■ Represents areas of Touch-up

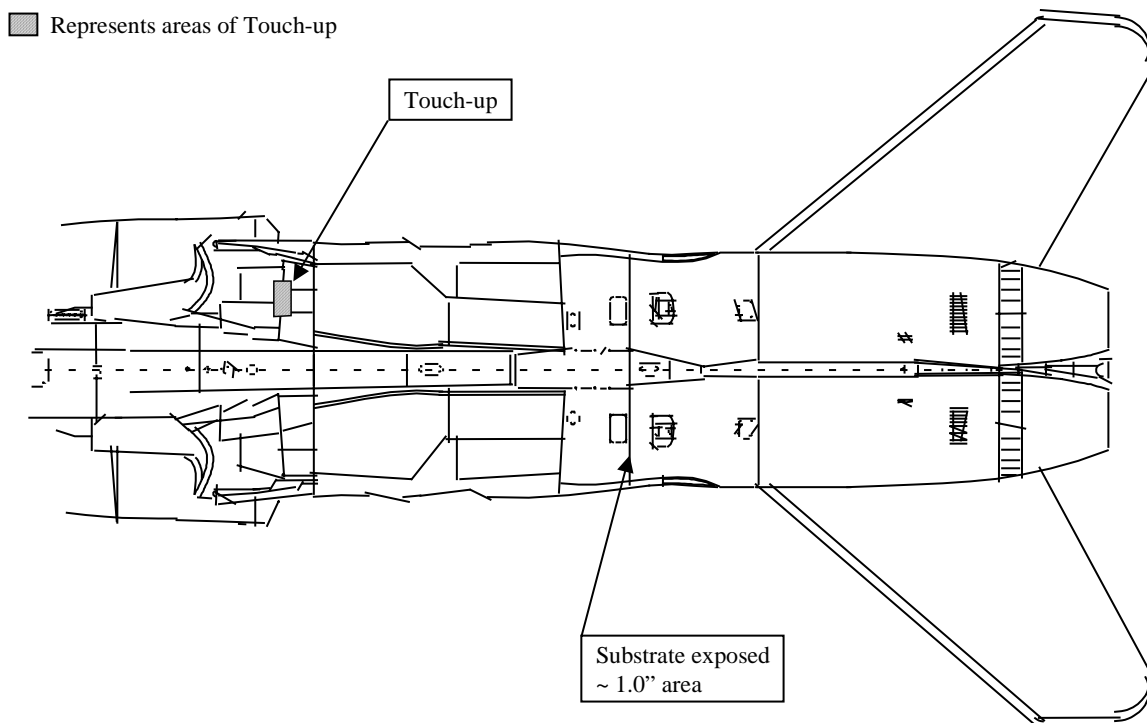
Figure 9. F/A-18 #164638, View Looking Up

■ Represents areas of Touch-up
