Engineering and Technical Services for Joint Group on Pollution Prevention (JG-PP) Projects

Field Evaluation Report XI:

Inspection of Aircraft for Validation of Alternatives to Chromate-Containing Primer Coatings for Aircraft Exterior Mold Line Skins

May 19, 1999

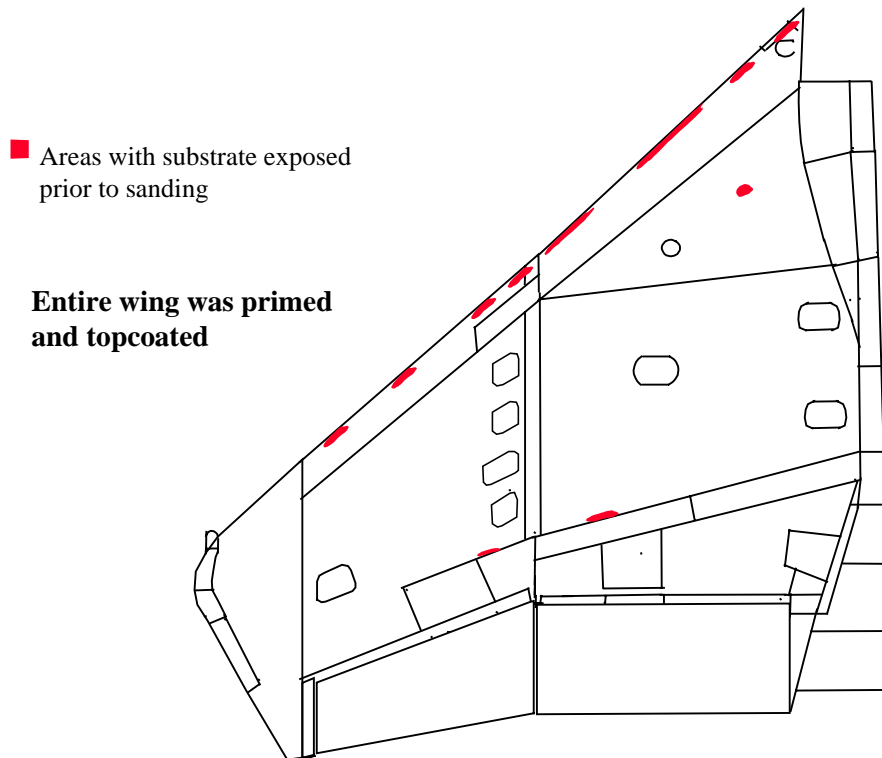
Figure 1. F-15 #81-024, Left-Hand Wing Looking Down

Similar coating failures with exposed substrate were observed on the upper surfaces of the left and right wings, as shown in Figures 1 and 3. The leading edges also appeared to be similar in severity of coating failures. Both wings had been previously touched-up by the squadron with topcoat only, without primer. Previously touched-up areas were sanded to remove the paint to the substrate to expose sound original coating with minimal expansion of the previous bare areas. The left-hand wing had been primed with MIL-P-23377G chromate primer while the right-hand wing had been primed with Dexter nonchromate primer.

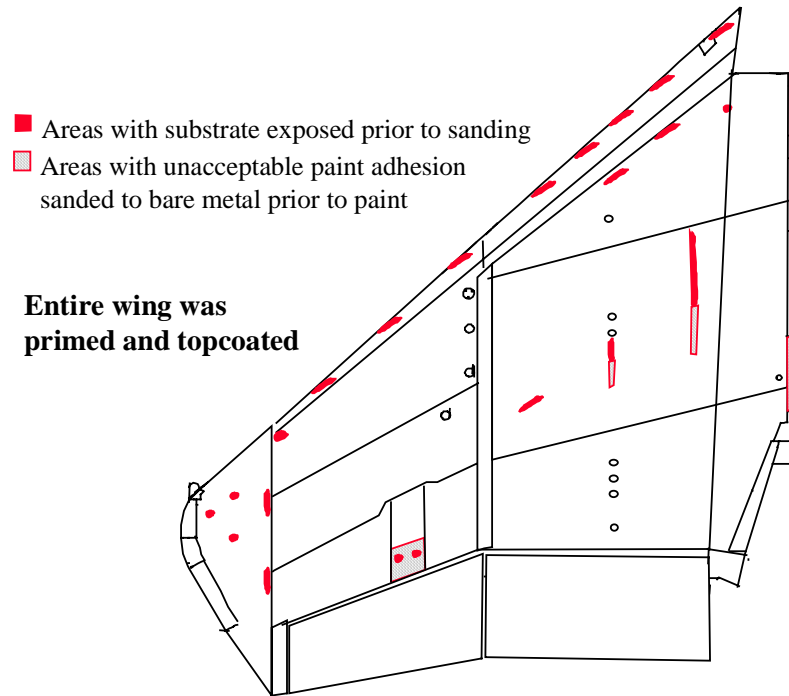
Figure 4. F-15 #81-024, Right-Hand Wing Looking Up

Lower wing surfaces had the most extensive coating failures (see Figure 4). The largest areas of coating failure were on the titanium skins and most coincided with fuel seepage areas. When feathering the failed paint areas, poorly adhered paint was also mechanically removed until sound coating was encountered.

Areas with evidence of fuel or hydraulic fluid seepage were cleaned with DS-104 wipe solvent followed by denatured alcohol. They were then treated with MIL-C-81706 chromate conversion coating. All bare substrate areas on the right-hand wing were primed with Dexter 10PW22-2/ECW119 followed by a tie coat over the entire right wing. A similar process was followed on the left wing using MIL-C-23377G, Type I, Class C high-solids chromate primer. Two coats of MIL-C-85285B topcoat were subsequently applied over the entire surface of both wings and the remainder of the aircraft.

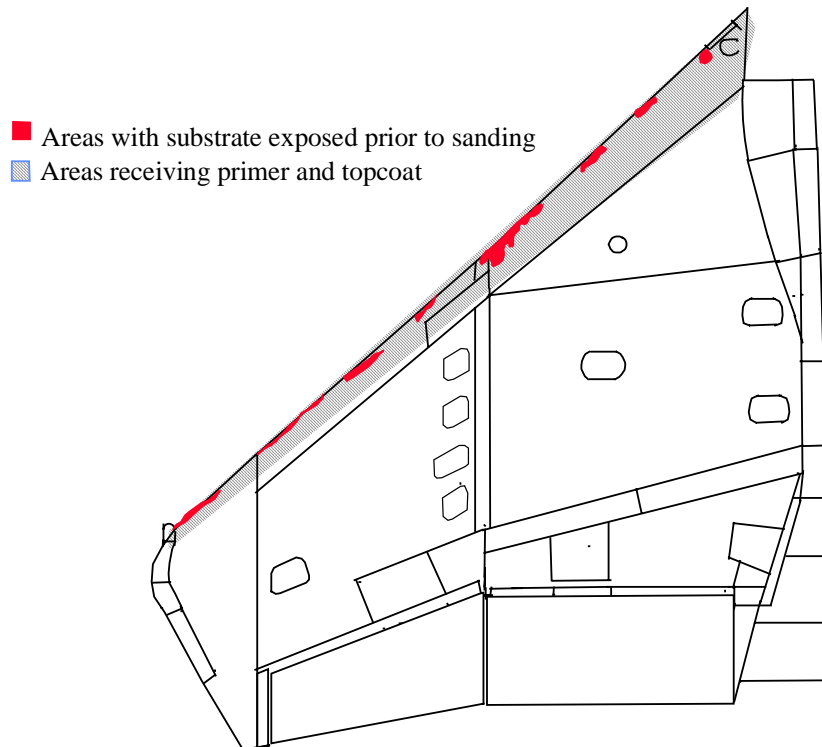
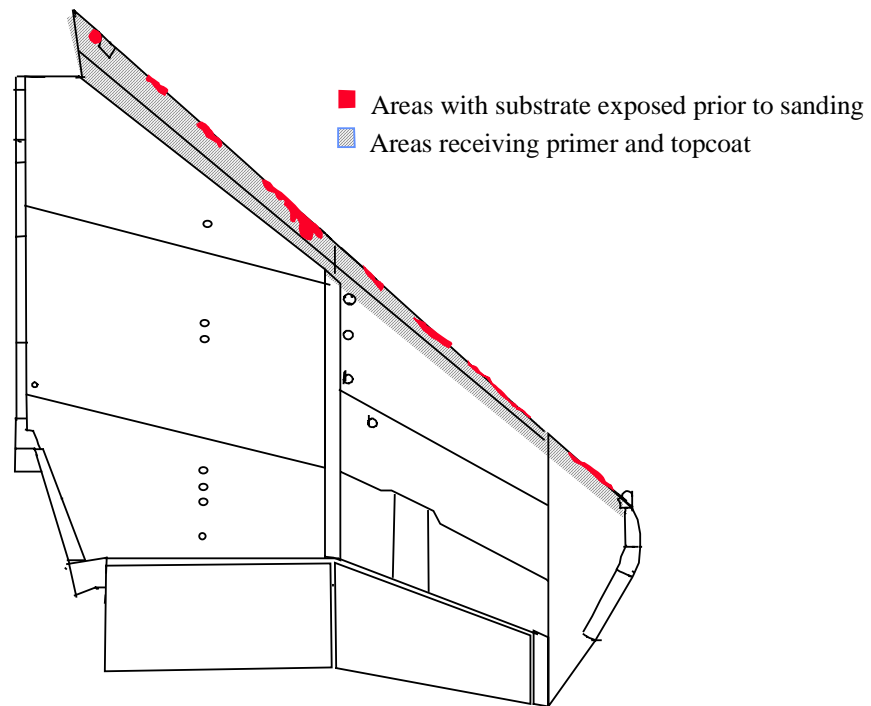
Most paint defects on the left wing, which had been primed with MIL-C-23377G chromate primer, were confined to the leading edge (see Figures 5 and 6). In preparation for coating system repair, the upper surface of the left wing was masked except for the leading edge skins. Substrate or primer was exposed over approximately 60% of the leading edge. Erosion areas were sanded with DA sanders using 180 grit paper to feather the edges. The remainder of the leading edge was sanded to remove only oxidized topcoat. After sanding the surfaces were solvent wiped with DS-104. All bare areas were treated with MIL-C-81706 chromate conversion coating, rinsed, and allowed to dry. MIL-C-23377G, Type I, Class C high-solids chromate primer was applied approximately one mil thick over the bare substrate areas and as a tie coat over the remaining portions of the leading edge. Two coats of MIL-C-85285B topcoat were subsequently applied over the entire leading edge.

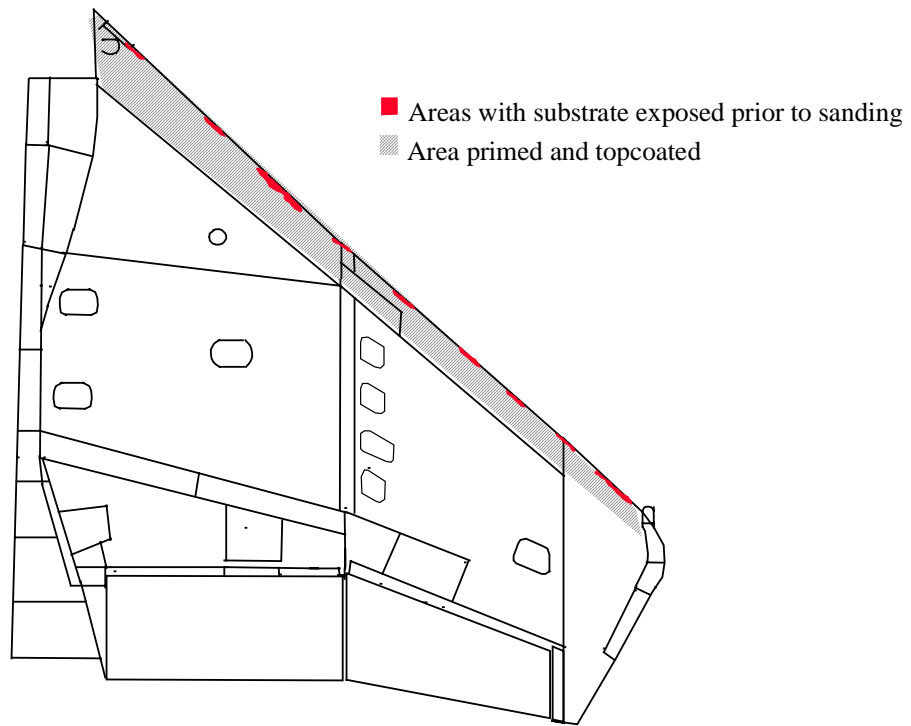
Figure 7. F-15 #79-011, Right-Hand Wing Looking Down

Paint defects on the upper surface and the leading edge of the right-hand wing were similar to those on the left-hand wing (see Figure 7). In preparation for coating system repair, the upper surface of the right wing was masked except for the leading edge skins. Substrate or primer was exposed over approximately 60% of the leading edge. Erosion areas were sanded with DA sanders using 180 grit paper to feather the edges. The remainder of the leading edge was sanded to remove only oxidized topcoat. After sanding the surfaces were solvent wiped with DS-104. All bare areas were treated with MIL-C-81706 chromate conversion coating, rinsed, and allowed to dry. Dexter 10PW22-2/ECW119 waterborne nonchromate primer was applied approximately one mil thick over the bare substrate areas and as a tie coat over the remaining portions of the leading edge. Two coats of MIL-C-85285B topcoat were subsequently applied over the entire leading edge.

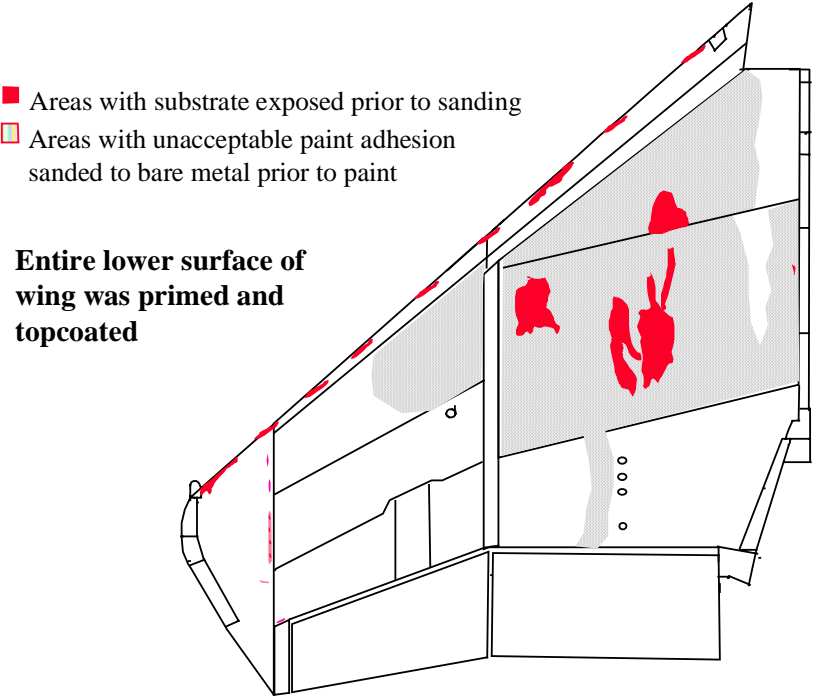
Figure 8. F-15 #79-011, Right-Hand Wing Looking Up

The lower surface of the right-hand wing had extensive coating failures with large areas of substrate exposed (see Figure 8) when the aircraft entered the paint facility. The paint adjacent to the bare areas was obviously not well adhered and large areas were easily removed with plastic scrapers. When the paint could not be removed with scrapers it was feathered with DA sanders using 180 grit paper.

“Fisheyes” (a non-continuous film) immediately formed at the areas wiped with MEK.

Titanium surfaces were cleaned with DS-104 and denatured alcohol followed by MIL-C-81706 conversion coating. A water-break-free surface could not be obtained and the surface was sanded with DA sanders using 220 grit paper followed by a methyl ethyl ketone (MEK) wipe. MIL-C-81706 conversion coating was reapplied and constantly agitated with abrasive pads for forty minutes followed by a tap water rinse and water-break check. The surface was initially water-break-free but quickly became contaminated with fuel around the pylon attach points and at some skin joints. A decision was made to proceed with primer application and wipe the contaminated areas immediately prior to priming.

Dexter nonchromate primer, base 10PW22-2 batch # 90121009 and activator ECW119 batch #90141010, was mixed and allowed to stand for 15 minutes. Prior to priming the contaminated areas on the lower wing surfaces were wiped with MEK to remove fuel contamination. A light coat of Dexter primer was applied to the leading edge and the entire lower surface of the right-hand wing.

The nonchromate primer was allowed to dry for two hours and areas showing signs of contamination were sanded and wiped to remove sanding dust. A second coat of primer was applied to sanded areas and all other surfaces where the metal substrate had been exposed. The second coat of primer also exhibited “fisheyes” at the contaminated areas but no further action was suggested since a film of primer did cover substrate. The areas were documented and the nonchromate primer was allowed to cure for two hours prior to coating with two coats of MIL-C-85285B topcoat.
