**Engineering and Technical Services for
Joint Group on Pollution Prevention
(JG-PP) Projects**

Field Evaluation Report XIX:

**Inspection of Aircraft for
Validation of Alternatives to
Chromate-Containing Primer Coatings
for Aircraft Exterior Mold Line Skins**

March 24, 2000

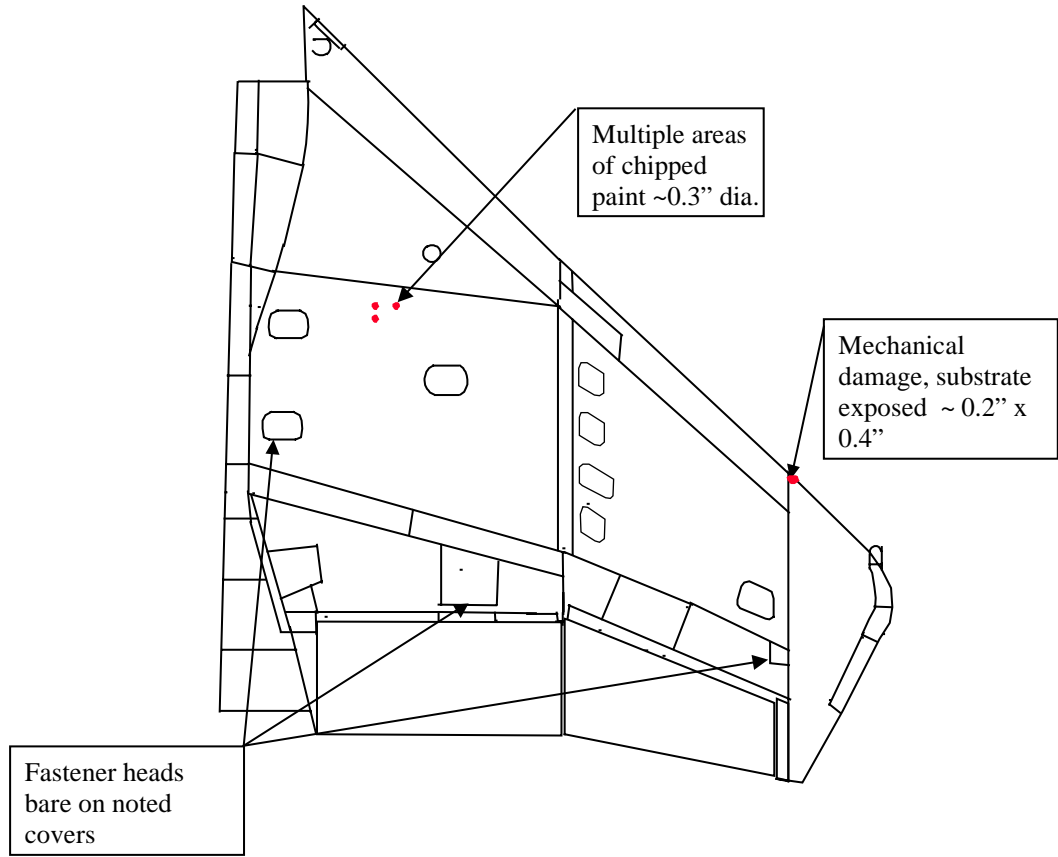
Figure 1. F-15 #81-024, Looking Down at Right-Hand Wing

This aircraft has logged only 16.8 flight hours since the inspection performed in July 1999 and there were minimal changes from previous inspection. The small blister noted on the previous inspection was touched-up as shown in Figure 2. There were minor areas of mechanical damage on the leading edge and upper wing skin.

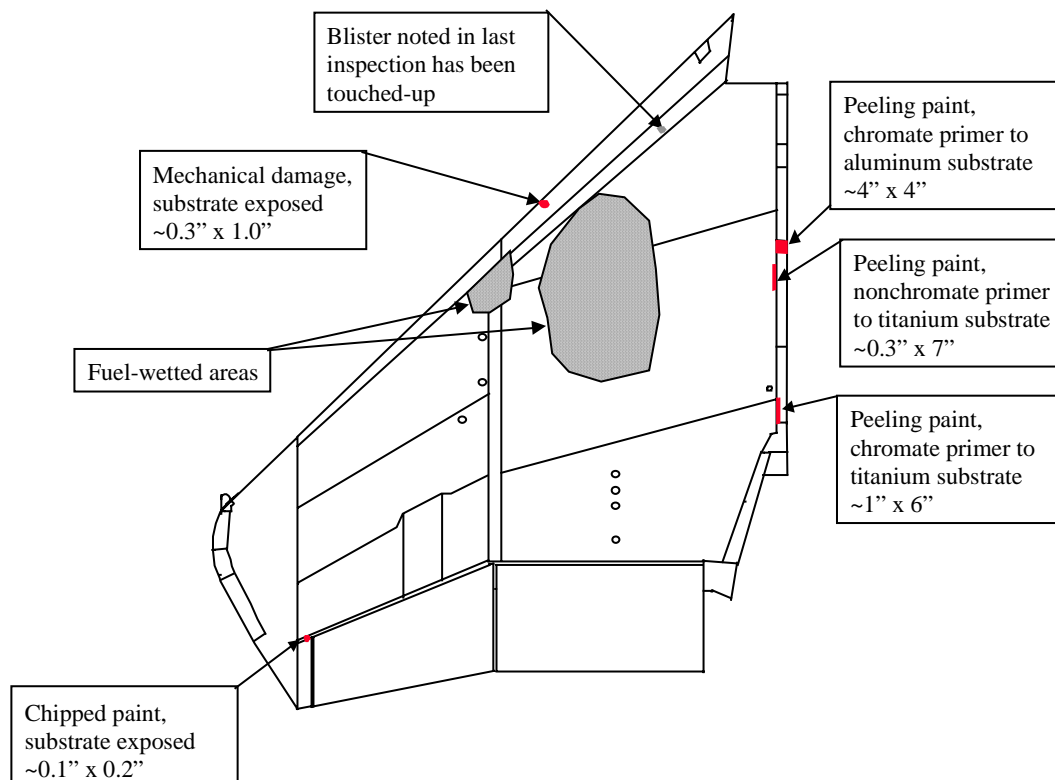
Figure 2. F-15 #81-024, Looking Up at Right-Hand Wing

Peeling paint along the inboard most edge of the lower wing was not present at the last inspection. Two of the areas were chromate primer peeling from the substrate and one area was nonchromate primer (see Figure 2). Large areas of the under-wing area were wet with fuel but no paint defects were present in the wetted area.

All of the defects were relatively minor except for adhesion failures on the inboard edge of the lower right-hand wing. The adhesion failures were at the intersection of the wing to fuselage where the chromate and nonchromate primer met. Two of the defect areas were chromate primer failures and one was nonchromate primer.

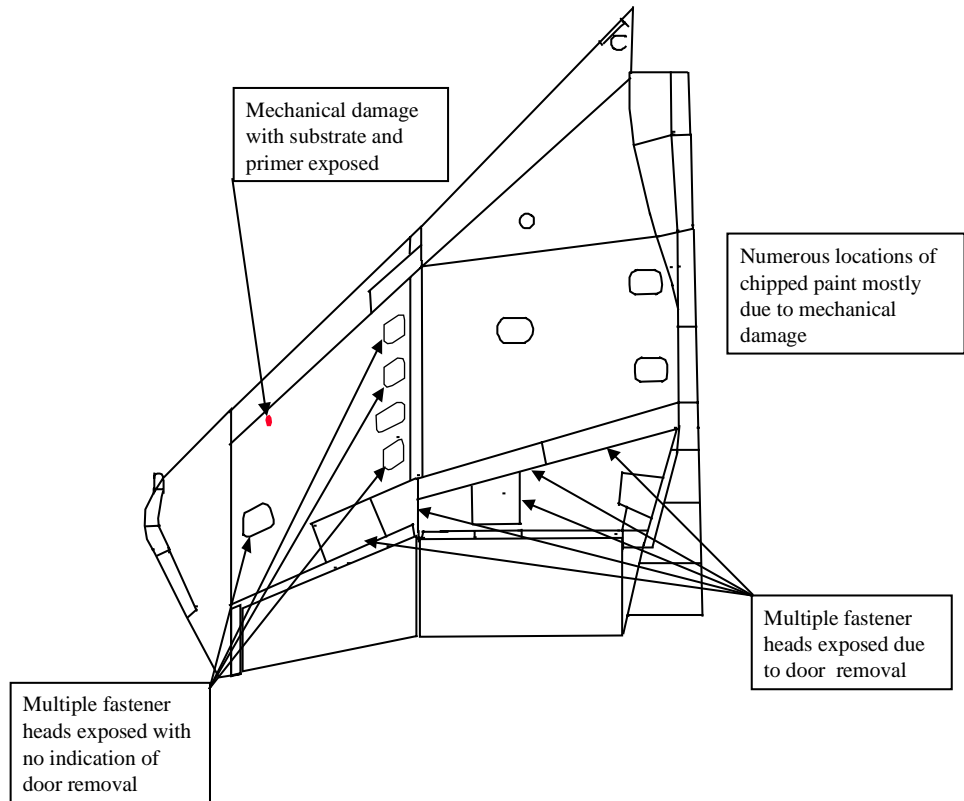
Figure 3. F-15 #79 011, Looking Down at Left-Hand Wing

The upper surface had several areas of chipped paint. Much of the defects appeared to be due to mechanical damage. Paint was also missing from most of the fastener heads on removable covers with most due to cover removal. However, several fastener heads were bare with no signs of fastener or cover removal indicating poor adhesion to the fasteners (see Figure 3).

There were multiple areas of exposed aluminum substrate on the leading edges. Some of the paint failures were due to obvious mechanical damage and some due to erosion.

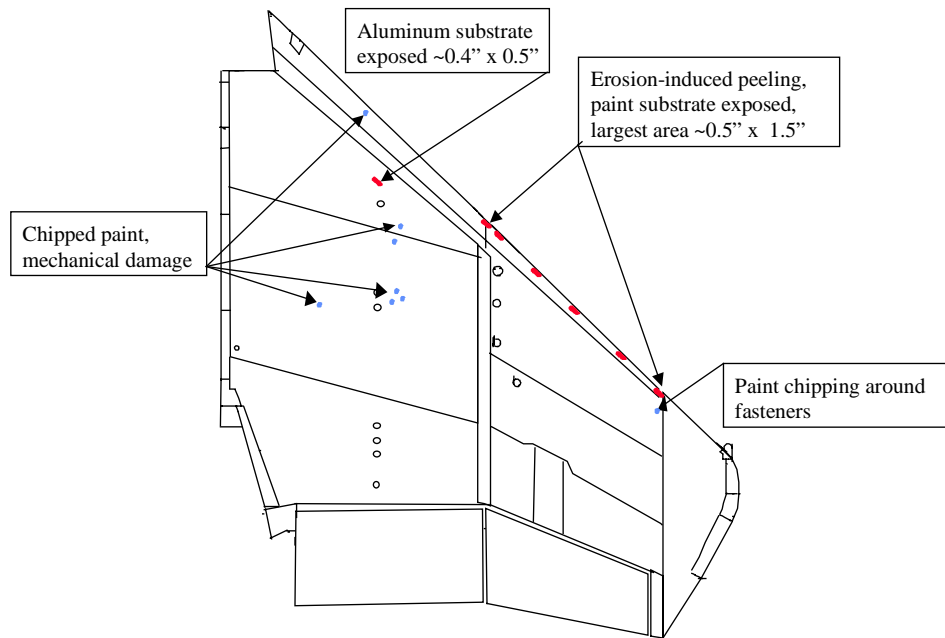
Figure 4. F-15 #79 011, Looking Up at Left-Hand Wing

There were several area of chipped paint on the lower wing skins due to mechanical damage and one small area of peeling paint.

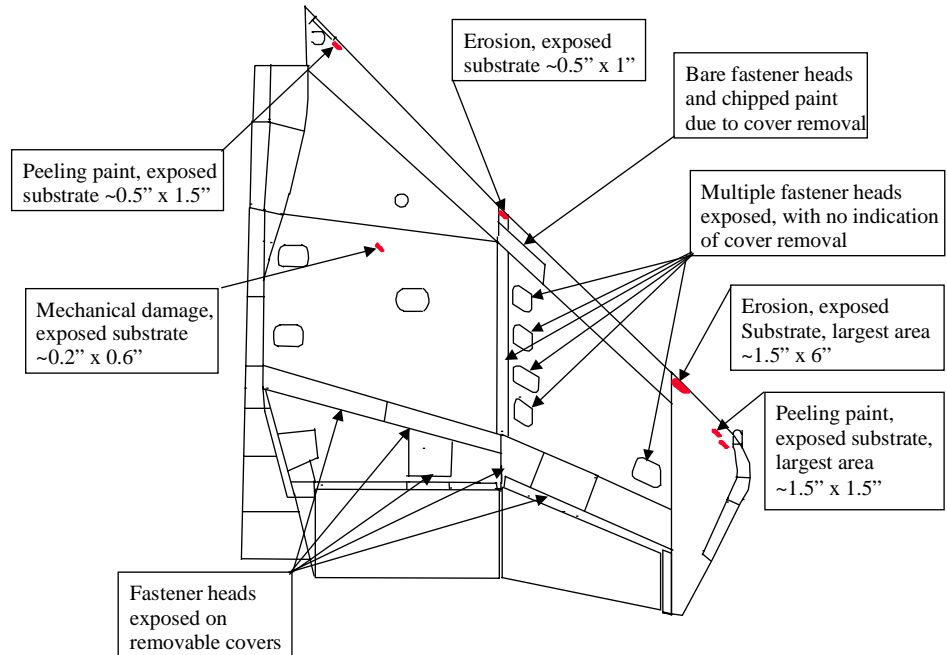
Figure 5. F-15 #79 011, Looking Down at Right-Hand Wing

There were several bare fasteners on the upper surface, similar to the left-hand wing. The fasteners were not touched-up when the paint repairs were performed in April 1999. There were fewer areas of erosion/peeling on the leading edge of the right-hand wing than on the left-hand wing, but the wing tip had a larger erosion/peeling area than any location on the left wing (see Figure 5).

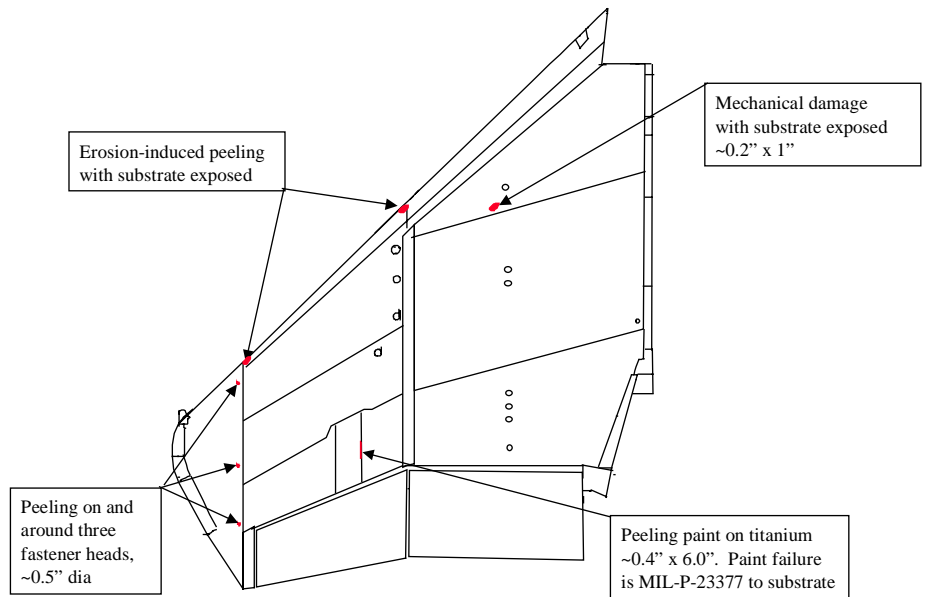
Figure 6. F-15 #79 011, Looking Up at Right-Hand Wing

The peeling paint on the titanium aileron actuator cover (see Figure 6) was noted at the last inspection and has grown in size. The failure is chromate MIL-P-23377 primer that was likely applied by the squadron prior to the paint repairs in April 1999, or the actuator cover was replaced by the squadron.
