**Engineering and Technical Services for  
Joint Group on Pollution Prevention  
(JG-PP) Projects**

**Field Evaluation Report XVIII:**

**Inspection of Aircraft for  
Validation of Alternatives to  
Chromate-Containing Primer Coatings  
for Aircraft Exterior Mold Line Skins**

**February 17, 2000**

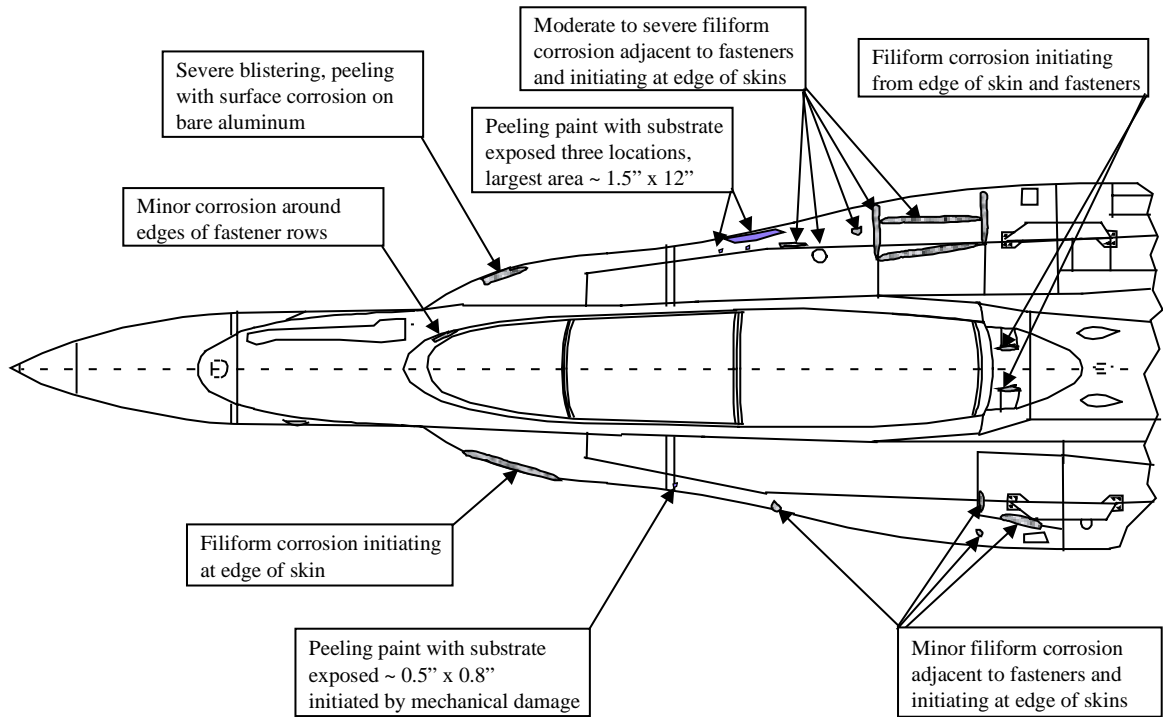
**Figure 1. F/A-18 #164268, View Looking Down at Forward Fuselage**

There were significant differences between the right and left-hand leading edge extensions (LEXs) with more corrosion sites and much more severe corrosion on the nonchromate side (see Figure 1 and Figure 7). The number of corrosion sites on the nose barrel was greater on the chromate side, however the corrosion on the nonchromate side was more severe.

There were paint adhesion failures on the upper right-hand LEX with primer lifting from the substrate. Chromate conversion coating was evident on the skin and no corrosion was observed where the paint had peeled. Surface area of peeling paint was approximately 10-12 square inches.

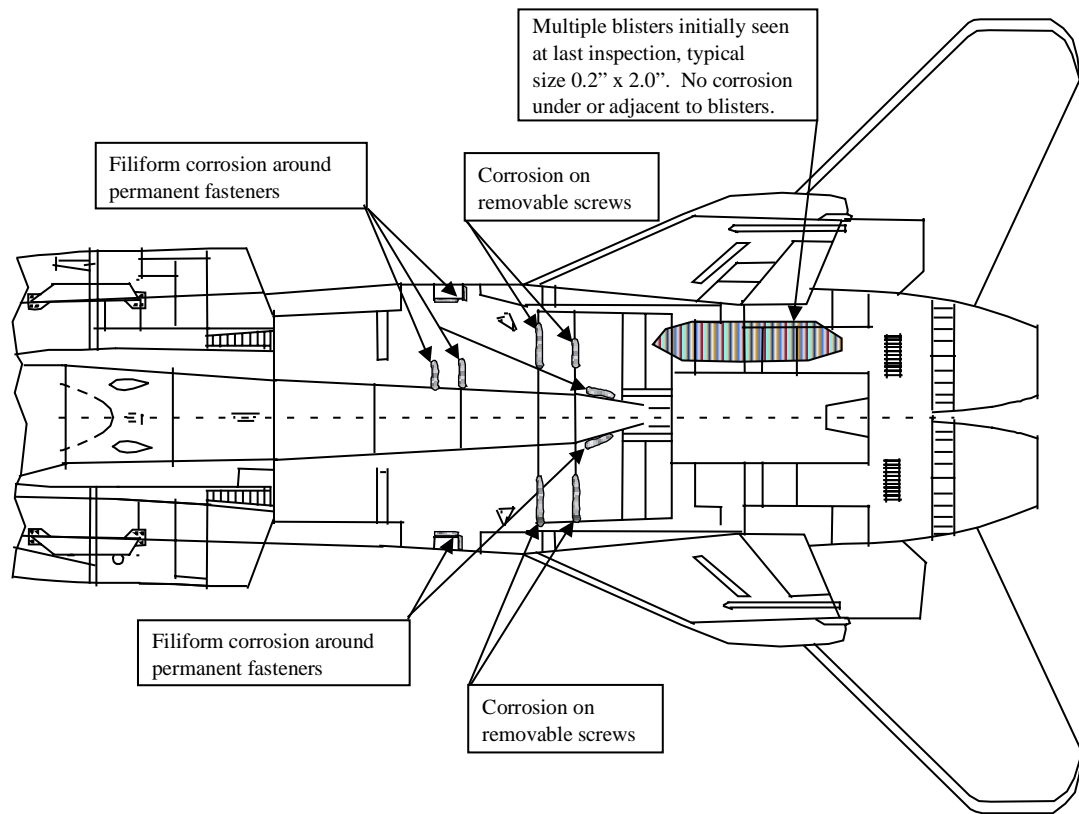
**Figure 2. F/A-18 #164268, View Looking Down at Aft Fuselage**

As reported in the May 1999 inspection there were multiple blisters on the right-hand of the fuselage above the engine bay. There was no corrosion associated with the blisters and this defect has not been seen on other test aircraft.
