**Engineering and Technical Services for
Joint Group on Pollution Prevention
(JG-PP) Projects**

Field Evaluation Report XXI:

**Inspection of Aircraft
for Validation of Alternatives to
Chromate-Containing Primer Coatings
for Aircraft Exterior Mold Line Skins**

July 11, 2000

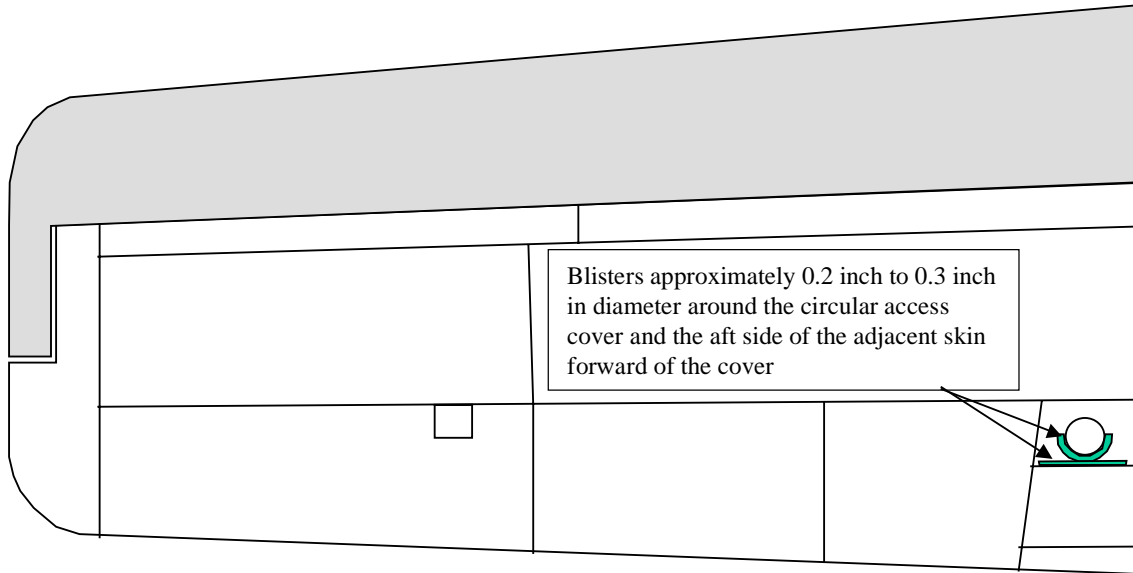
Figure 1. C-130 #62-1811 Right-Hand Horizontal Stabilizer

Except for one area of blisters around an access cover on the upper surface of the right-hand horizontal stabilizer (see Figure 1), the coating system was intact on the test and control areas. There were no indications of erosion, corrosion or peeling paint.

The blisters found on the nonchromate primer surfaces were all confined to within 0.4 inch of the edges of sealer-filled butt joints. Blisters were approximately 0.2 inch to 0.3 inch in diameter, and the paint film was not broken. During the inspection some blisters were broken and peeled away to inspect the substrate. There was no evidence of corrosion or visible contaminants present under the blisters. The location of blisters around the perimeter of the cover and adjacent to a skin is indicative of contamination of the surface prior to painting.

After three months and 44 flight hours the coating system is in excellent condition, as expected, except for the area with small blisters. Squadron maintenance personnel were made aware of the blisters and they committed to repairing the area using the nonchromate test primer. The inspection team made a specific request to treat the area with chromate conversion coating prior to application of primer.

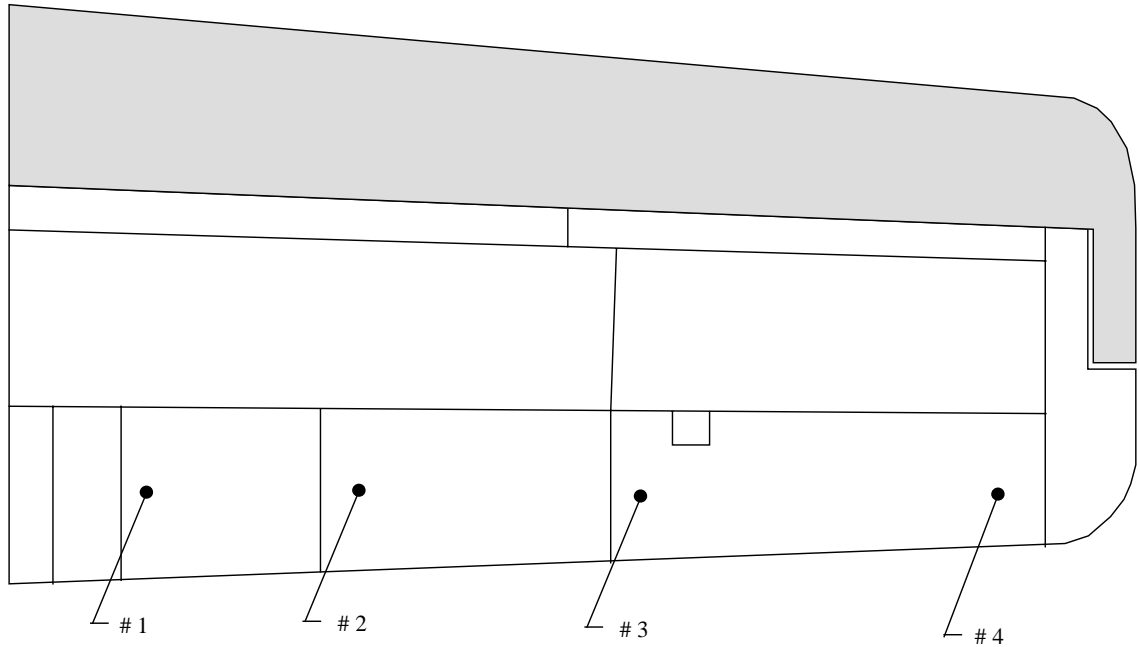
Figure 2. C-130 #62-1811, Typical Locations of Gloss and Color Readings (Right and Left Sides)

Color and gloss readings were taken at the same locations as those recorded after painting in February with insignificant changes since the initial readings. Figure 2 shows the general locations of the color and gloss measurements. Table 2 documents the changes between the initial color readings and those recorded during this inspection, while Table 3 documents changes in gloss readings. There was no evidence of paint application since the aircraft left the paint facility, therefore coating thickness was not measured.
