**Engineering and Technical Services
for Joint Group on Pollution Prevention
(JG-PP) Projects**

C-17 Field Evaluation Report:

**Inspection of Aircraft
for Validation of Alternatives to
Chromate-Containing Primer Coatings
for Aircraft Exterior Mold Line Skins**

09 January 2001

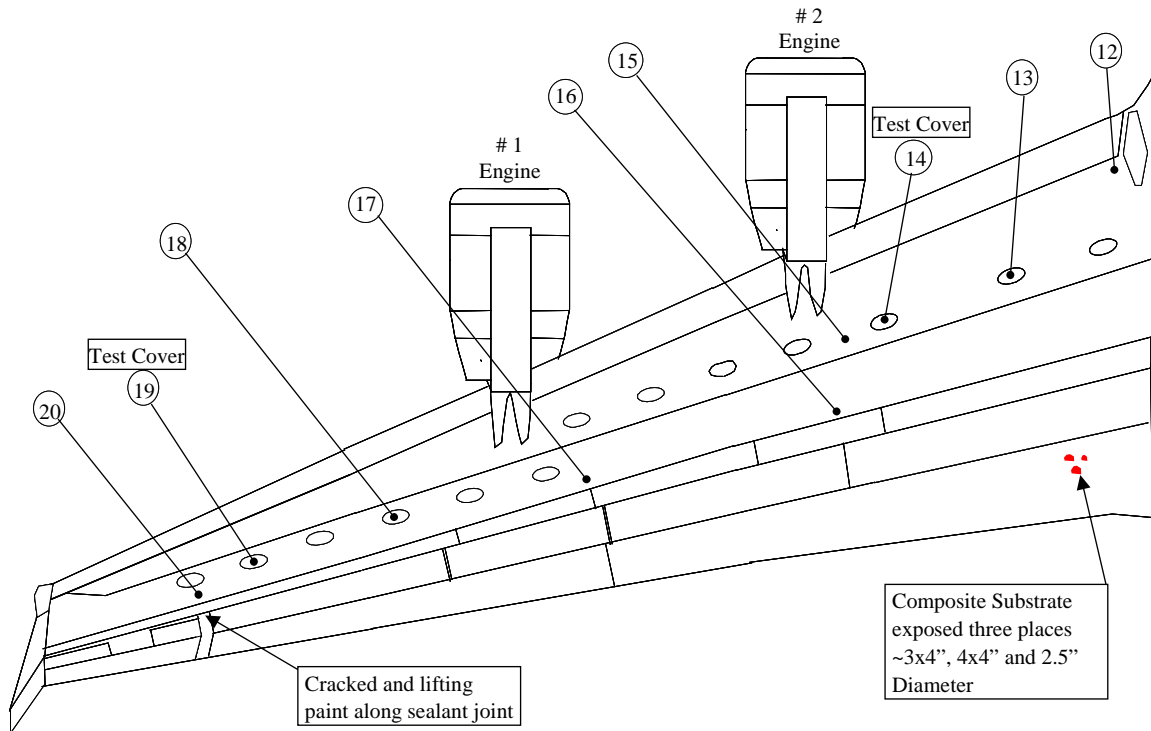
Figure 1. Left-Hand Wing Looking Down

There were minor defects seen on the upper surface of the left-hand wing. An area of peeling paint on the inboard flap noted in the last report was approximately three inches in diameter at the previous inspection and has now increased in size plus two additional areas were noted nearby. (See in Figure 1) The failure mode was primer to substrate but the defect area was not observed to be bare prior to painting at the depot, indicating the failure was with previously applied primer.

A second defect area was cracked and lifted paint on the outboard upper wing over a sealant joint. (See in Figure 1) The failure was at the interface of previously applied primer.

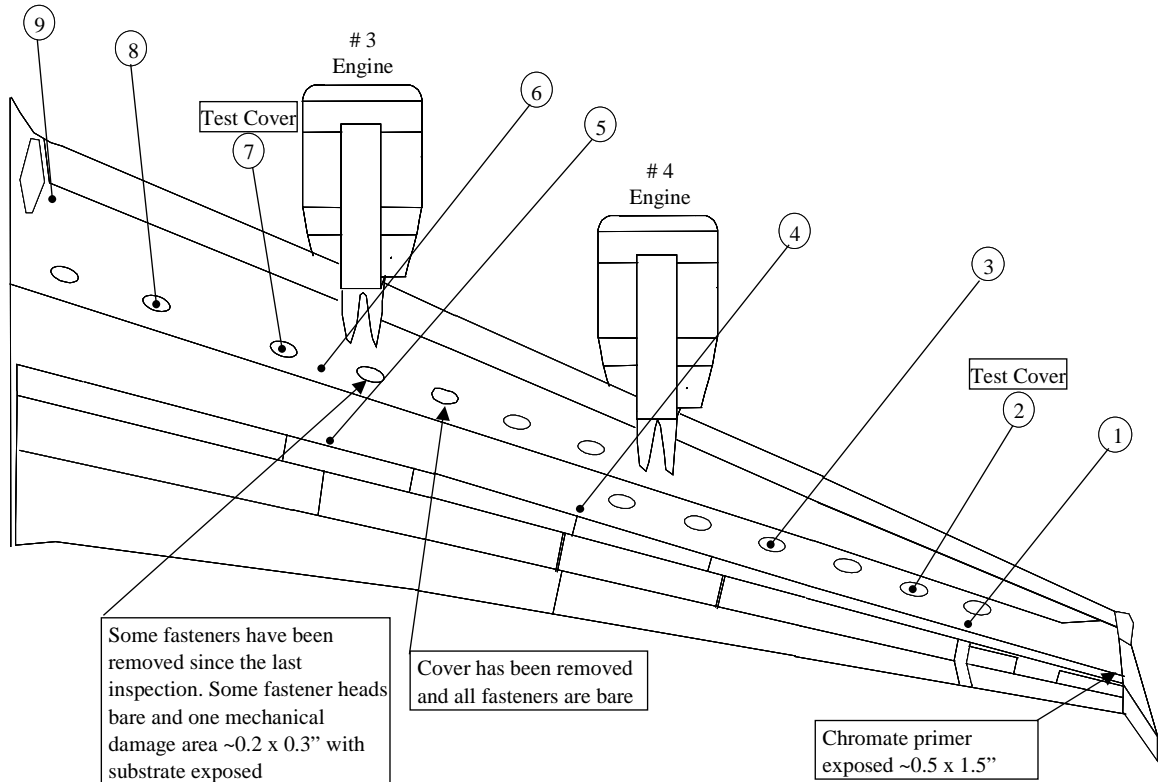
Figure 2. Right Hand Wing Looking Down

There were no defects on the upper surface of the right-hand wing attributable to the nonchrome primer. Three defect areas are shown in Figure 2 but all were due to mechanical damage or failure at an interface other than the nonchrome primer.

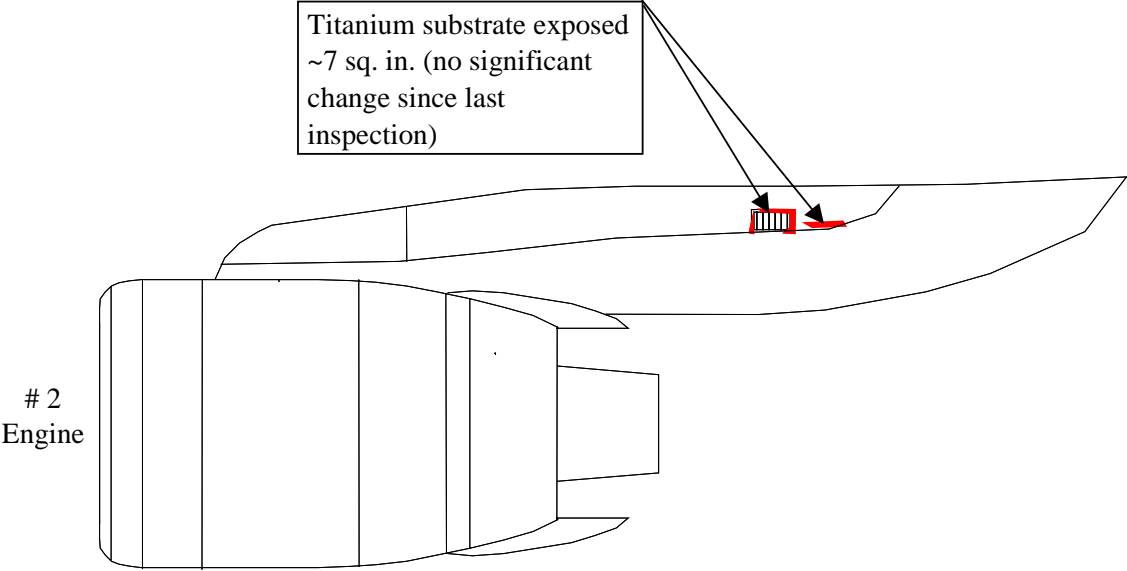
Figure 3. Left Hand, #2 Engine Nacelle Looking Inboard

Two defects were found on the engine pylons and nacelles. An area of peeling paint around a sealant joint on the outboard side of the # 2 engine pylon was noted at the last inspection and has not significantly changed. The approximate total area of bare substrate is seven square inches. The substrate is titanium and the sealant is a high temperature silicone sealant. (Ref. Fig. 3) The second area was a scratch,

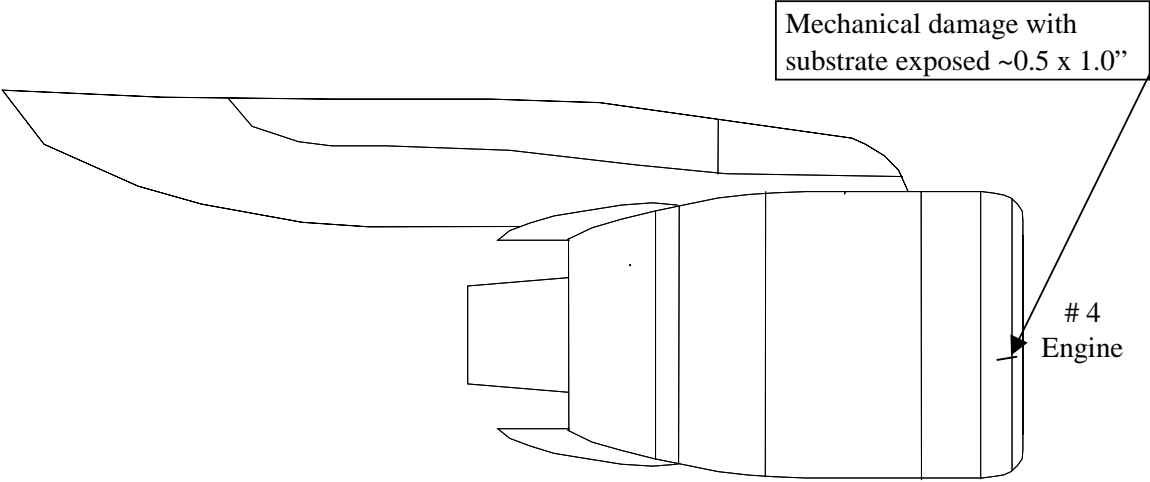
Figure 4. Left Hand, #2 Engine Nacelle Looking Inboard

due to mechanical damage, on the #4 engine nacelle. A close examination was not performed but the substrate was exposed approximately 0.5 x 1.0 inch. (Ref Fig. 4)

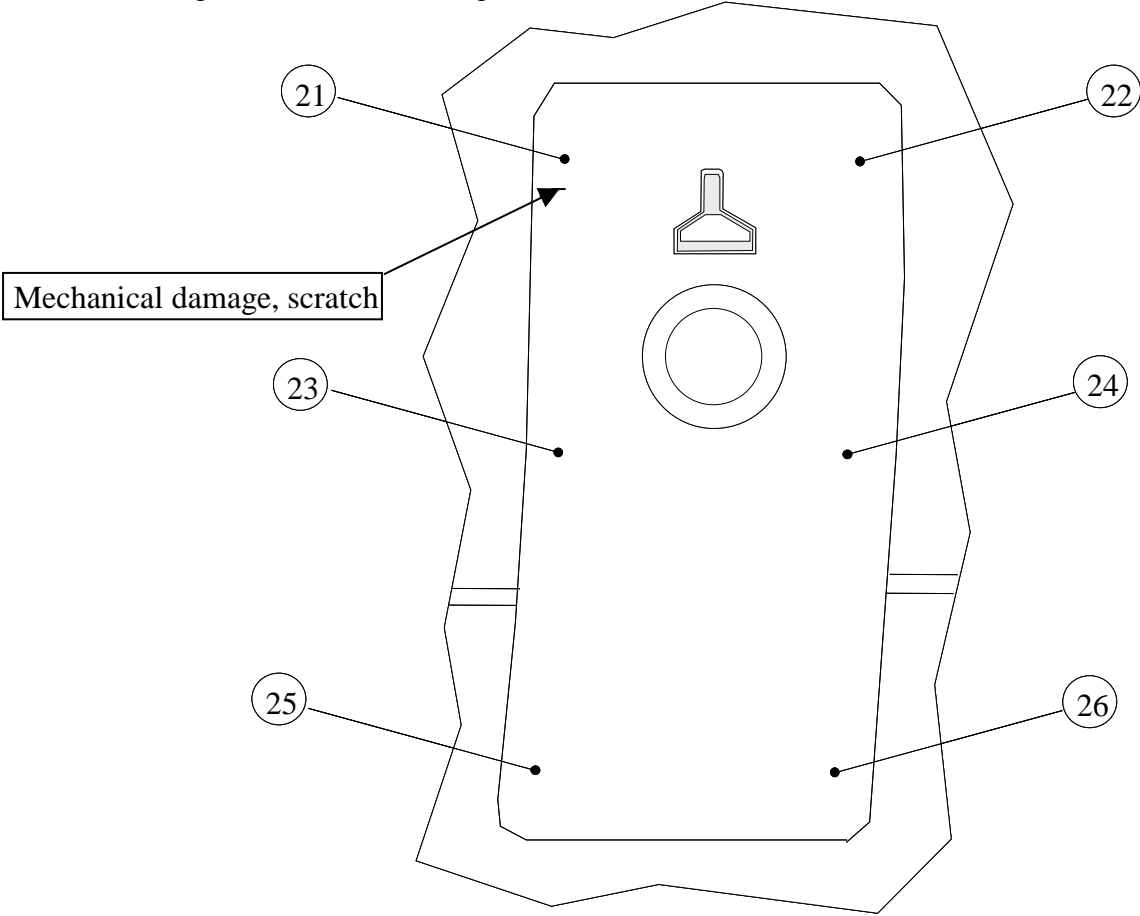
Figure 5. Emergency Door Right-hand Forward Fuselage, Looking Inboard

One scratch, due to mechanical damage was noted on the emergency crew door. The scratch was approximately two inches long varying in depth from marring the topcoat to exposing the substrate.
