**Engineering and Technical Services for
Joint Group on Pollution Prevention
(JG-PP) Projects**

C-130 Field Evaluation Report

**Inspection of Aircraft
for Validation of Alternatives to
Chromate-Containing Primer Coatings
for Aircraft Exterior Mold Line Skins**

January 20, 2001

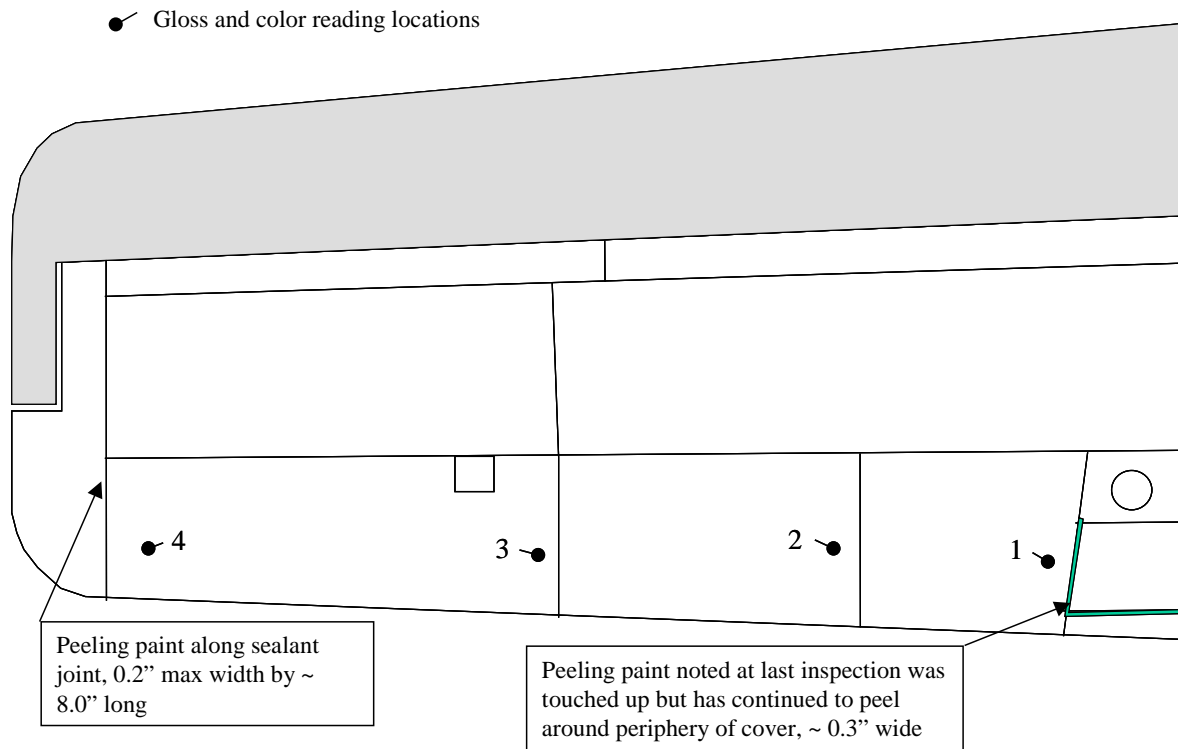
Horizontal Stabilizer Upper Surfaces: Minor peeling was noted around an access cover and adjacent to the sealant joint at the tip assembly of the right-hand upper horizontal stabilizer, (Ref. Figure 1). The peeling adjacent to the access cover was observed at the last inspection and has continued to grow in length. The adhesion loss was confined to within 0.2 to 0.4 inches of the sealant joint indicating potential contamination. There was no evidence of corrosion found on the aluminum substrates.

Figure 1. Right-hand Horizontal Stabilizer Looking Down

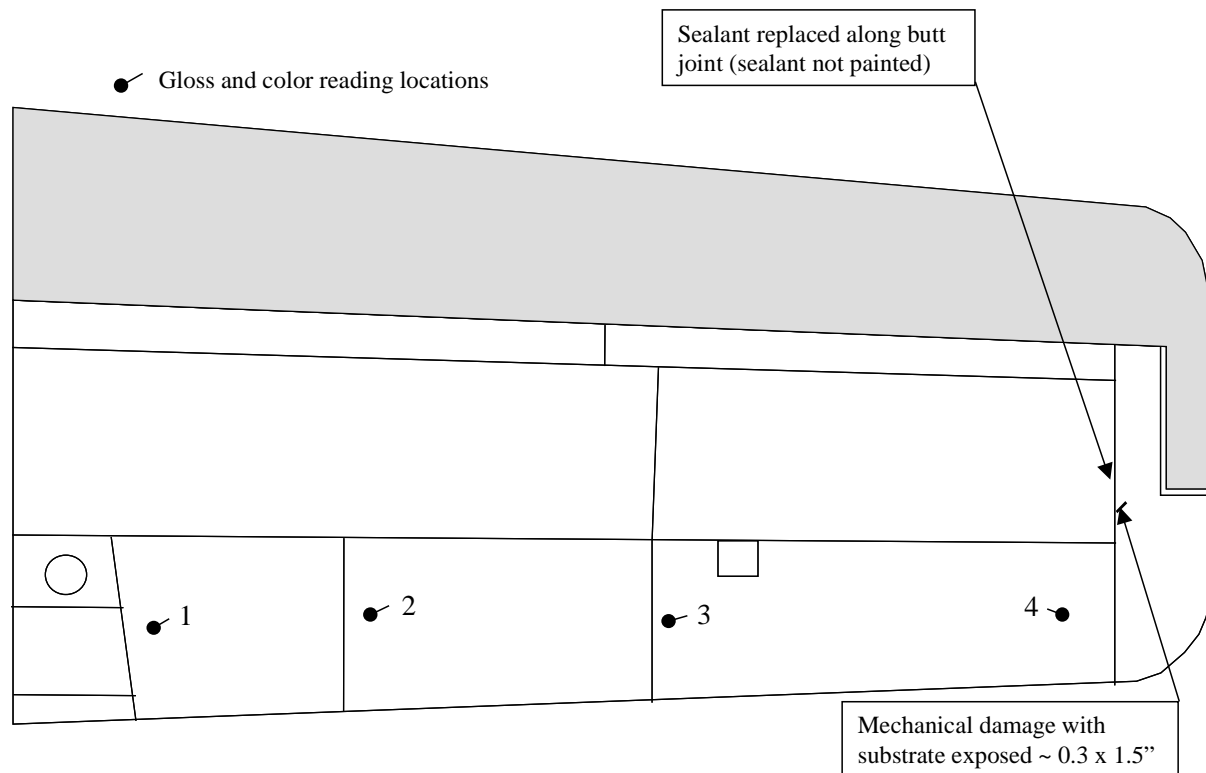
For documentation purposes it was noted at the last inspection that the anti-skid walkway coating on the upper surface of the left-hand horizontal stabilizer was not uniform. There were several areas where the filler material was concentrated resulting in thick clumps of coating toward the center and outboard end but the coating is still adhering well. Sealant had been replaced between the tip assembly and the torque box and not repainted. (Ref. Figure 2)

Figure 2. Left-hand Horizontal Stabilizer Looking Down

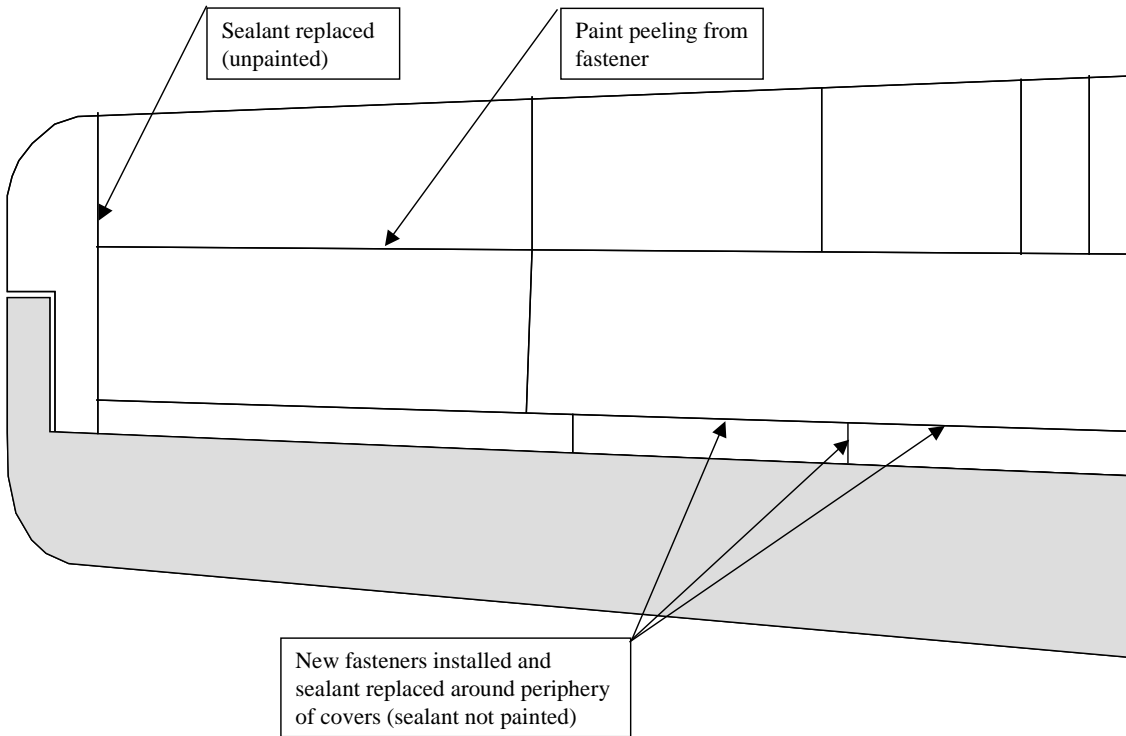
Horizontal Stabilizer Lower Surfaces: Butt joint sealant had been replaced and new fasteners installed in removable covers along the aft edge of the horizontals since the last inspections. There were also fasteners with chipped paint exposing the fastener heads. (Ref. Figures 3 & 4)

Figure 3. Right-hand Horizontal Stabilizer Looking Up

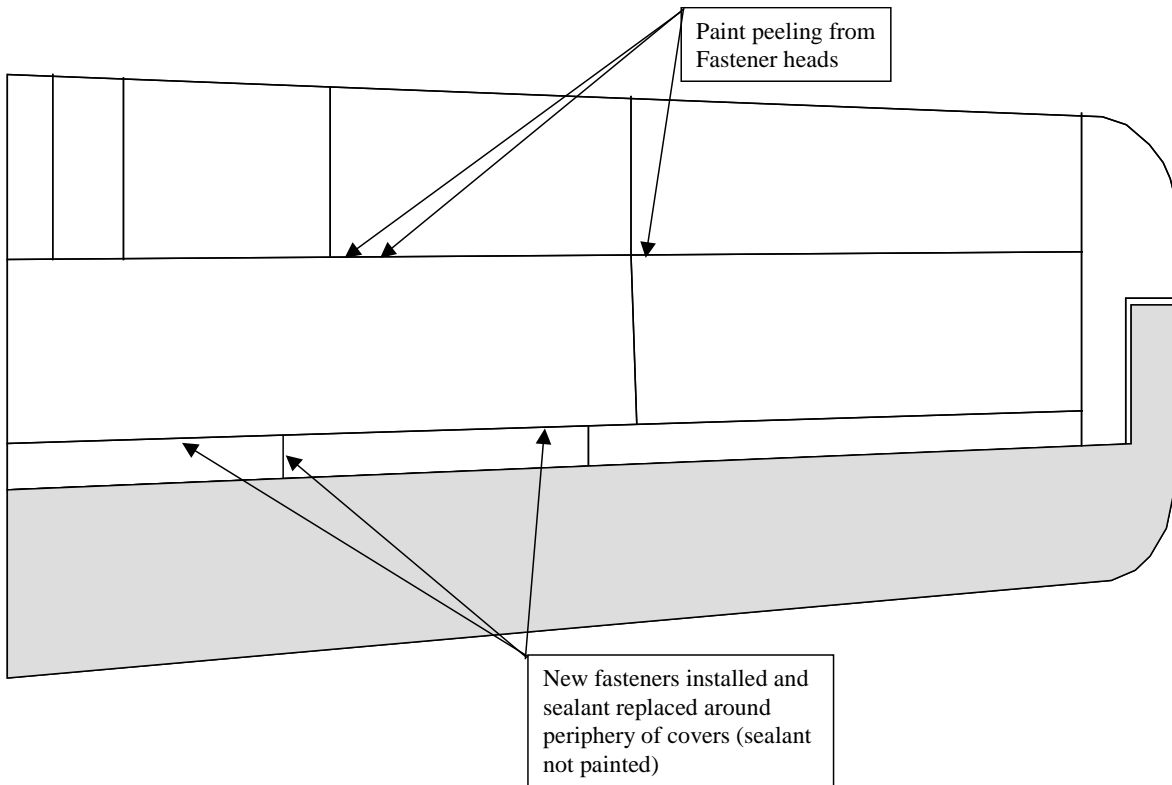
Figure 4. Left-hand Horizontal Stabilizer Looking Up

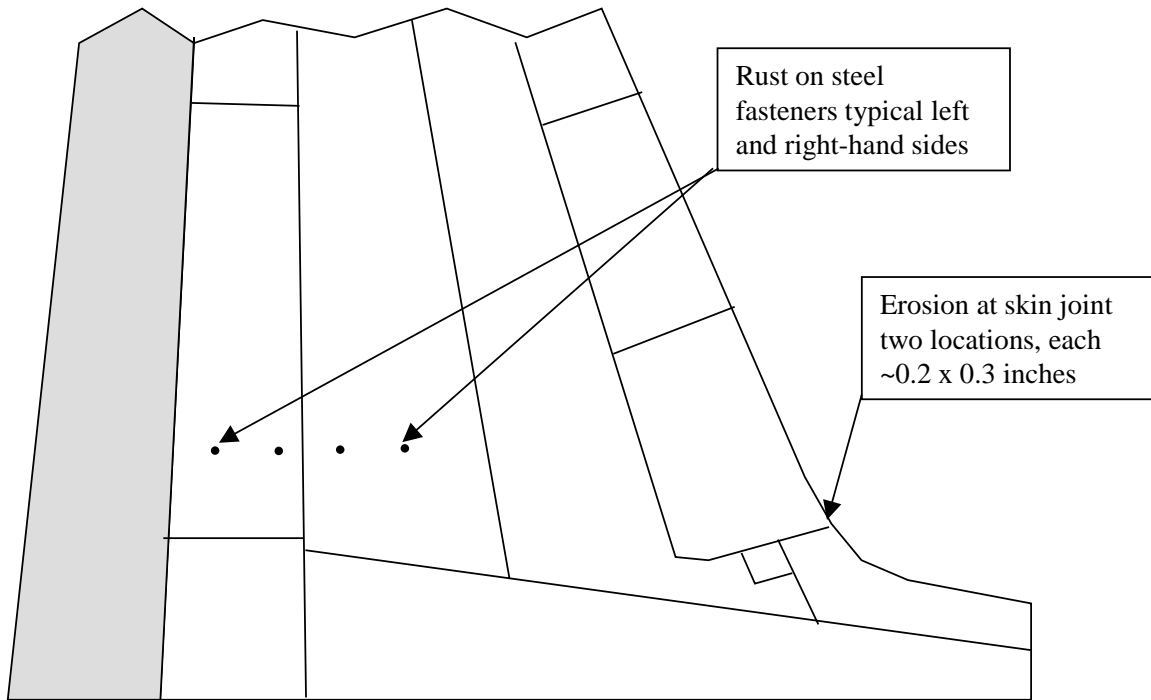
Vertical Stabilizer: Small areas of chipped paint, resulting from erosion, were found on the leading edge of the vertical stabilizer. Total film thickness adjacent to the defect area was thin, ranging 2.5 – 2.9 mils. Four steel screws on each side of the vertical had rust stains penetrating the paint. There was no difference between the severity of rust between the test and control side. (Ref. Figure 5)

Figure 5. Vertical Stabilizer Right-hand View
