**Engineering and Technical Services  
for Joint Group on Pollution Prevention  
(JG-PP) Projects**

**C-17 Field Evaluation Report:**

**Inspection of Aircraft  
for Validation of Alternatives to  
Chromate-Containing Primer Coatings  
for Aircraft Exterior Mold Line Skins**

**29 June 2001**

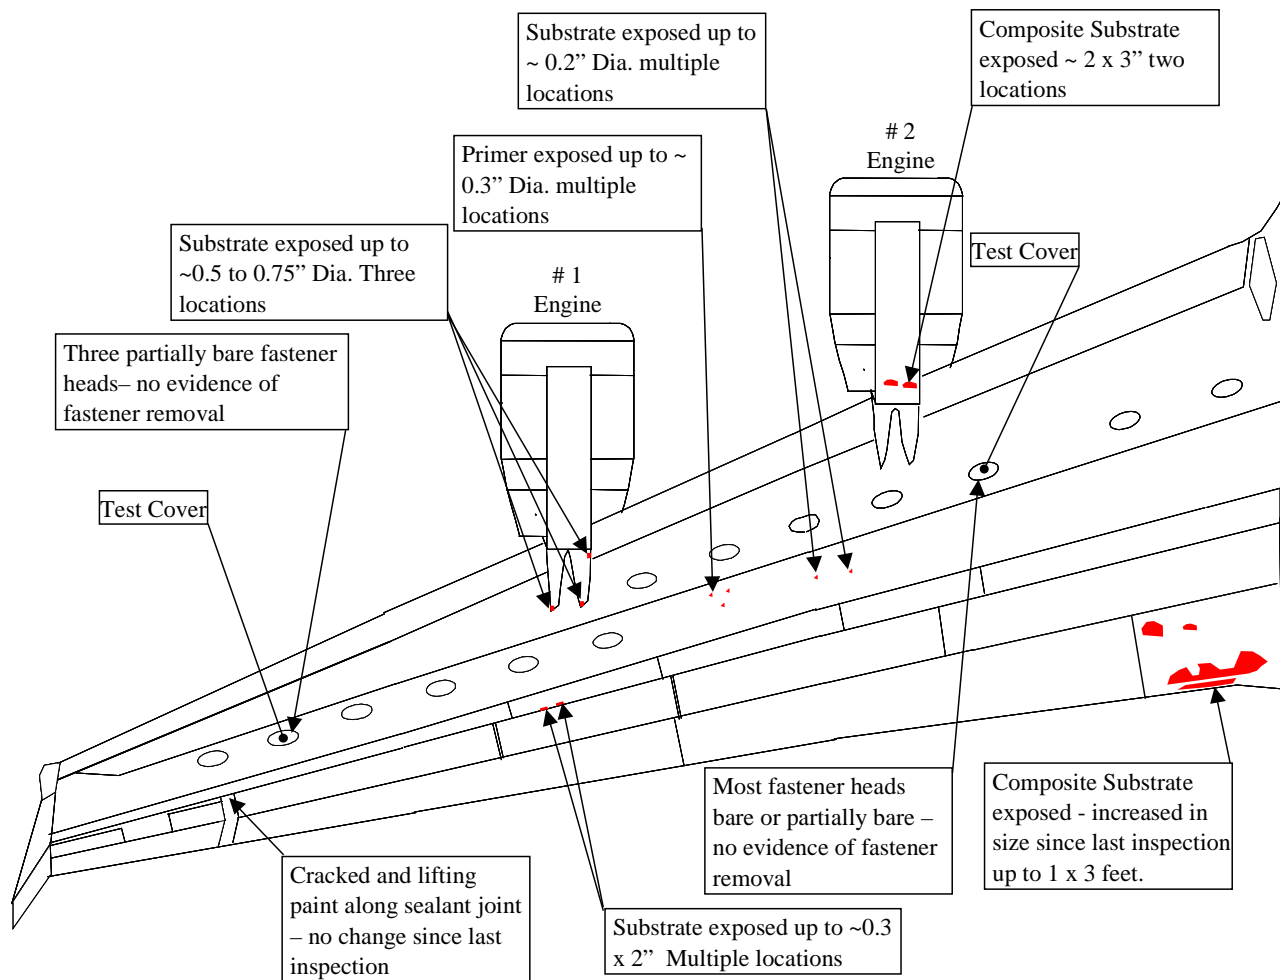
**Figure 1. Left-Hand Wing Looking Down**

Most of the defects seen on the upper surface of the left-hand wing were minor with the exception of an area of peeling paint on the inboard flap. Peeling paint was noted on the flap at the last inspection but has now increased in size by a significant amount (Ref. Figure 1). The failure mode was primer to substrate but the defect area was not observed to be bare prior to painting at the depot, indicating the failure was with previously applied primer.

The cracked and lifted paint on the outboard upper wing over a sealant joint identified at the first inspection has not significantly changed. The failure was at the interface of previously applied primer to substrate.

New defect areas of chipped or peeling paint approximately 0.3" diameter was noted on the wing skins. Some were primer to substrate and some were topcoat to primer. Three areas of primer to metal substrate up to approximately 0.5 to 0.75" diameter were noted on the #1 engine to wing fairing and two areas up to 2" x 3" primer to composite peeling on the #2 engine fairing. All defects are shown in Figure 1.

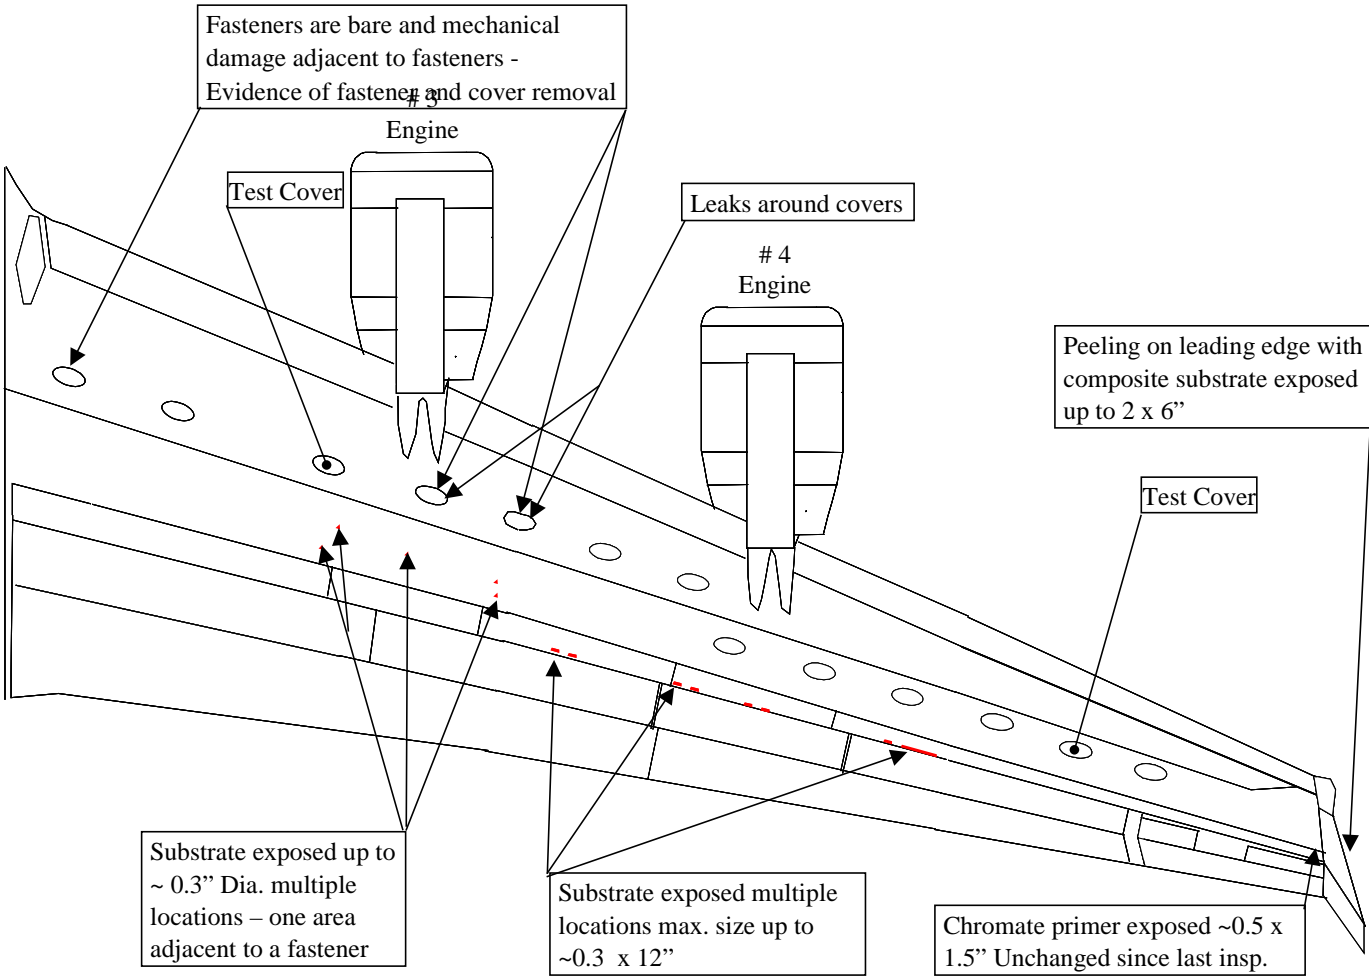
**Figure 2. Right Hand Wing Looking Down**

New defects on the upper surface of the right-hand wing consist of small areas of chipped or peeling paint approximately 0.3" diameter. Without peeling away more paint it was not possible to tell if it was the nonchrome primer that was peeling from the substrate or a previously applied primer. At the final inspection in December a chip of the coating will be removed to ascertain the failure interface.

There were multiple areas of peeling paint to the substrate along the flap seals in the same locations as on the control side but larger in size, up to approximately 0.3 x 12 inches. There was no evidence of peeling on the flap seals prior to applying the nonchrome primer indicating that the failure is at the previously applied primer to substrate interface.

Peeling paint was also noted on the leading edge of the winglet. The winglet was mostly bare prior to priming at the depot and the failure is nonchrome primer to composite substrate.

All of the defects areas are noted in Figure 2.

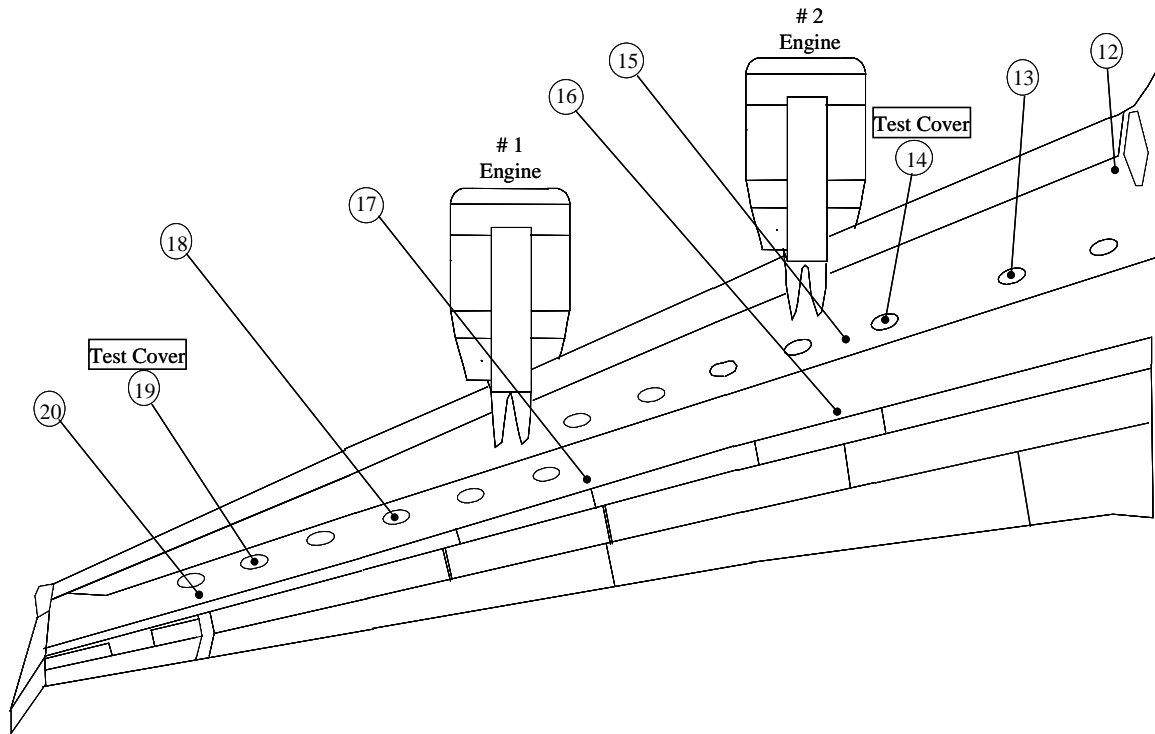
**Figure 3. Left-Hand Wing Gloss Locations**

Figure 3 identifies locations where the gloss readings were taken and locations of the stripped test covers. Each gloss reading location is numbered and results are shown in Table 2. Different color equipment was used to take color readings at this inspection and due to a variance of readings the data is not included in this report. Color readings will be taken at the final inspection with the previously used color meter.

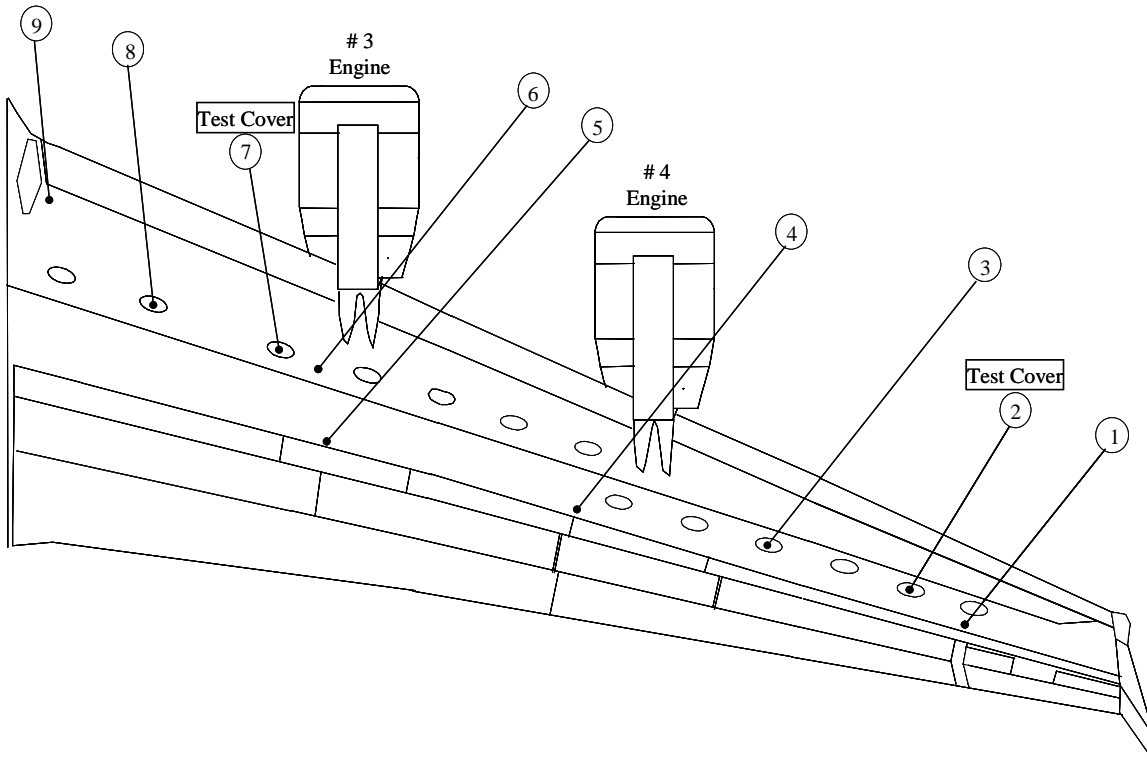
**Figure 4. Right-Hand Wing Gloss Locations**

Figure 4 identifies locations where the gloss readings were taken and locations of the stripped test covers. Each gloss reading location is numbered and results are shown in Table 2. Different color equipment was used to take color readings at this inspection and due to a variance of readings the data is not included in this report. Color readings will be taken at the final inspection with the previously used color meter.

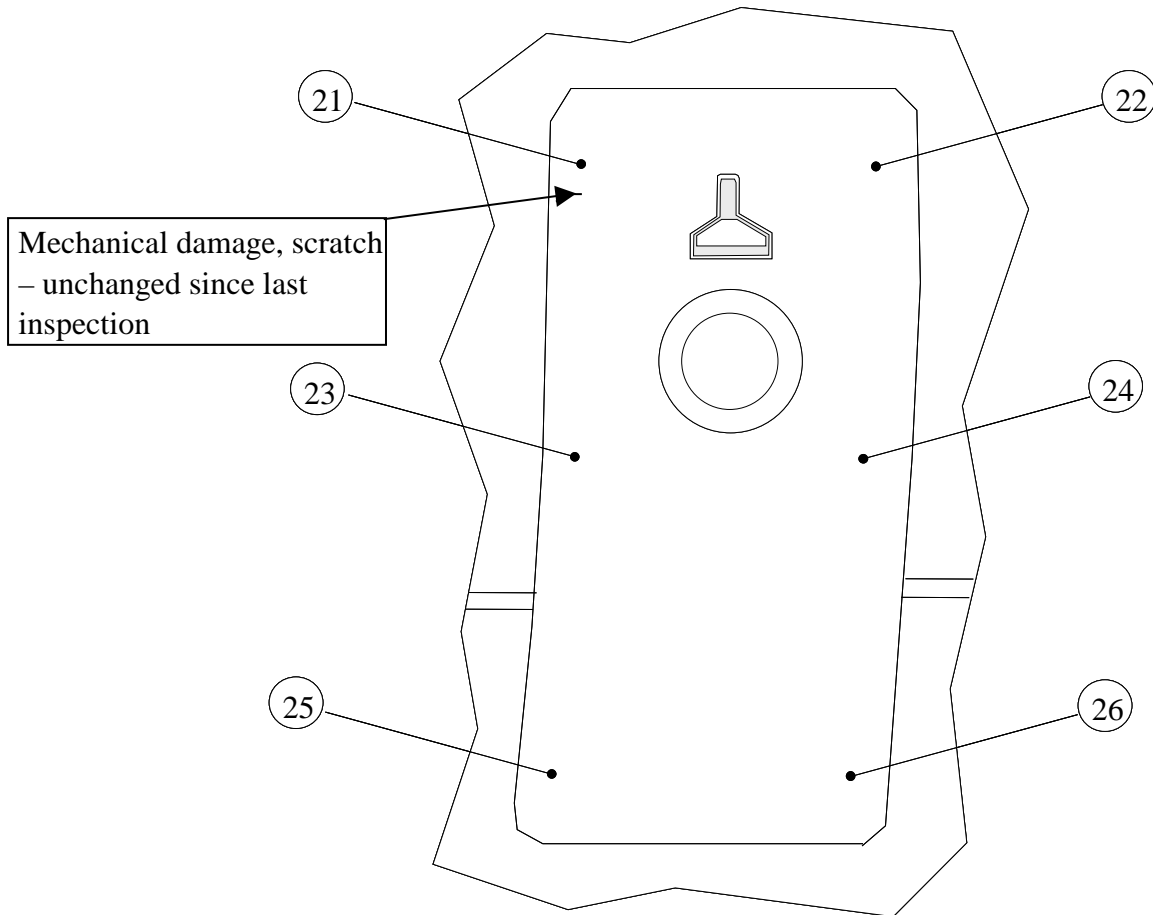
**Figure 5. Emergency Door Right-hand Forward Fuselage, Looking Inboard**

One scratch, due to mechanical damage noted at the last inspection is unchanged. The scratch is approximately two inches long varying in depth from marring the topcoat to exposing the substrate.

Figure 5 identifies locations where the gloss readings were taken. Each gloss reading location is numbered and the results are shown in Table 2.
