**Engineering and Technical Services for
Joint Group on Pollution Prevention
(JG-PP) Projects**

**C-130 Field Evaluation Report
for
29 August 2001 Inspection**

**Inspection of Aircraft
for Validation of Alternatives to
Chromate-Containing Primer Coatings
for Aircraft Exterior Mold Line Skins**

06 September 2001

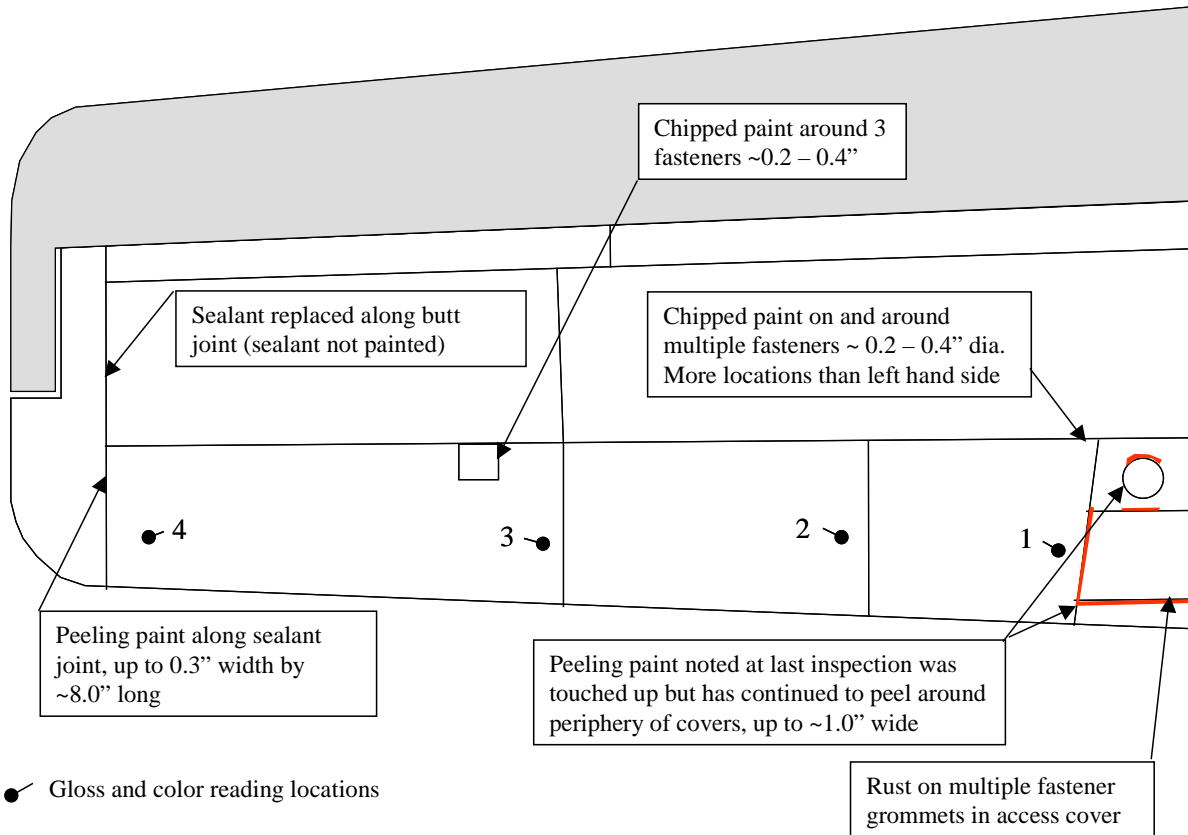
Minor peeling and blistered paint was noted around the access cover on the right hand side and adjacent to the sealant joints at the tip assembly of both horizontals, (Refs. Figure 1&2). The peeling adjacent to the inboard access cover was observed at the initial inspection and subsequent inspections. Evidence of touch-up topcoat was present and the touch-up paint is also peeling. The peeling paint was confined to within 0.2 to 1.0 inches of the sealant joint indicating potential contamination around the perimeter. There was no evidence of corrosion found on the aluminum substrates.

Figure 1. Right-hand Horizontal Stabilizer Looking Down

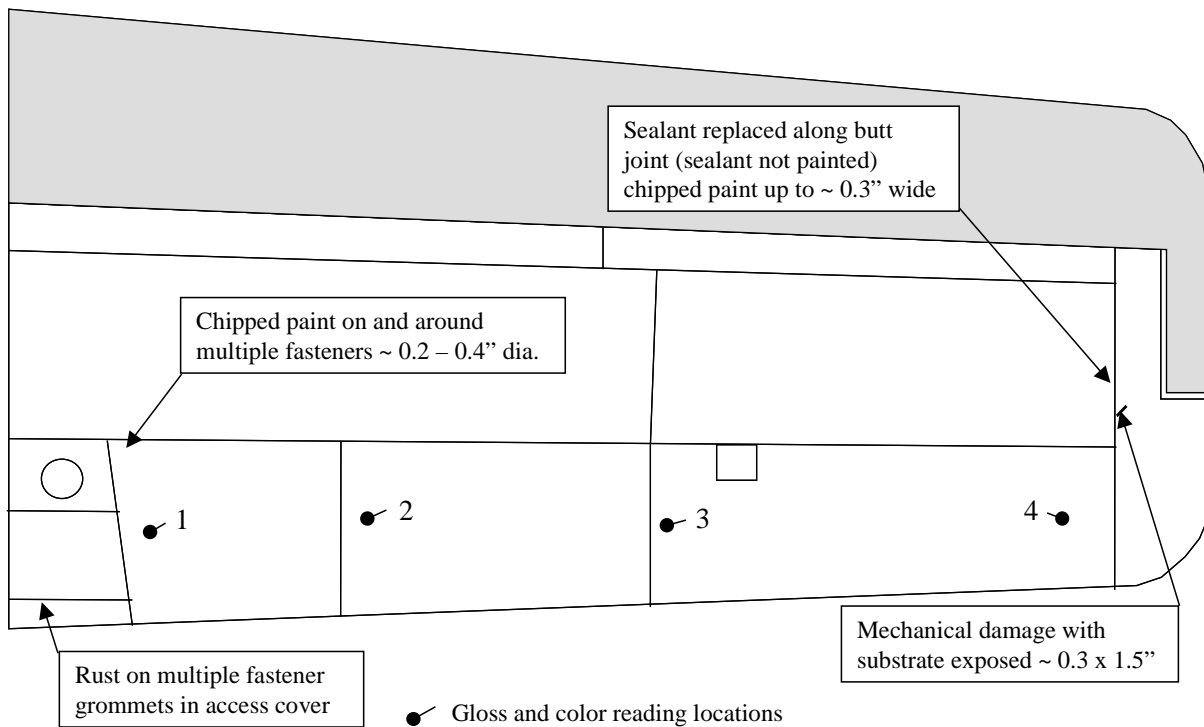
Figure 2. Left-hand Horizontal Stabilizer Looking Down

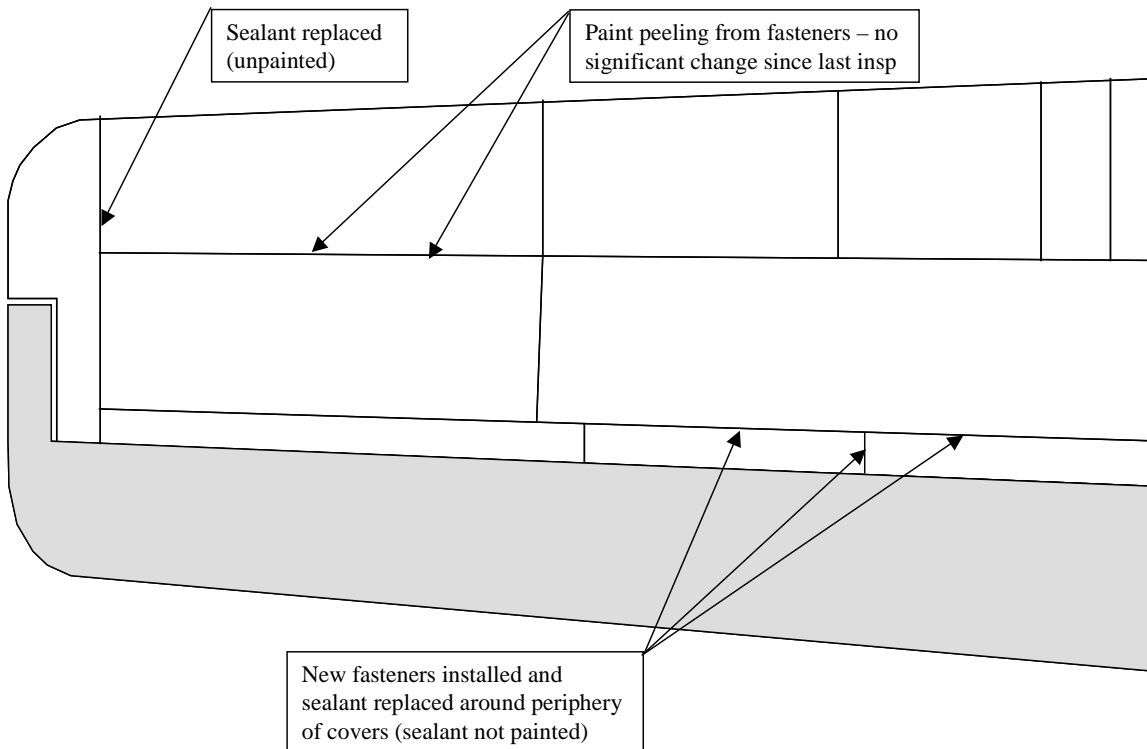
Horizontal Stabilizer Lower Surfaces: Unpainted butt joint sealant and new fasteners installed in removable covers along the aft edge of the horizontals noted at the last inspection were still unpainted. There were also fasteners with chipped paint exposing the fastener heads. (Ref. Figures 3 & 4)

Figure 3. Right-hand Horizontal Stabilizer Looking Up

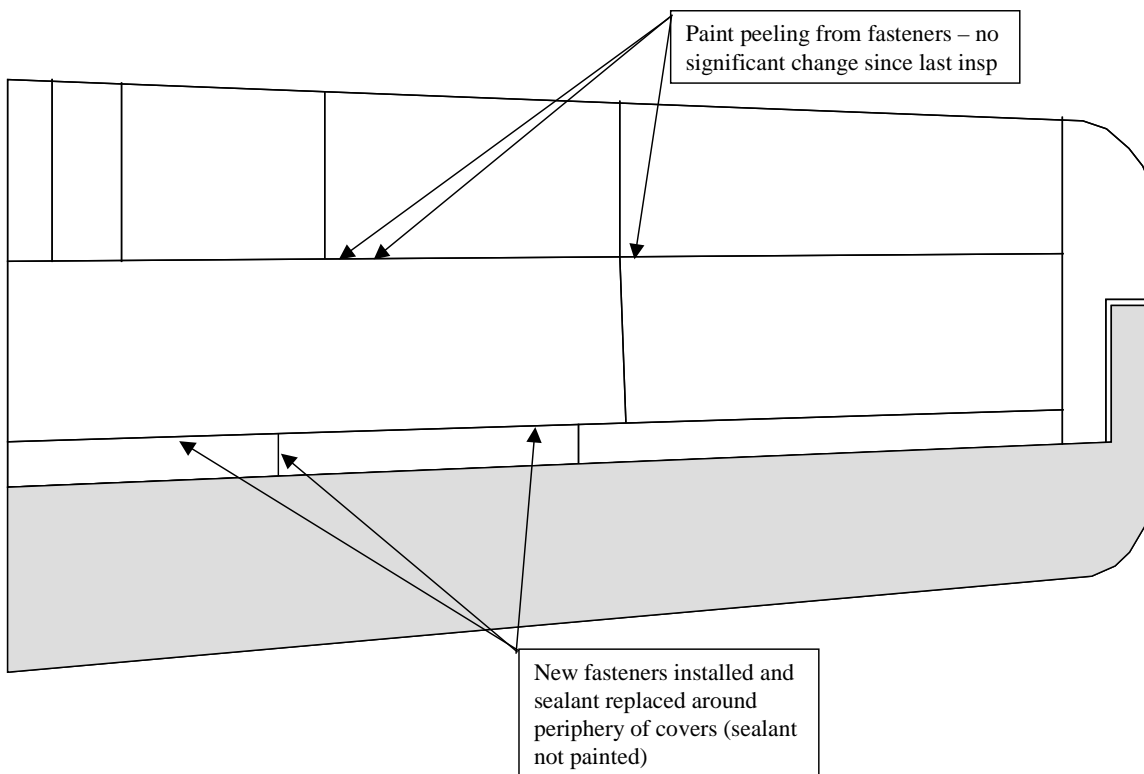
Figure 4. Left-hand Horizontal Stabilizer Looking Up

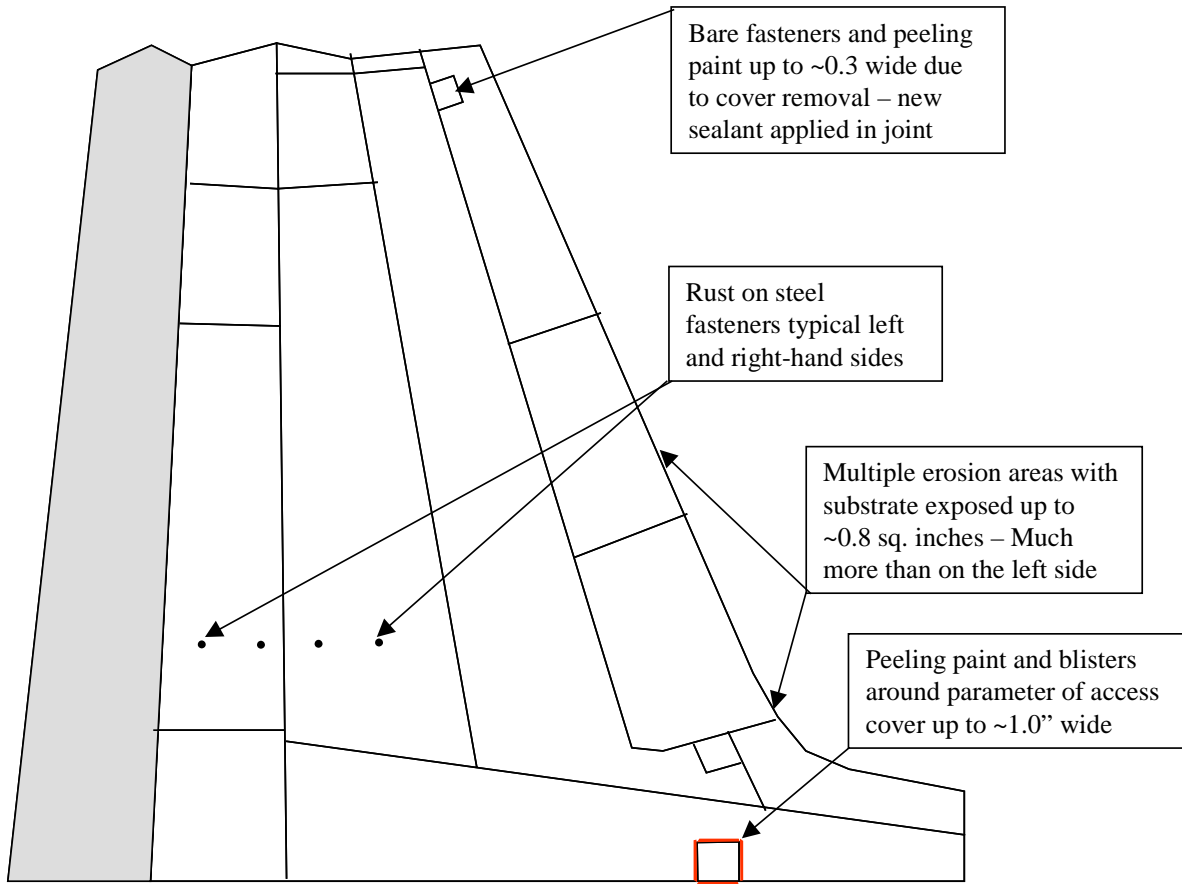
Peeling paint and blisters were noted adjacent to removable access covers on the test and control sides of the vertical. (Ref. Figures 5 & 6) The peeling was up to approximately 0.8 inches wide and 8 inches long.

Figure 5. Vertical Stabilizer Right-hand View

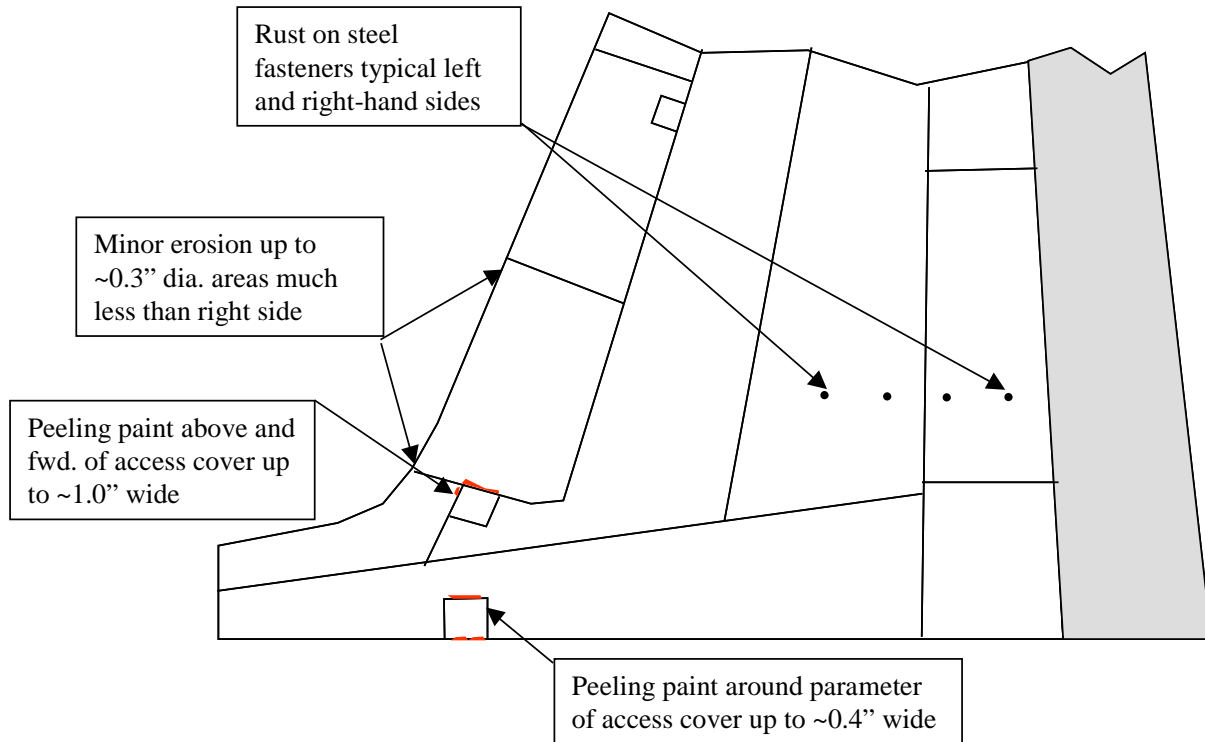
Figure 6. Vertical Stabilizer Right-hand View
