**Field Evaluation Report
of Nonchromate Primer Performance
on Exterior Mold Line Skins
of C-17 Aircraft**

**Inspection Date
01-22-03**

Altus AFB, FL

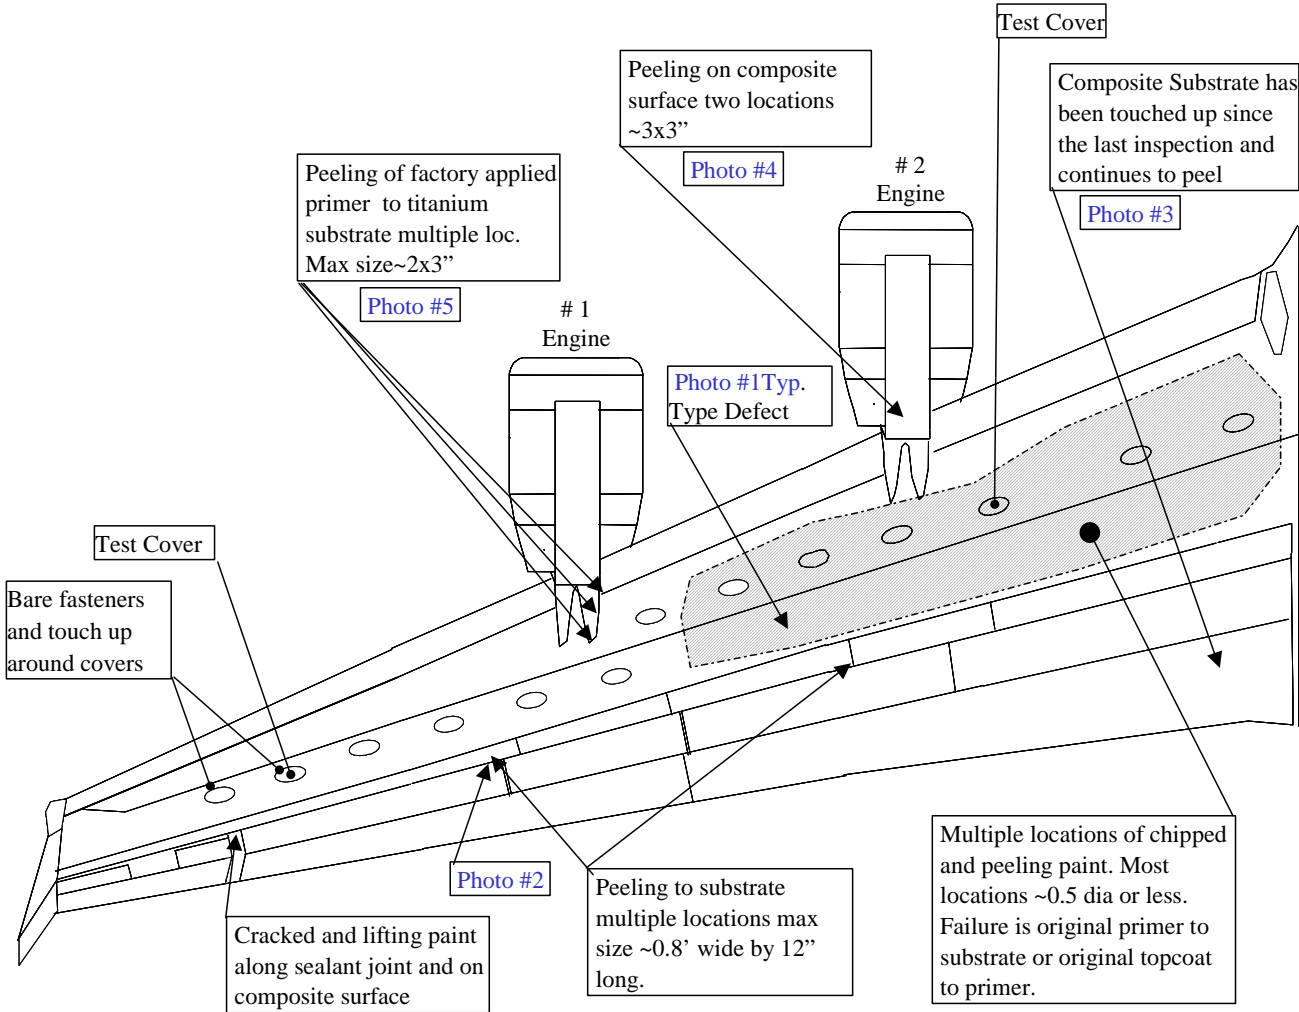
Figure 1. Left-Hand Wing Looking Down

Most defects documented at this inspection were not related to the coating applied for this test. (Ref. Figure 1) Since this aircraft was over coated with a coat of primer and topcoat specimens of paint chips could easily be inspected to determine the location of failure. In most cases the failure mode was original factory applied primer to substrate or original topcoat to primer.

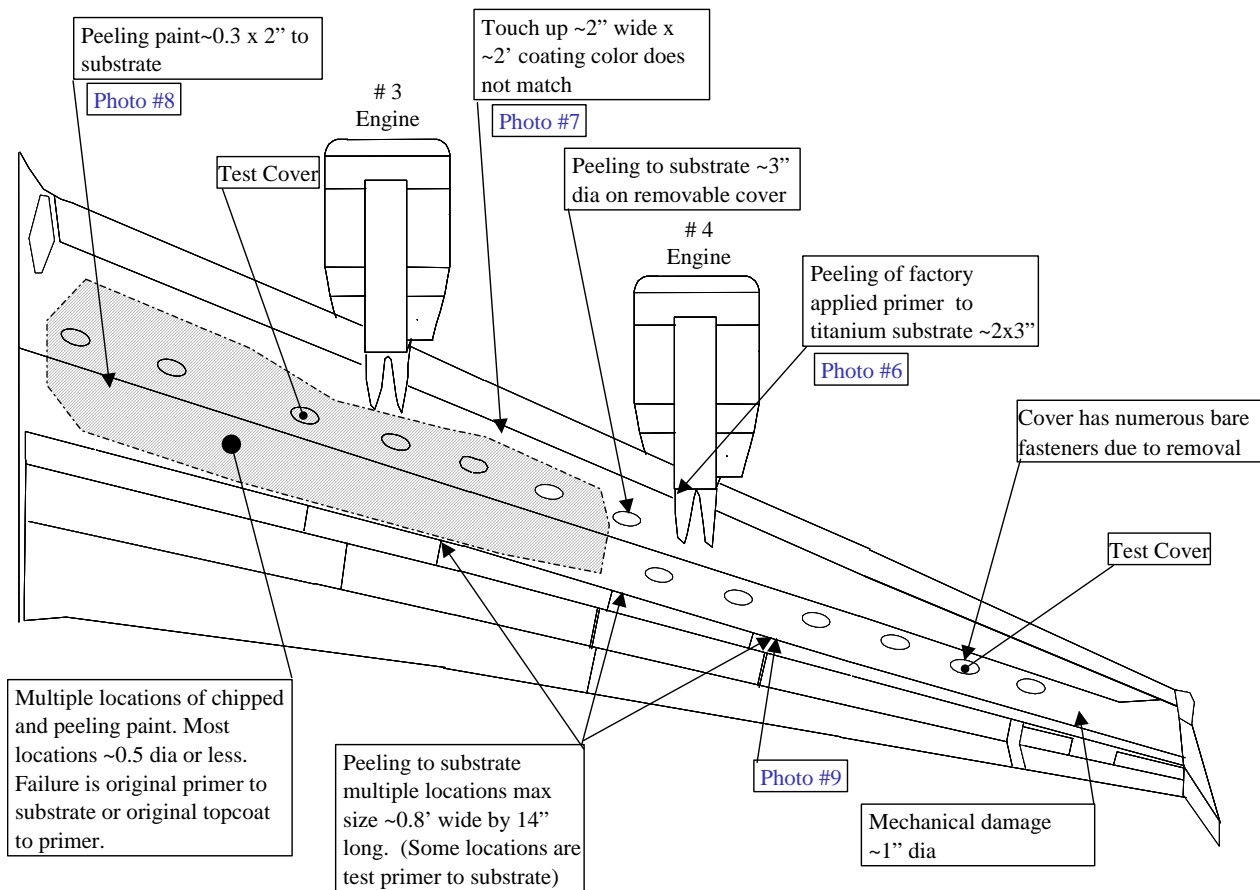
Figure 2. Right Hand Wing Looking Down

Defects seen on the upper surface of the right-hand wing were multiple locations of minor chipped and peeling paint. (Ref. Figure 2).

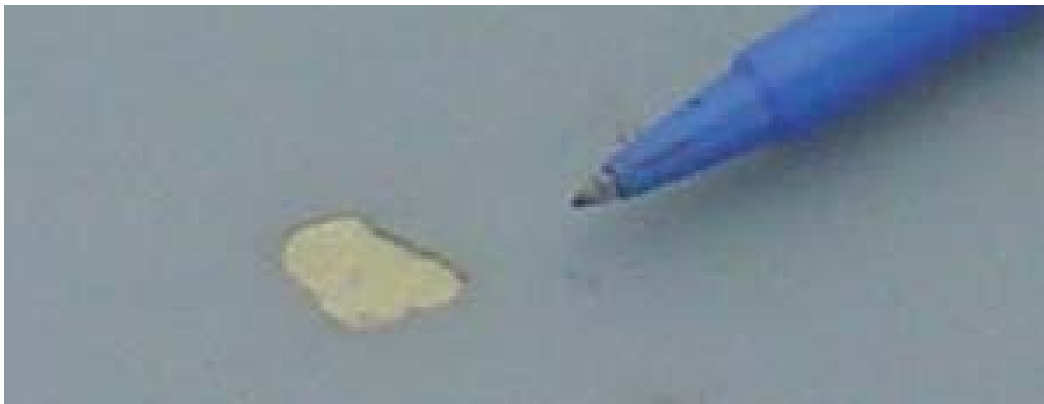
There were numerous locations of cracked and/or peeling paint that were approximately 0.3 to 0.5" diameter. (Ref Photo #1 for typical defect) Many of the sites were noted at the last inspection but additional locations were found at this inspection. Most of the sites initiated as cracked paint that begins to lift after prolonged exposure to moisture. Failure points were either original factory applied chromate primer to substrate or topcoat to original primer and in all cases the failure was the initial coat of primer for this type of defect. The chromate control primer was identified in multiple paint chips between the two layers of topcoat indicating the adhesion failures to be at the original primer surface.

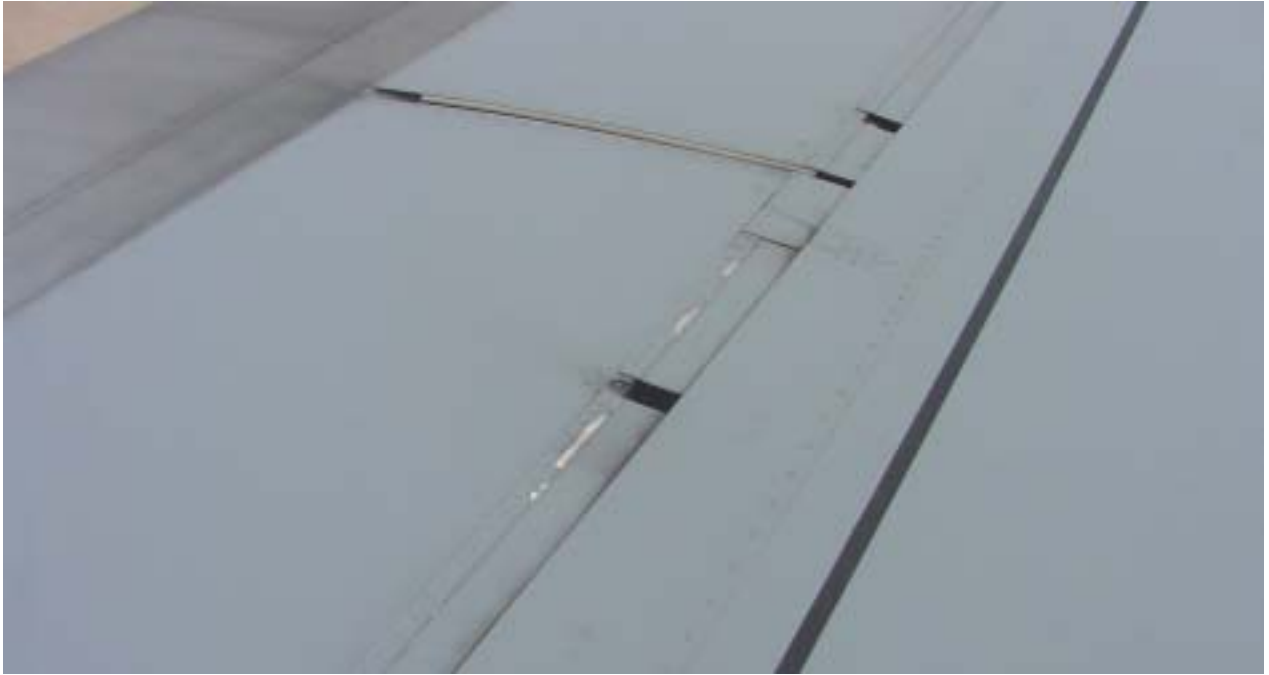
Photo #2

Other defects included peeling paint along the trailing edges of the wing to flap seals. Some of the failures were at the original factory applied primer and some were at the test primer to substrate. (Ref. Photo #2)

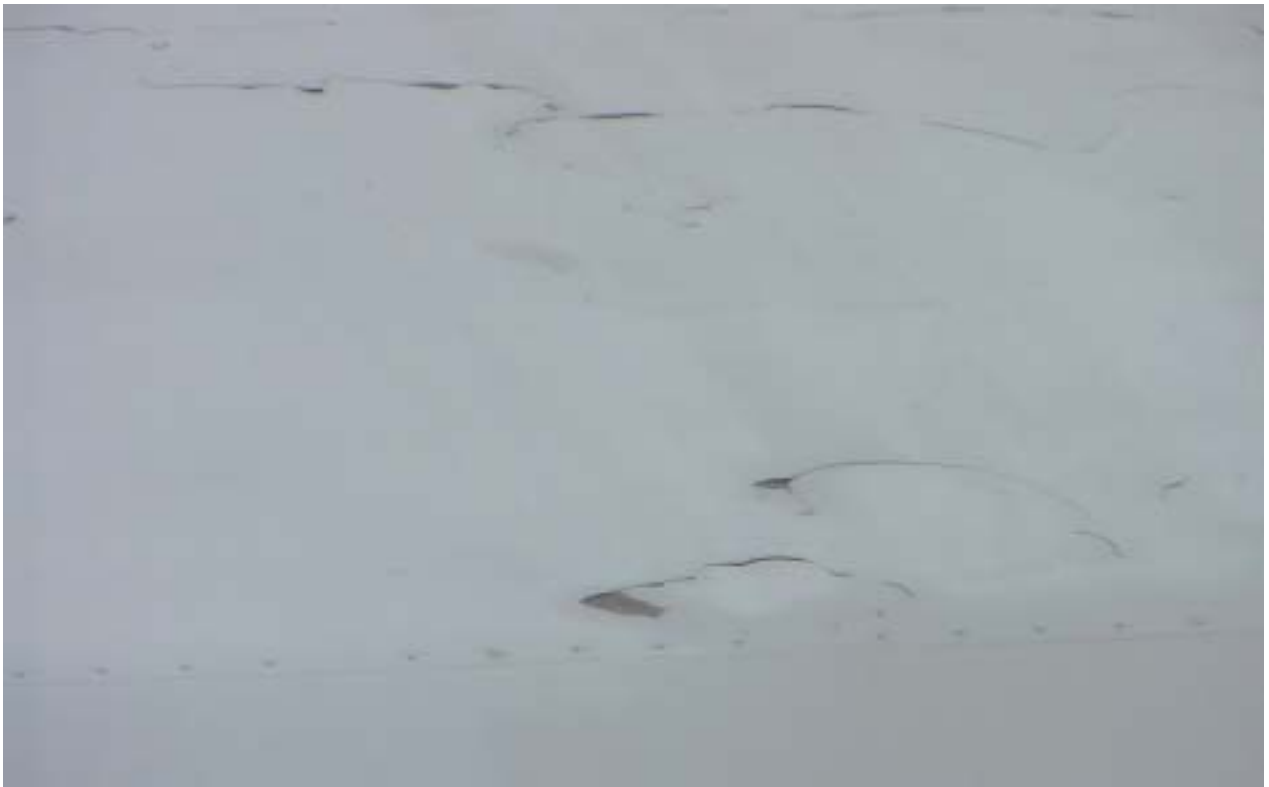
Photo #3

An adhesion failure noted on the top of inboard flap at the last inspection has been repaired. The size of the defect at the last inspection was approximately three square feet and after the repair peeling has continued exposing the composite substrate. (Ref. Photo #3) The composite substrate exposed on the top of the #2 engine pylon has not been touched up and has not changed significantly in size since the last inspection. (Ref. Photo #4)

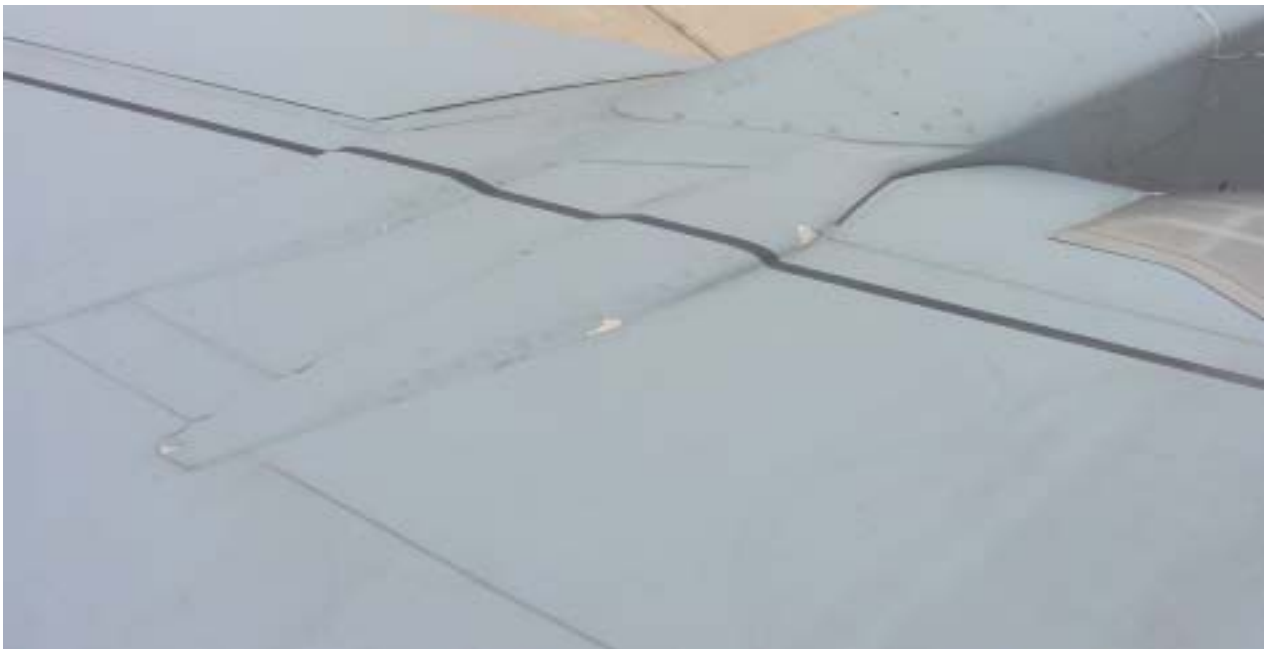
Photo #5

Peeling paint on the titanium engine supports have increased slightly but the failure mode continues to be the factory-applied primer peeling from the substrate. (Ref. Photo #5)

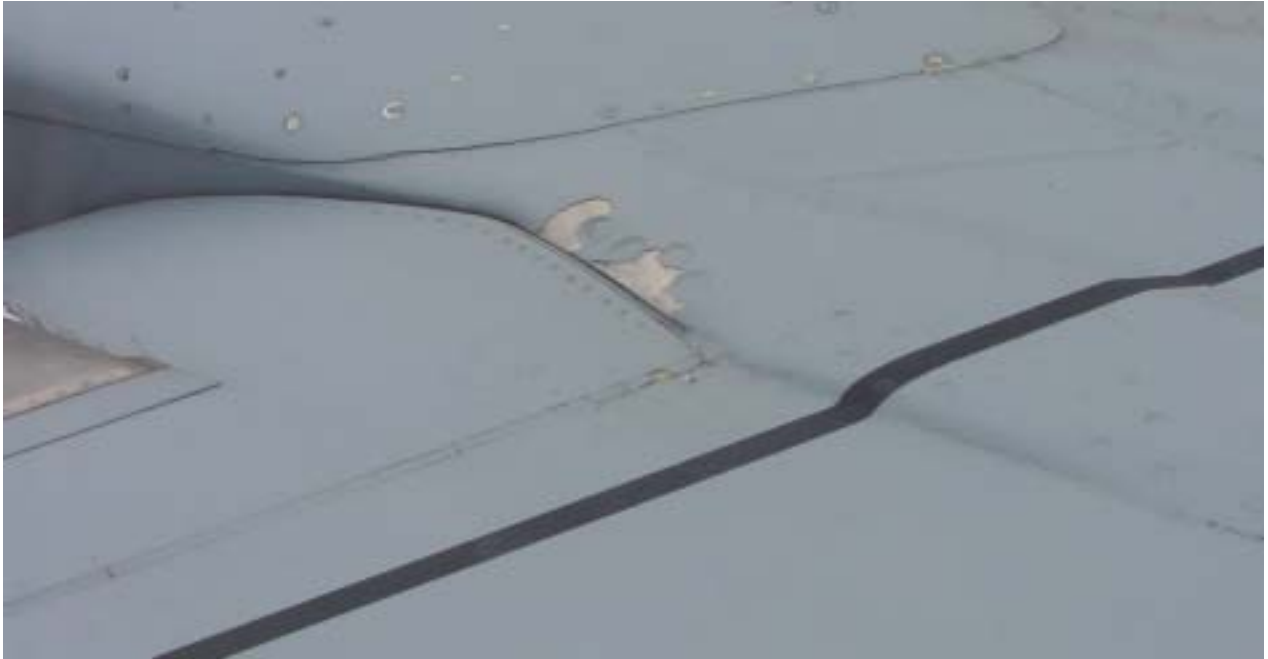
Photo #6

Primer to titanium substrate failure up to approximately 2 x 3" was noted on the #4 engine to wing support. (Ref. Photo #6) The failure mode of the peeling paint areas was the original factory applied primer to substrate. Based on the color, the primer on the engine support was identified as DMS 2144 primer.

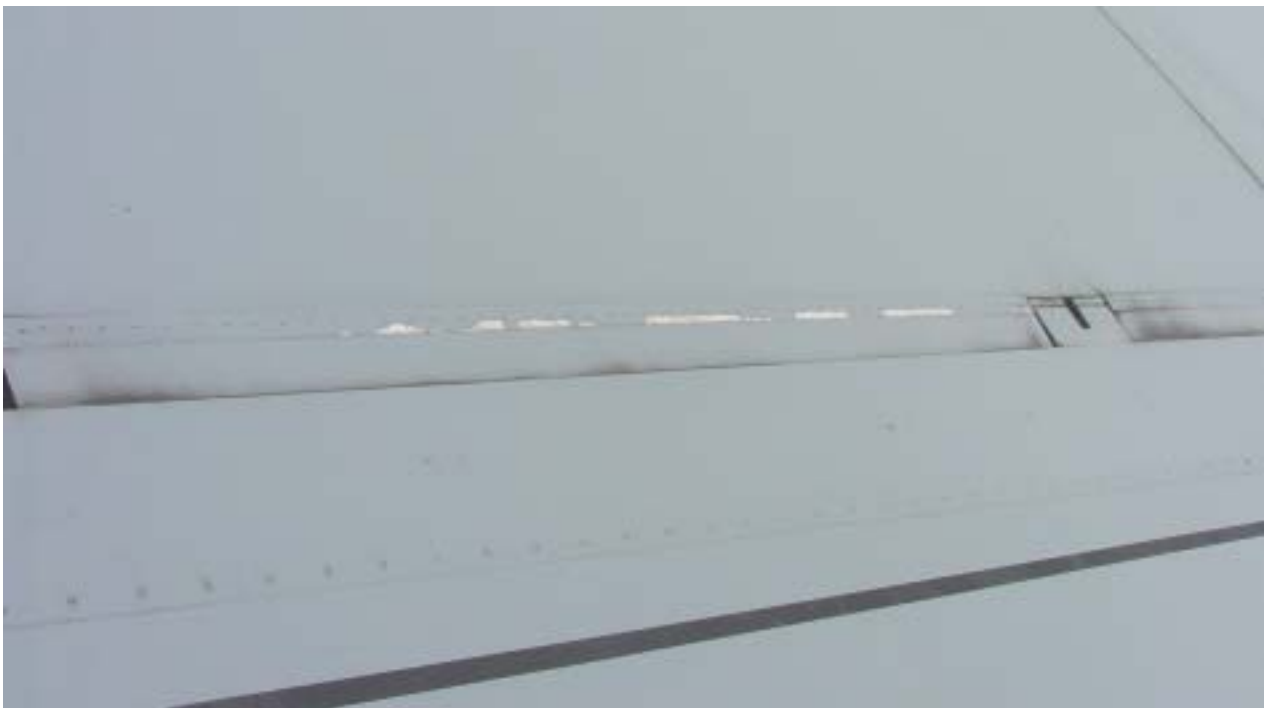
Photo #9

There were multiple areas of peeling paint to the substrate along the aft edges of the flap seals as noted at the last inspection. (Ref. Photo #9) The largest location was approximately 0.8 x 14 inches long. Some of the peeling paint was test primer to substrate and some is original factory applied primer to substrate.
