LOW/NO VOC AND NONCHROMATED COATING SYSTEMS FOR SUPPORT EQUIPMENT

FIELD EVALUATION REPORT #1

3 JULY 2002

Field Evaluation Report #1

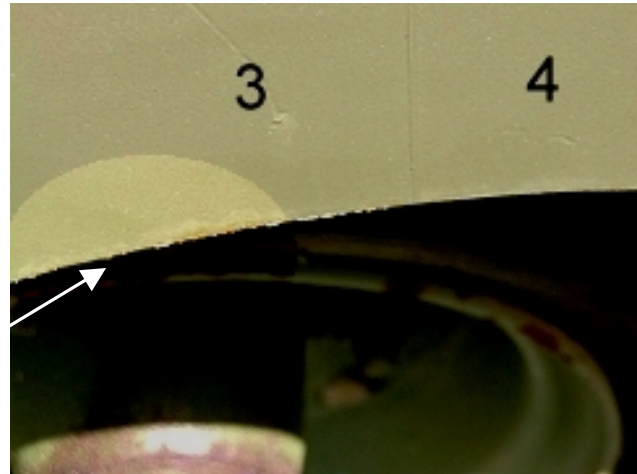
Aircraft Generator, Registration # 83X1003, #137

The survey team rated the overall appearance and surface condition of the test coating systems as good to excellent. The team visually compared each of the coating systems using the color standard (two pieces of metal painted with all five coating systems made at the time of the initial coating application) showed minor color differences. Water spots and dust appeared over the entire fender, likely cause would be morning dew or rain and dust from the surrounding area. The team members were unable to effectively clean off the spots and dusty dirt, which may attribute to the lower gloss measurement readings. As with the other -86 generator panels, the pre-existing corrosion located in a seam weld area has not progressed beyond the surface rust previously reported. Wash schedules and materials are the same as reported on our initial visit. No major corrosion was identified; however, a small area exhibited coating lifting and minor corrosion noted along the edge of the wheel well opening with coating system #3. The team determined the probable cause was a lack of coating wraparound along the edge. SAIC will request the on-site project manager track this area more often to determine if the corrosion is propagating.

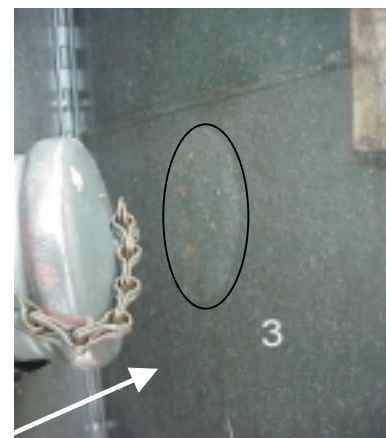
NF-2 Light Cart, Registration # R-96

The local equipment registration number has changed from R-21 to R-96. The registration number correction has been entered in the coating tracking workbooks. The overall test coating appearance on the door panel appears good to excellent with some minor surface corrosion in coating system # 3. The corrosion occurred where the test coating has chipped to bare metal. The apparent cause of the chipping is related to the door's operation. Technicians opening the door are not properly latching the door. As a result, the door is repeatedly striking the gas cap and chain, shown in this high- lighted area. The survey team will track the

progression of these areas of corrosion. Pre-existing corrosion located in the hinge and latch area has not progressed beyond the surface rust previously reported. No major coating failures were noted. As part of the normal equipment corrosion preventive maintenance, all assigned equipment, including this unit is coated with "Corrosion X" Corrosion Preventative Compound (CPC). Prior to color and gloss measurements, the survey team removed all "Corrosion X" using a General Purpose Detergent, 7930-00-926-5280, Fed Spec P-D-1747C, Class 1. The 920 MXS maintenance personnel provided this product.

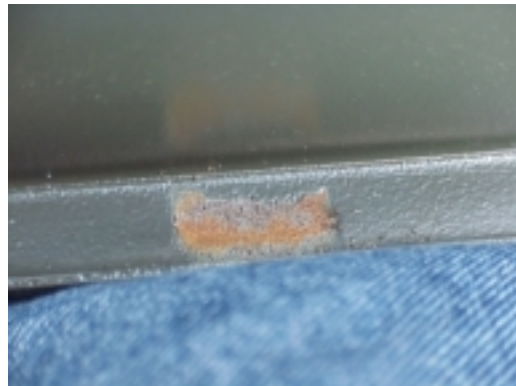
NF-2 Light Cart, Registration # R-98

The local equipment registration number has changed from R-73 to R-98. The registration number correction has been entered in the coating tracking workbooks. The overall appearance of the door panel looks good with minor rust found inside the door bottom lip caused by a 1-inch piece of masking tape that was not removed when the initial coating application took place. This will be considered as pre-existing corrosion as reported at the beginning of this report. Pre-existing corrosion located in the

hinge and latch area has not progressed beyond the surface rust previously reported. This unit was coated with "Corrosion X", (CPC), which is used by maintenance personnel to help reduce corrosion on assigned equipment. Prior to color and gloss measurements, the survey team removed all "Corrosion X" using a General Purpose Detergent, 7930-00-926-5280, Fed Spec P-D-1747C, Class 1. The 920 MXS maintenance personnel provided this product.

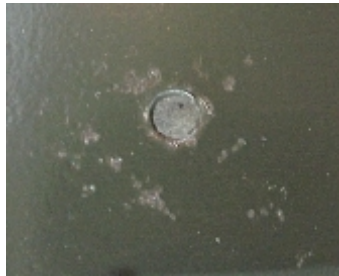
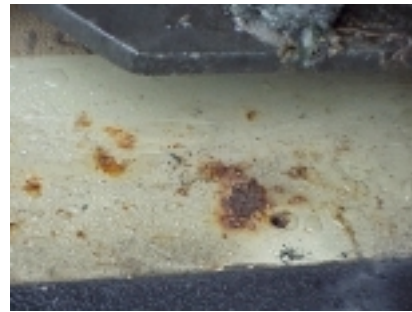
De-Icing Truck Boom Cover Plate, Truck Registration # T-46

coating systems to high heat, humidity, carbon deposits, deicing fluids, and exhaust gases. The panel had numerous scuffmarks and scratches in coating systems 1, 2, and 5. These discrepancies are not a result of coating degradation, but could have occurred during installation and normal maintenance. The boltholes around the outer edge of the panel each had, what the team initially thought to be corrosion, originating on the test

panel. Further investigation revealed the panel was installed over a corroded spot on the mating surface of the truck. The supposed corrosion on the panel was actually staining transferred from the corroded spot. The coating was marred but no actual corrosion

was evident in the coating depressions. Pre-existing corrosion located in a seam weld area has not progressed beyond the surface rust previously reported.

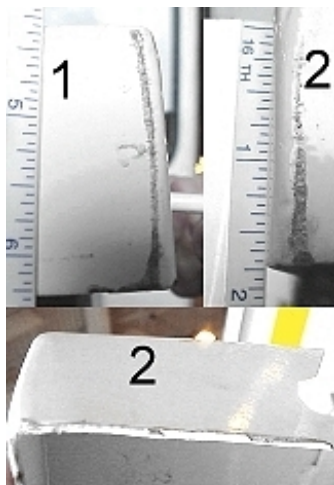
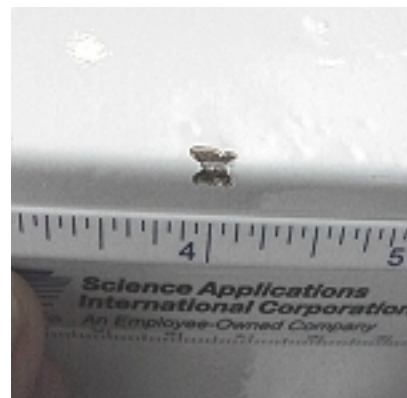
Towing Tractor Hood, Registration # LTC-084

The overall appearance of the tractor hood appears good to excellent. No major corrosion was noted during this visit. Prior to taking gloss and color measurement, the survey team removed the "road film". The hood was cleaned using a Navy approved cleaner, (Oasis 136, NSN 7930-01-398-0955, manufactured by ECOLAB), and rinsed with water. Gloss measurements were taken twice and both reading series were higher than our initial measurements. Coating system 5 had a small chip that

went to the substrate; probable cause maybe a dropped tool. No corrosion was seen on the substrate. Coating systems 1 and 2 were worn and scratched on the leading edge corners; probable cause was standing on end prior to installation.

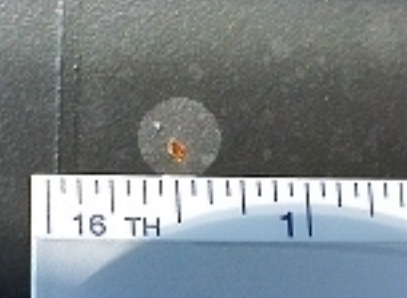
The survey team rated the overall appearance and surface condition of the test coating systems as good to excellent. However, the survey team did note coating systems 3 (Photo [mvc-003x](#)) and 4 (Photo [mvc-006x](#)) had singular spots of corrosion resulting from a break in the coating system. The breaks in the coating systems appeared a result of impact damage; however, this could not be confirmed. The spot in both coating systems indicated red rust in the point of origin, but there were no indications of rust creepage under the coating. Water spots and dust appeared over the entire fender, likely cause would be morning dew or rain and dust from the surrounding area. We were unable to effectively clean off the spots and dust, which may attribute to the lower gloss measurement readings. As previously noted, all three –86 generator fender wells had similar areas on the underside of the panels where primer and topcoat missed a closed seam. We are monitoring each of the condition of the fenderwells. As of this survey, the condition of the specific welds area on the fenderwells, (typical condition shown here [mvc-001x](#)), have not progressed beyond the surface rust previously reported. Wash schedules and materials are the same as reported on our initial visit.
