Field Evaluation Report

8 August 2003

Location: Naval Air Station (NAS) Brunswick, ME
Cape Canaveral Air Force Station (AFS), FL
Patrick Air Force Base (AFB), FL
Naval Station (NS) Everett, WA

Visit all test locations and document gloss and color measurement readings and inspect test articles for coating failure and corrosion.

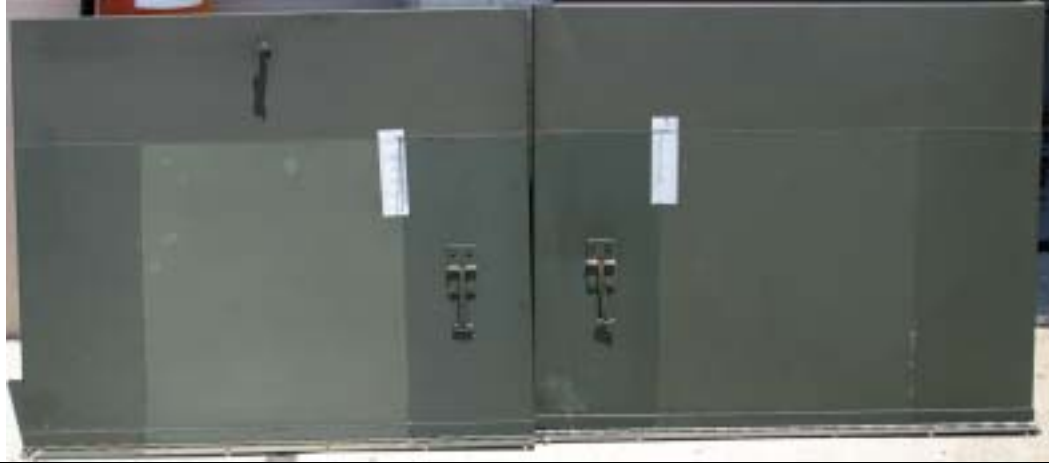
This survey completes the 18-month field test evaluation. All field evaluation report (FER) findings will be compiled into a final project report. Overall, the test topcoat materials were comparable with the baseline topcoat, MIL-PRF-85285. With exception being the Deft 0-VOC topcoat, semi-gloss green color number 24052. This material exhibited far more gloss loss and chalking at the 18-month point, than when initially identified at the 12-month inspection. Figure [1](#), [2](#), and [3](#) illustrate the typical

fading and chalking experienced on the 0-VOC test sections. Our conversation with the Deft Coating government sales representative, Mr. Chris Anthanasopoulos, (847) 698-7535, indicated his belief that the green, being a lab batch, contain substandard resins that were not UV resistant. The white coating was formulated earlier using a different resin batch number. Both the white and green 0-VOC materials were applied per the manufacturer's instructions on the same day. The white 0-VOC did not exhibit the same fading and chalking characteristics as was shown on the Cape Canaveral AFS and Patrick AFB FL test panels. The semi-gloss green 0-VOC coating applied to the de-icing truck panel located in Brunswick ME, was protected from UV exposure, and did not exhibit chalking or fading. Based upon this information, we concur with the coating formulator that the chalking and fading exhibited on the semi-gloss green was the result of a substandard resin used by the coating formulator for the semi-gloss green test coating batch.

Figure 1 – Side by side comparison of panel with chalked coating removed and not removed

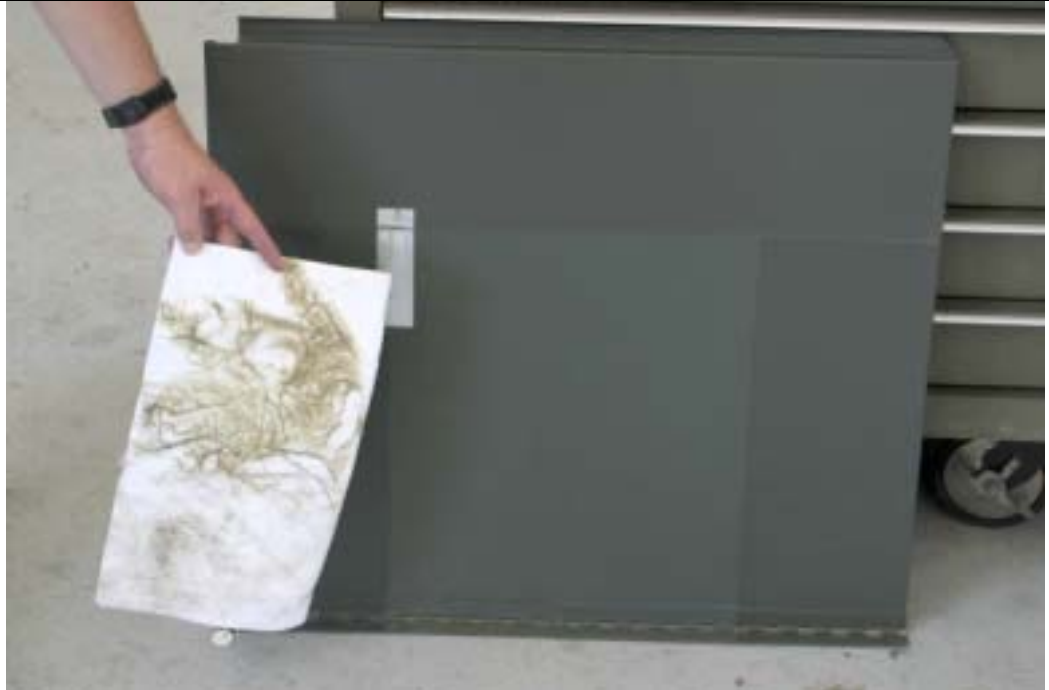
Figure 2 – Chalked 0-VOC coating removed

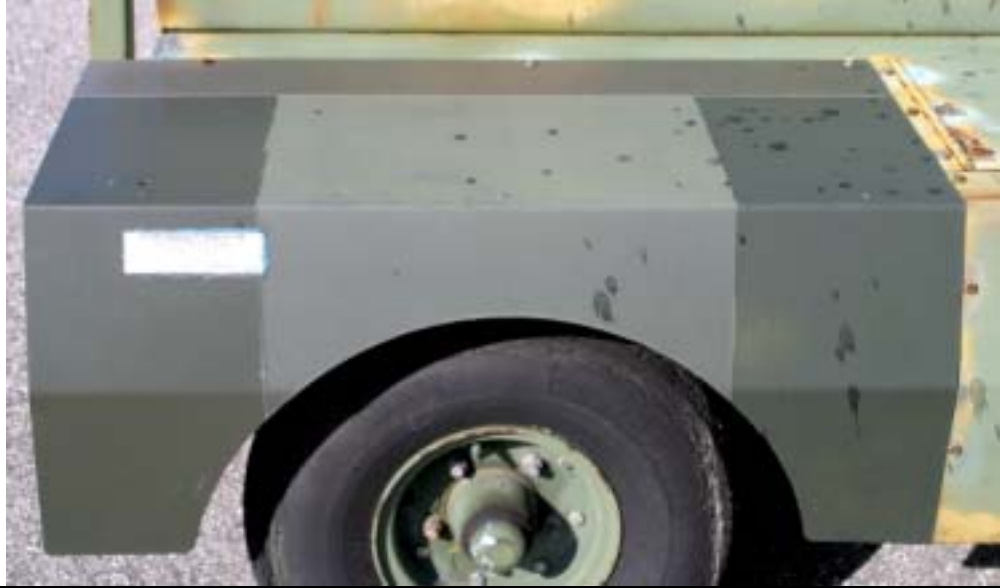
Panel 3 – Typical color/shade variation noted on all of the 0-VOC coating, semi-gloss green test panels

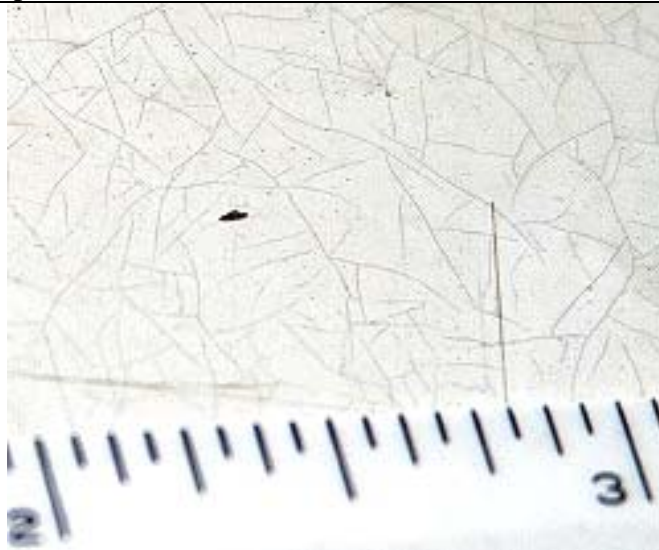
Coatings 1 and 2 are both thermoset powder coating systems. Both systems performed exceptionally well except when the test articles were exposed to high heat. Both powder coating systems exhibited micro-cracking/crazing on the Navy A/S47A-1 Enclosure panel that was assigned to the USS Abraham Lincoln, see Figure 4. This panel was exposed to almost continual use on-board the USS Abraham Lincoln while deployed at sea for approximately 10.5 months. We are unable to determine at what point the powder coated sections began to exhibit the micro-cracking/crazing. However, the panel in question is positioned directly over two turbine engine exhaust vents, see Figure 5. The baseline coating displayed heat damage in areas approximately 12-inches in diameter in the baseline coating area and 6 inches in diameter in the 0-VOC coating area, see Figure 6 and 7. Thermal profiling of the affected heat zones were not accomplished, however based upon the visual discoloration exhibited the damage is consistent with coating being in a range capable of visual discoloration of the baseline coating. The micro-cracking/crazing did not result in chipping or peeling of the coating. There was one area of corrosion noted in the coating 2 and coating 5 area where a part had been removed and the coating had deteriorated, see Figure 8.

Figure 4 – Close-up enhanced photo of the micro-cracked/crazed powder coating on panel 01

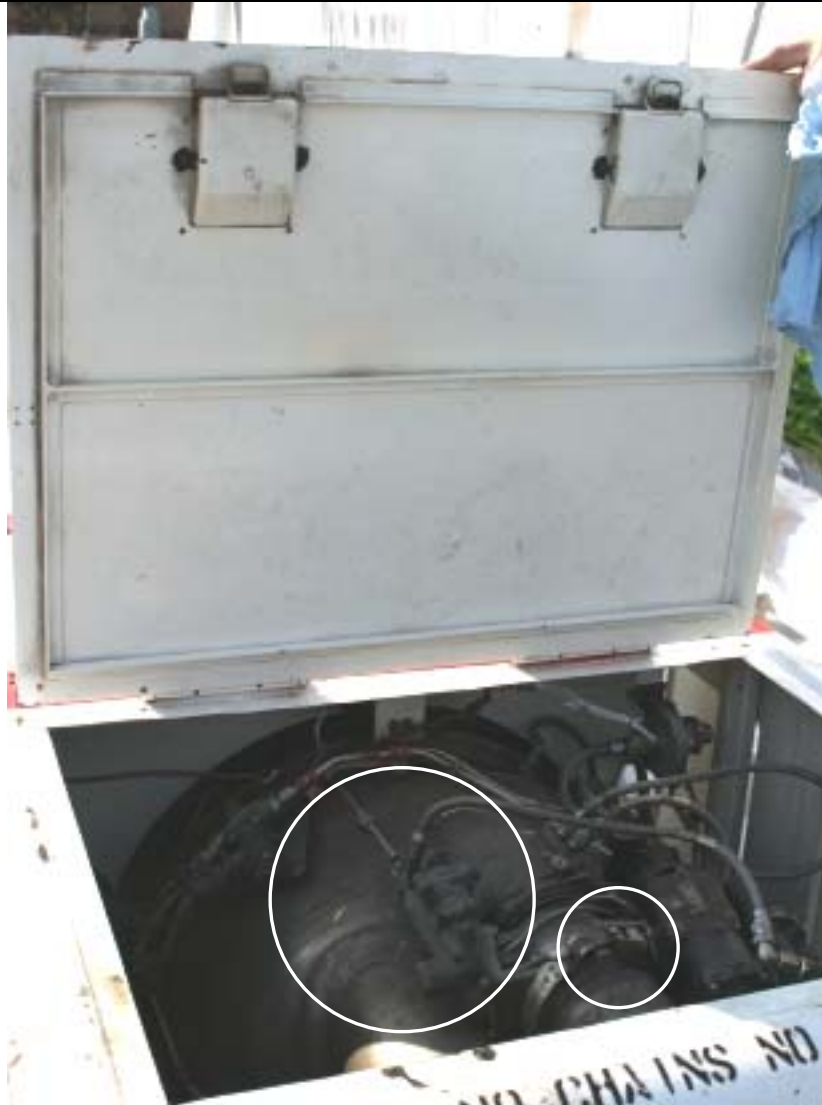
Figure 5 –Circled areas highlight typical heat vent source areas on the A/S47A-1 Enclosure panel

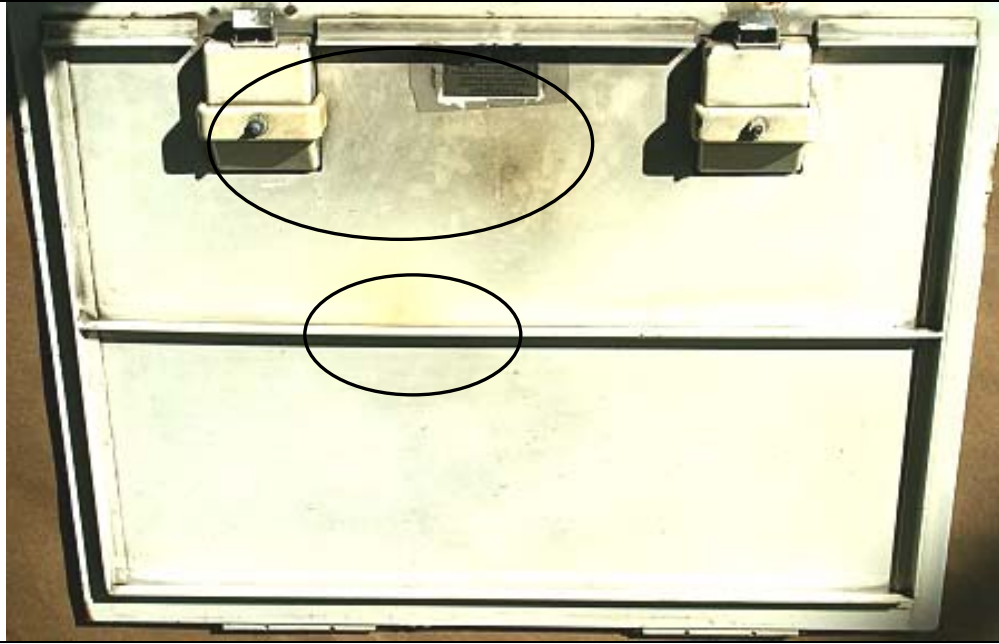
Figure 6 – TAC 4 Huffer panel interior view. Circled areas indicate discoloration from the auxiliary power unit heat exhaust

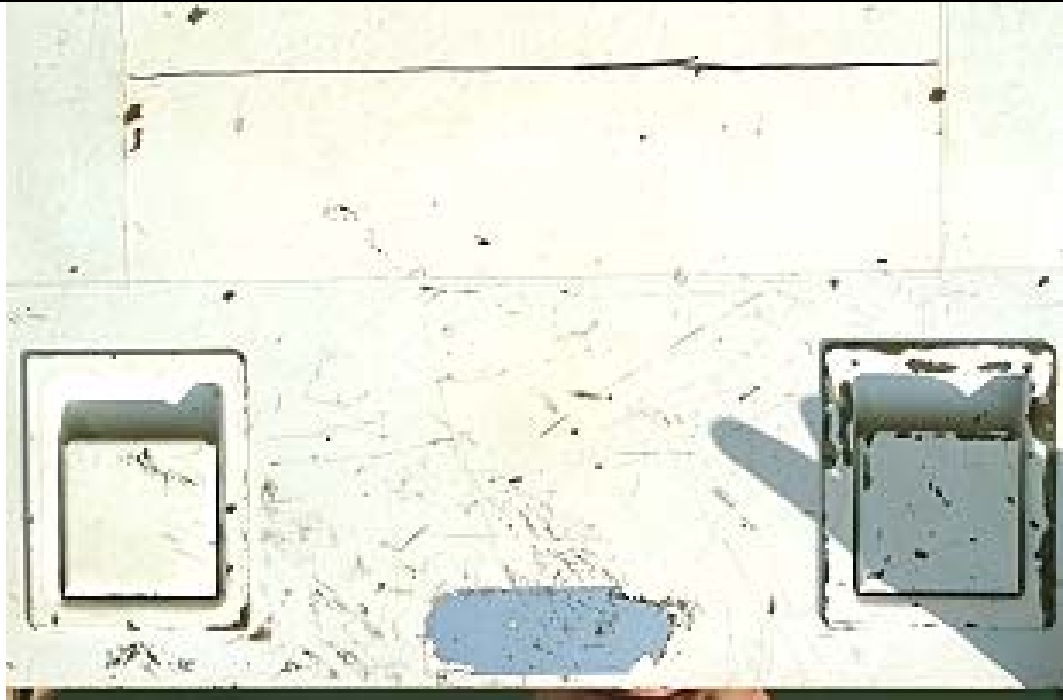
Figure 7 – External view of heat zones – Black line indicates stiffener location on the underside.

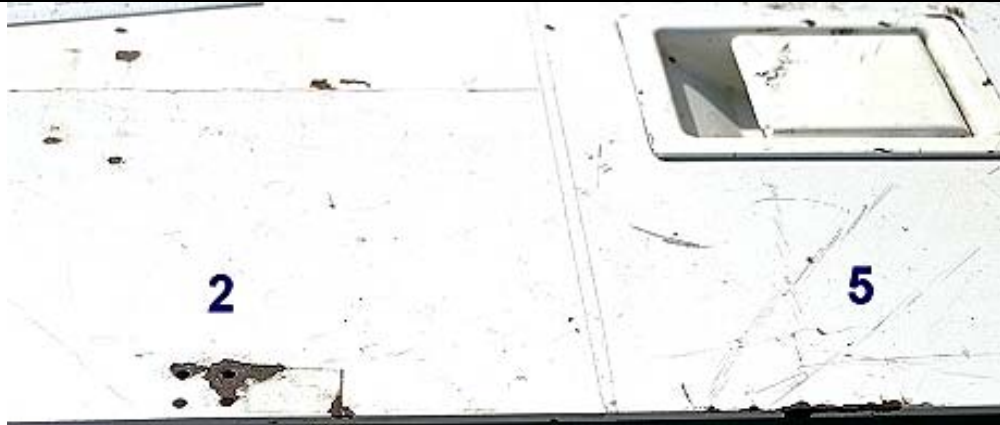
Figure 8 – Panel 01 - Damage noted on coating system 2 and 5

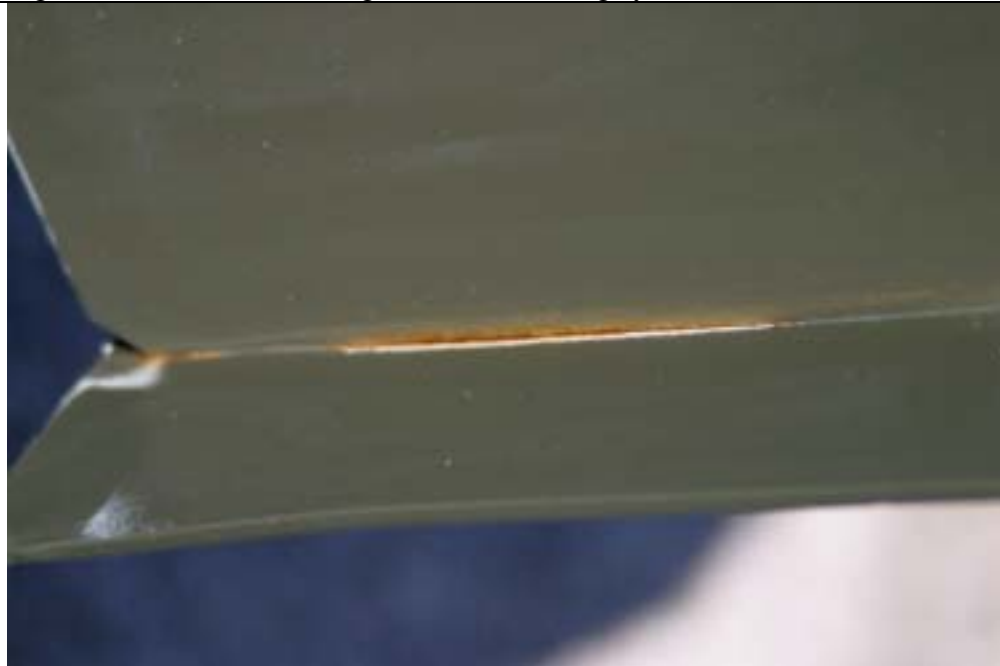
As noted in the initial and follow-on reports there were several coating defects purposely induced in the initial coating application as a part of this test, see Figure 9. Those areas will not be part of the coating comparison scoring. However, the coating defects will be evaluated subjectively as to any coating deterioration or corrosion propagation noted during the 18-month test. The induced defects are those such as rust formed in the hinge and/or seam areas (e.g. missed in hidden areas; opened piano hinge and Faraday Effect of the powder coating) during the initial coating application.

Figure 9 – Typical induced coating defect after 18-months exposure at Cape Canaveral AFS, FL

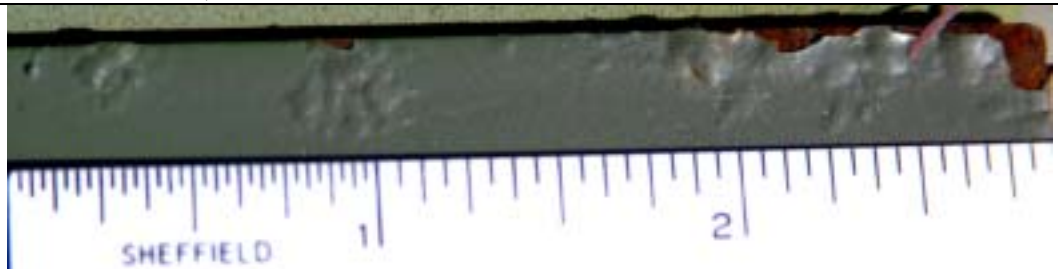
Figure 10 - Panel 07 Corrosion noted on edge of the panel in the baseline coating section
