**Field Evaluation Report
of Nonchromate Primer Performance
on Exterior Mold Line Skins
of C-17 Aircraft**

**Inspection Date
01-22-03**

Altus AFB, FL

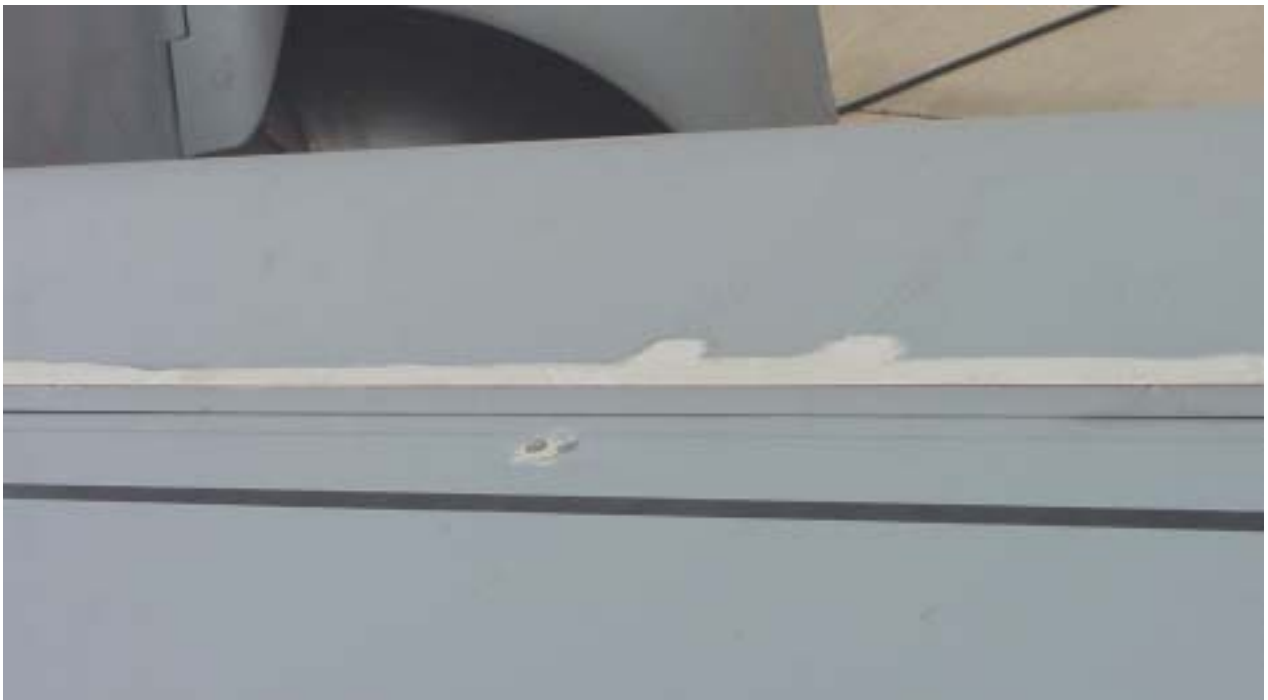
Photo #6

Primer to titanium substrate failure up to approximately 2 x 3" was noted on the #4 engine to wing support. (Ref. Photo #6) The failure mode of the peeling paint areas was the original factory applied primer to substrate. Based on the color, the primer on the engine support was identified as DMS 2144 primer.
