**Field Evaluation Report II
USS John F. Kennedy**

23 Sept 02

Location: Naval Station Mayport, FL

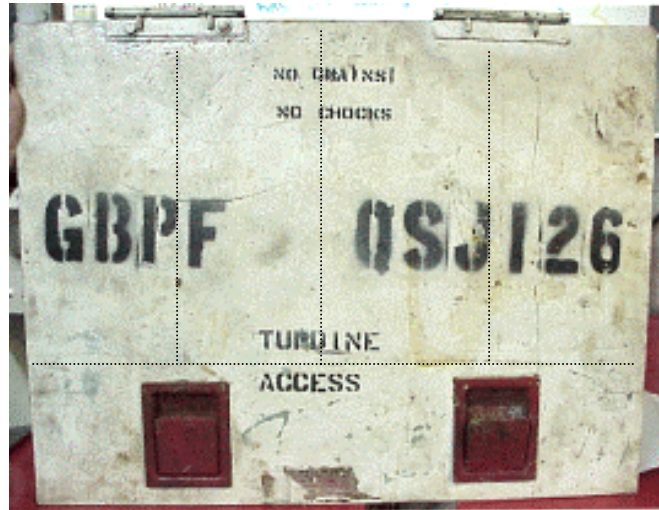
The test coatings were applied to sectionalized panels on operational SE. Each panel was divided into 5 sections. Sections 1-4 received one of the test coating systems with the baseline coating intersecting all of the test coatings in section 5. The typical coating pattern is shown here. We have inserted gray lines on the photos to approximate the test areas. These lines are not on the test panels themselves.
